The geopolymer composition for restoration, construction and substitution

Hanzlicek Tomas, Perna Ivana, Steinerova Michaela

The Institute of Rock Structure and Mechanics of the Academy of Sciences in collaboration with Sculpture and restoration school of prof. P.Siegel City of Adršpach,

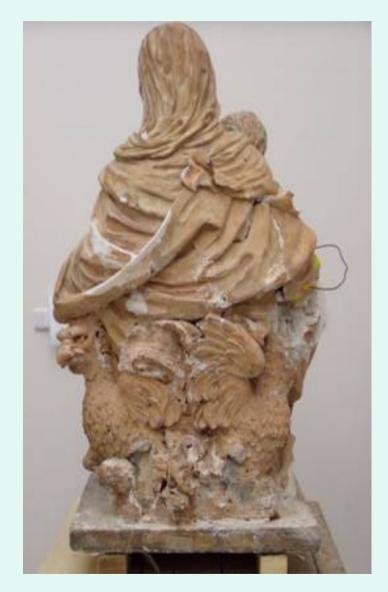
State before restoration

- Rear view with large damages all over the sculpture – visible cracks and fissures missing parts, etc.
- The stabilization
 previously saturated by
 calcareous binding
 agents inside the statue.
 Damage also on robe and
 its gathering and two
 eagles in lower rear part
 were partially destroyed.

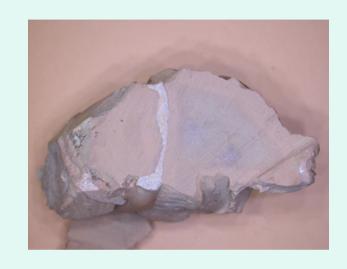
Joint of two original pieces of terracotta by geopolymer composite with calculated amount of non plastic additives.

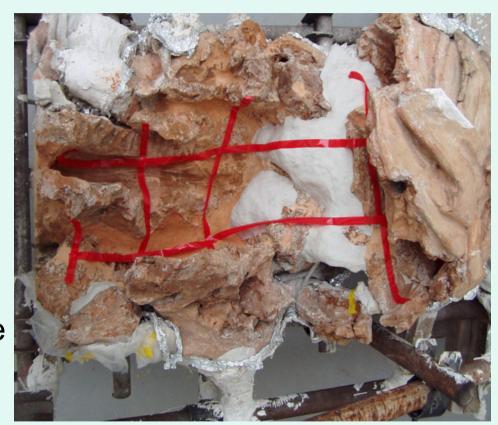
View from the open rear

- All damaged rear parts and all kind of cementitious agents were removed.
- Red strips mark the reinforcement plan of geopolymer ribs.
- The white parts are made from plasticine to avoid the penetration of the geopolymer on the front modulation.

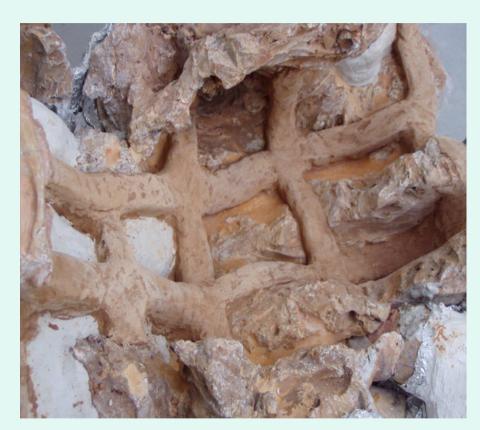
State after the first geopolymer application

- The lengthways and cross ribs fixing the terracotta front parts.
- The specific singularity in masters technology was in picking the terracotta material from the inner part of the statue

irregularity in thickness of the body caused cracks and fissures during the drying and later firing of the statue the formation of "black core" identifies the irregularity in firing process.
- White parts on the left is the plasticine support of the ribs, this will be finally replaced by ceramic.

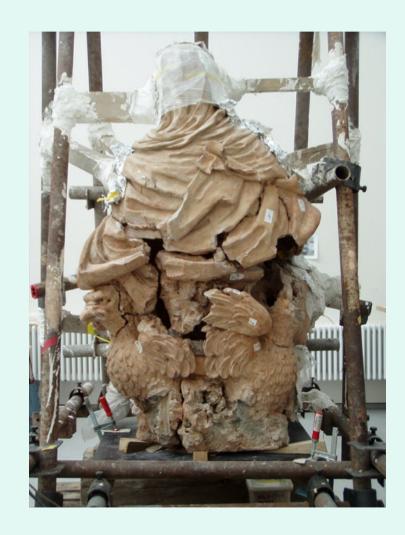
Replacement of rear parts

- Every returned rear part of the statue means extension of the ribs, fixing them on geopolymer reinforcement.
- The main advantage is possibility of perfect joint between previous and new part of inner ribs.
- The picture shows the whole range of damages on the rear side and necessity of reinforcement.

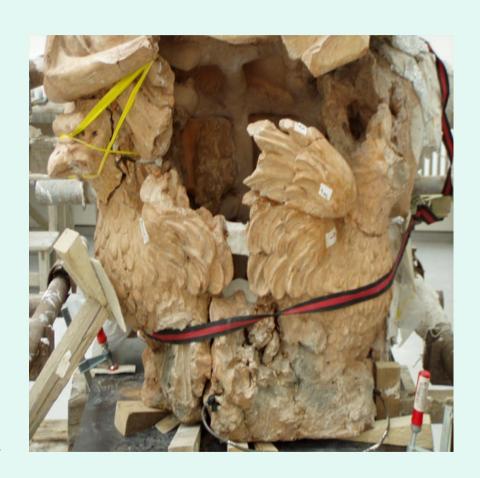
Detailed view – inner ribs

- Each part of terracotta was fixed by new portion of geopolymer rib,
- Between the eagles could be seen white strip of plasticine substituting temporary missing part of out viewed modulation.
- The fixed parts were in many cases temporary secured by plastic bands or ropes and also by wooden spars, etc.

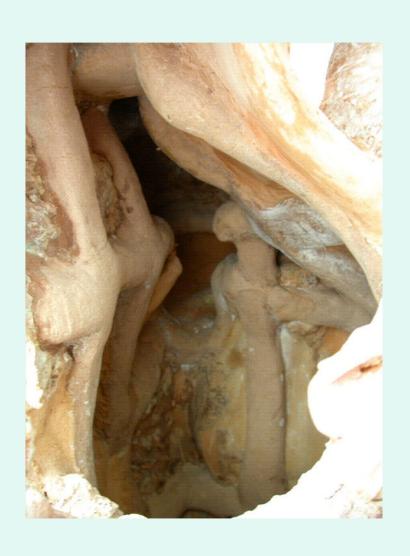
The final stage

- Side view on the reinforcement inner construction before replacement of the last part of right shoulder.
- The lengthways strips are ending in the statue neck supporting the Virgin head.
- Geopolymer construction fully stabilized the statue and any filling material was not necessary.

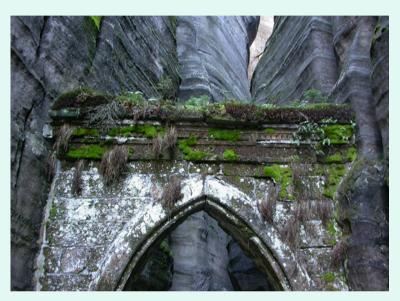
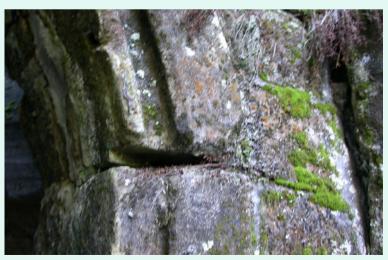
Repair of Adršpach Gate

- Upper picture shows state of the sandstone gate (19.cetury)

main entry to the National
 Park of Adršpach Rocks. The upper cornice is inclined, the sandstone is hardly damaged in joints between the stones and also between the rock and stones.
- Lower picture shows detailed damage with pronounced erosion by the vegetation.

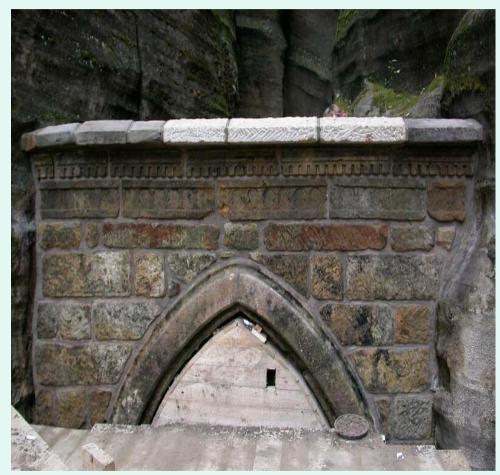
View on reconstructed gate

- New cornice stones were placed on the top substituting the most damaged ones. Well could be seen the joints between natural sandstone rocks and blocks of gate.
- The control after two years application constants perfect linkage on both sides and any destructions or damages even the gate is in shade and in wet surroundings.
