# The geopolymer composition for restoration, construction and substitution

Tomas Hanzlicek, Ivana Perna, Michaela Steinerova

The Institute of Rock Structure and Mechanics of the  
Academy of Sciences in collaboration with  
Sculpture and restoration school of prof. P.Siegel  
City of Adršpach,  
and Museum of Decorative Arts in Prague

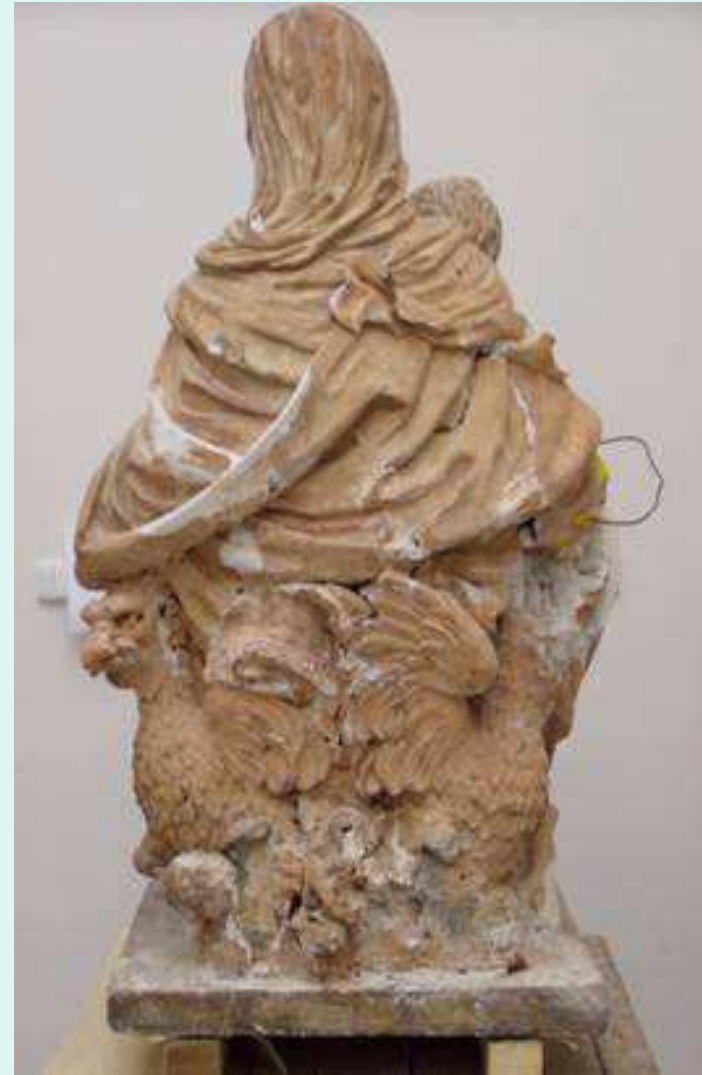
## State before restoration

- Rear view with large damage all over the sculpture – visible cracks and fissures missing parts, etc.
- The stabilization previously saturated by calcareous binding agent inside the statue. Damage also on robe and its gathering and two eagles in lower rear part were partially destroyed.

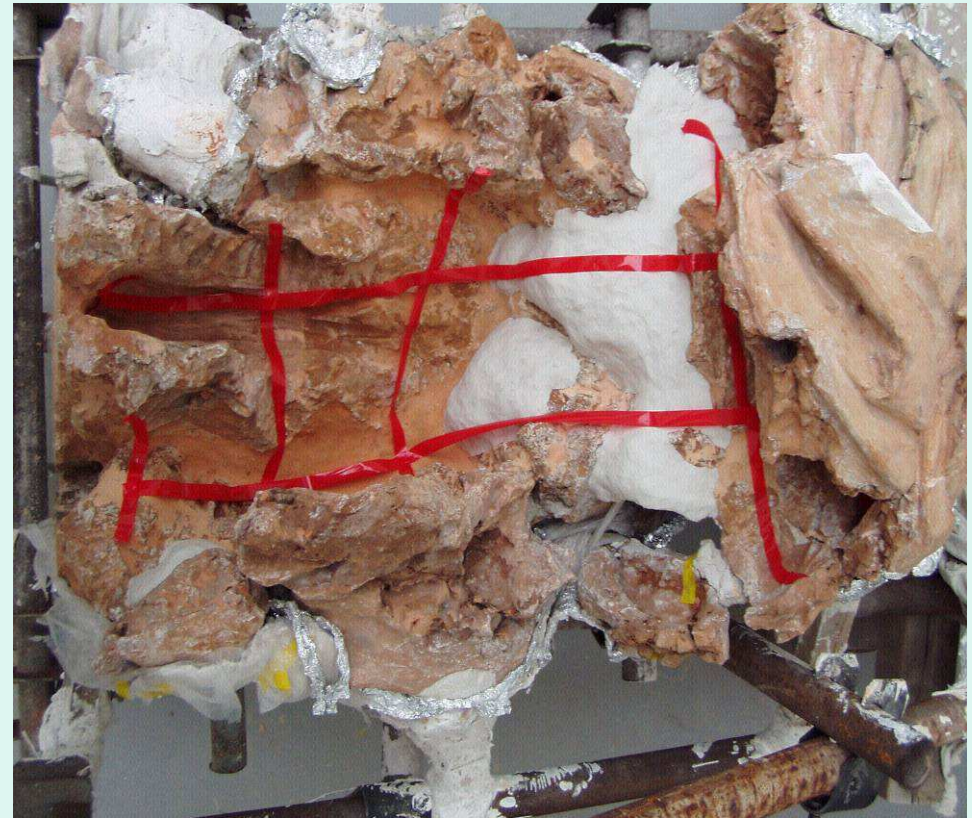
# View from the open rear

- All damaged rear parts and all kind of cementitious agents were removed.
- Red strips mark the reinforcement plan of geopolymer ribs.
- The white parts are made from plasticine to avoid the penetration of geopolymer on the front modulation.

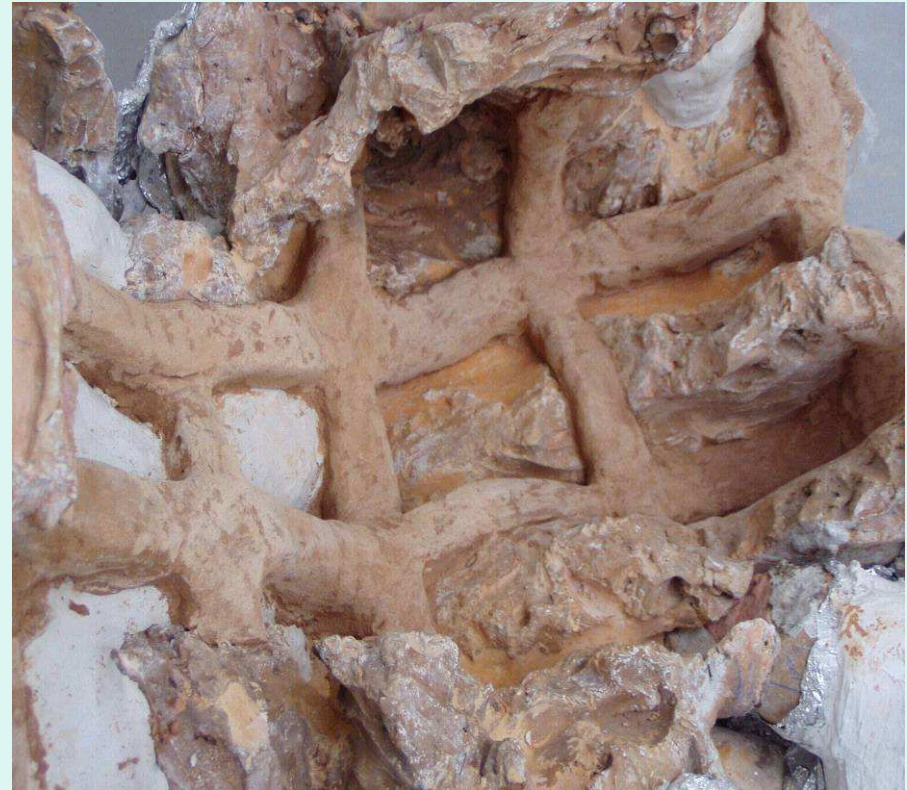
# State after the first geopolymer application

- The lengthways and cross ribs fixing the terracotta front parts.
- The specific singularity in masters technology was in picking the terracotta material from the inner part of the statue – irregularity in thickness of the body caused cracks and fissures during the drying and later firing of the statue the formation of „black core“ also identify the irregularity in firing process.
- White parts on the left is the plasticine support of the ribs, this will be finally replaced by ceramic.

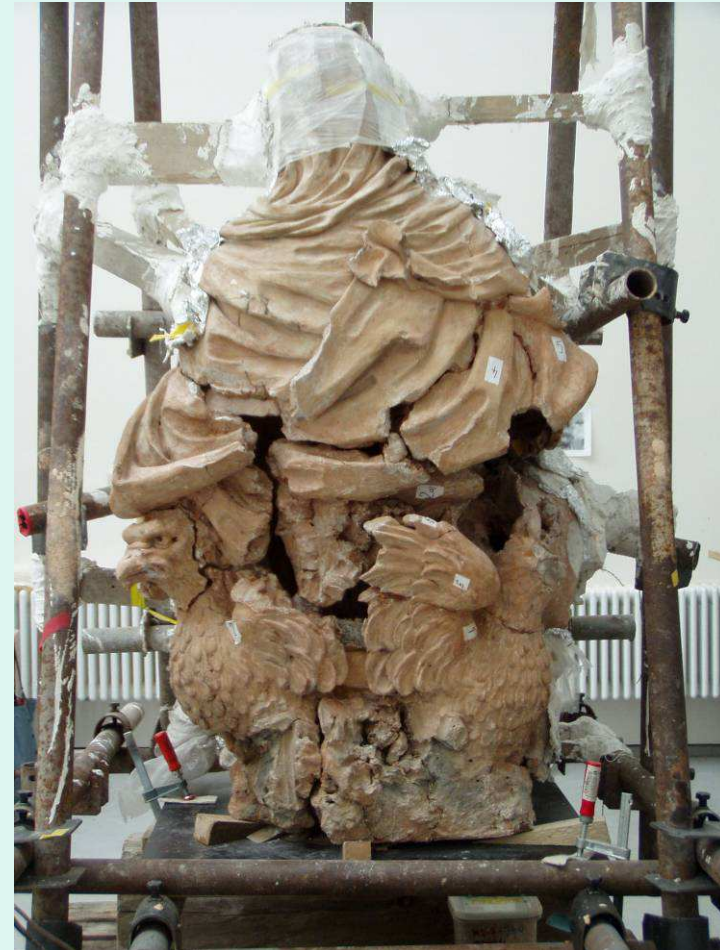
## Replacement of rear parts

- Every returned rear part of the statue means extension of the ribs, fixing them on geopolymer reinforcement.
- The main advantage is possibility of perfect joint between previous and new part of inner ribs.
- The picture shows the whole range of damages on the rear side and necessity of reinforcement.

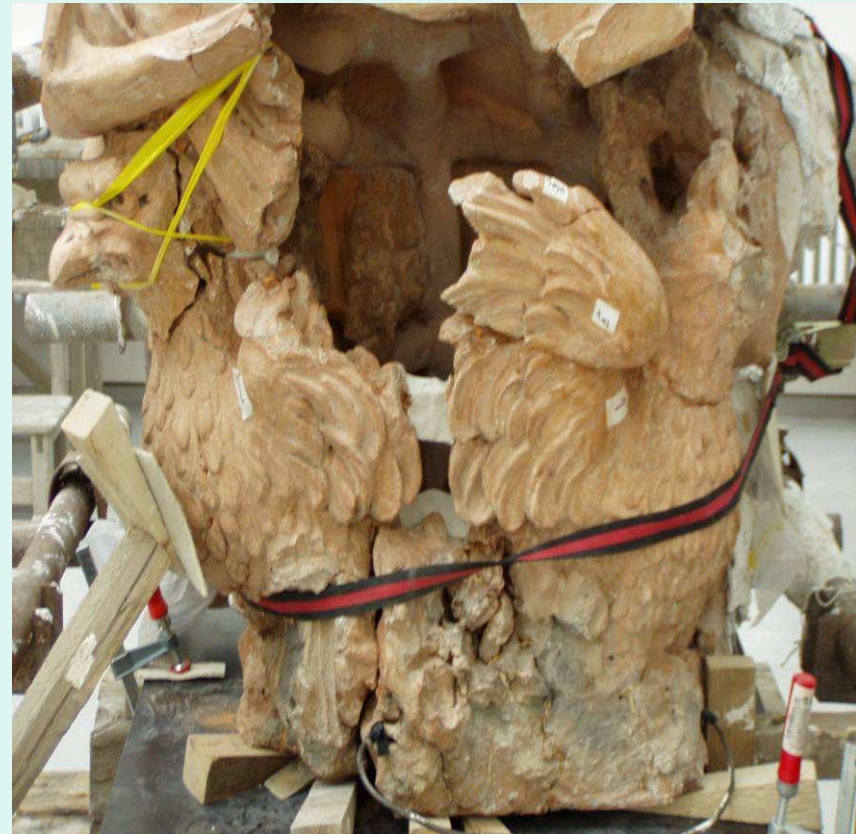
## Detailed view – inner ribs

- Each part of terracotta was fixed by new portion of geopolymer rib,
- Between the eagles could be seen white strip of plasticine substituting temporary missing part of out viewed modulation.
- The fixed parts were in many cases temporary secured by plastic bands or ropes and also by wooden spars, etc.

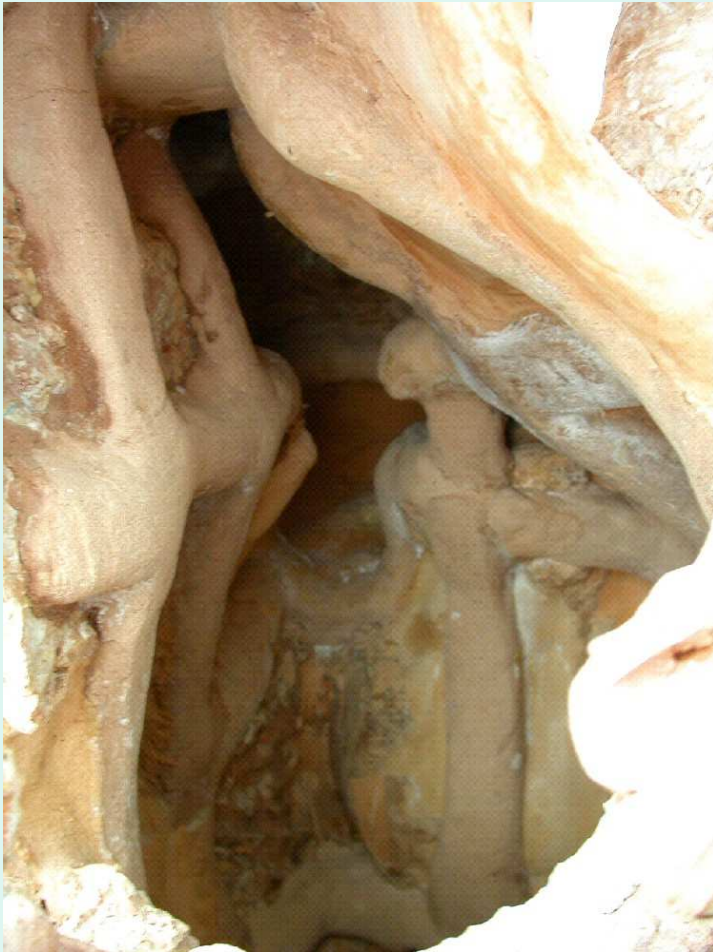
# The final stage

- Side view on the reinforcement inner construction before replacement of the last part of right shoulder.
- The lengthways strips are ending in the statue neck supporting the Virgin head.
- Geopolymer construction fully stabilized the statue and any filling material was not necessary.

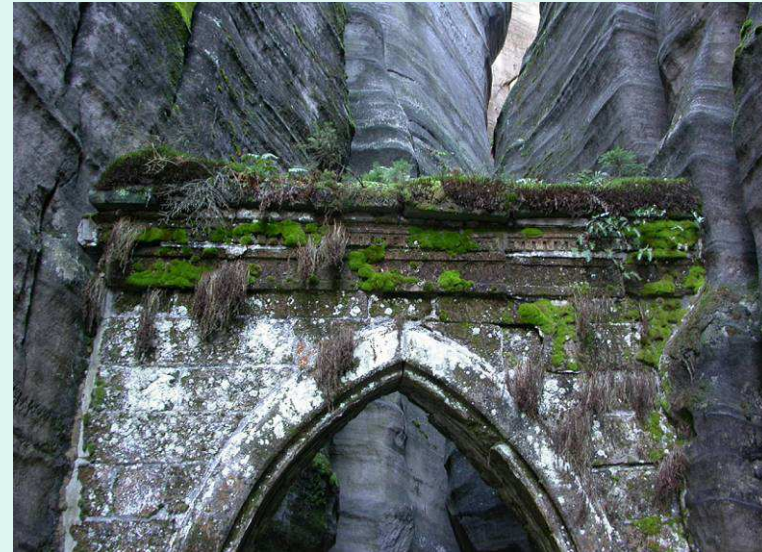
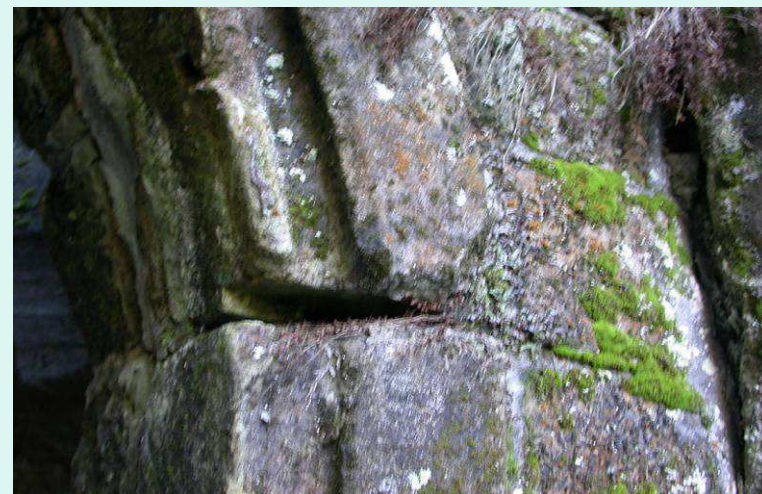
# Repair of Adršpach Gate

- Upper picture shows state of sandstone gate (19.cetury) the main entry to the National Park of Adršpach Rocks. The upper cornice is inclined, the sandstone is hardly damaged in joints between the stones and also between the rock and stones.
- Lower picture shows detailed damage with pronounced erosion by the vegetation.

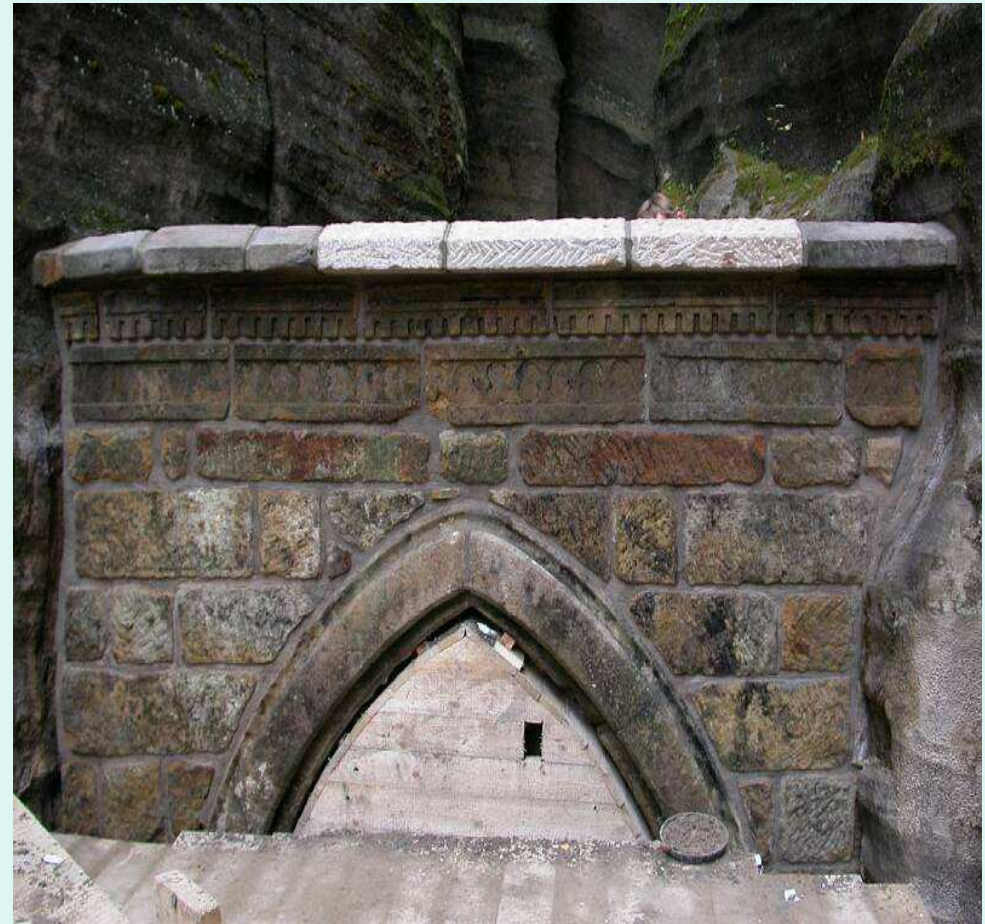
## View on reconstructed gate

- New cornice stones were placed on the top substituting the most damaged ones. Well could be seen the joints between natural sandstone rocks and blocks of gate.
- The control after two years application constants perfect linkage on both sides and any destructions or damages even the gate is in shade and in wet surroundings.

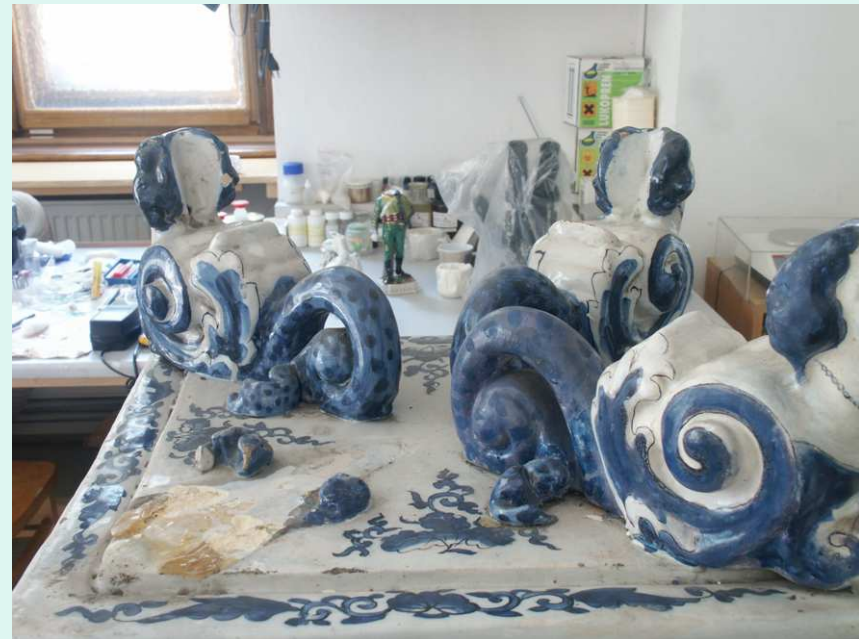
Top of pedestal with missing sphinx
