RECENT ROCK MASS MOVEMENTS INVESTIGATED IN THE TERRITORIES OF BULGARIA AND CZECHOSLOVAKIA

^aBLAHOŠLAV KOŠTÁK and ^bELKA AVRAMOVA-TAČEVA

Key words: rock movements; field measurements; neotectonic activity

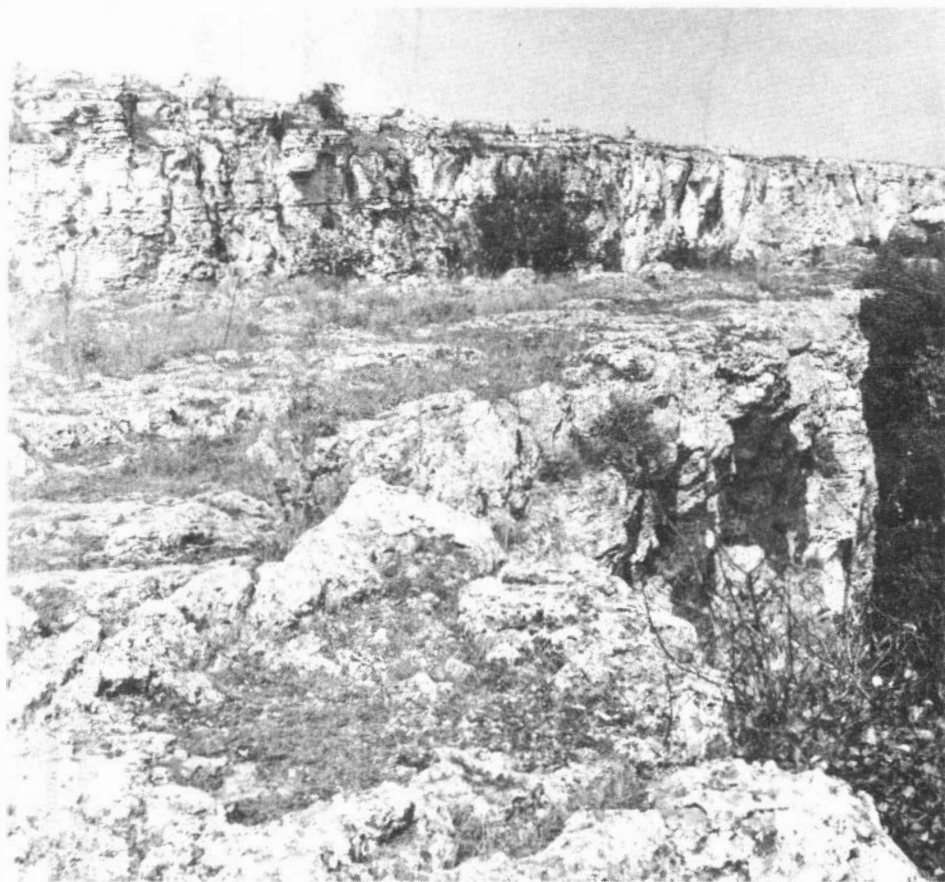
Fig. 2. A huge coastal deformation at Taukliman (Bulgarian Black Sea coast). Long and curved sinking steps of limestones at the margin of the Dobrudzha Plateau, where crack gauge measurements proved systematic displacements. Photo B. Košťák.

installed, therefore, one after the other, into the cracks cutting the margin of the plateau above the affected coastal area called Taukliman (Fig. 2).

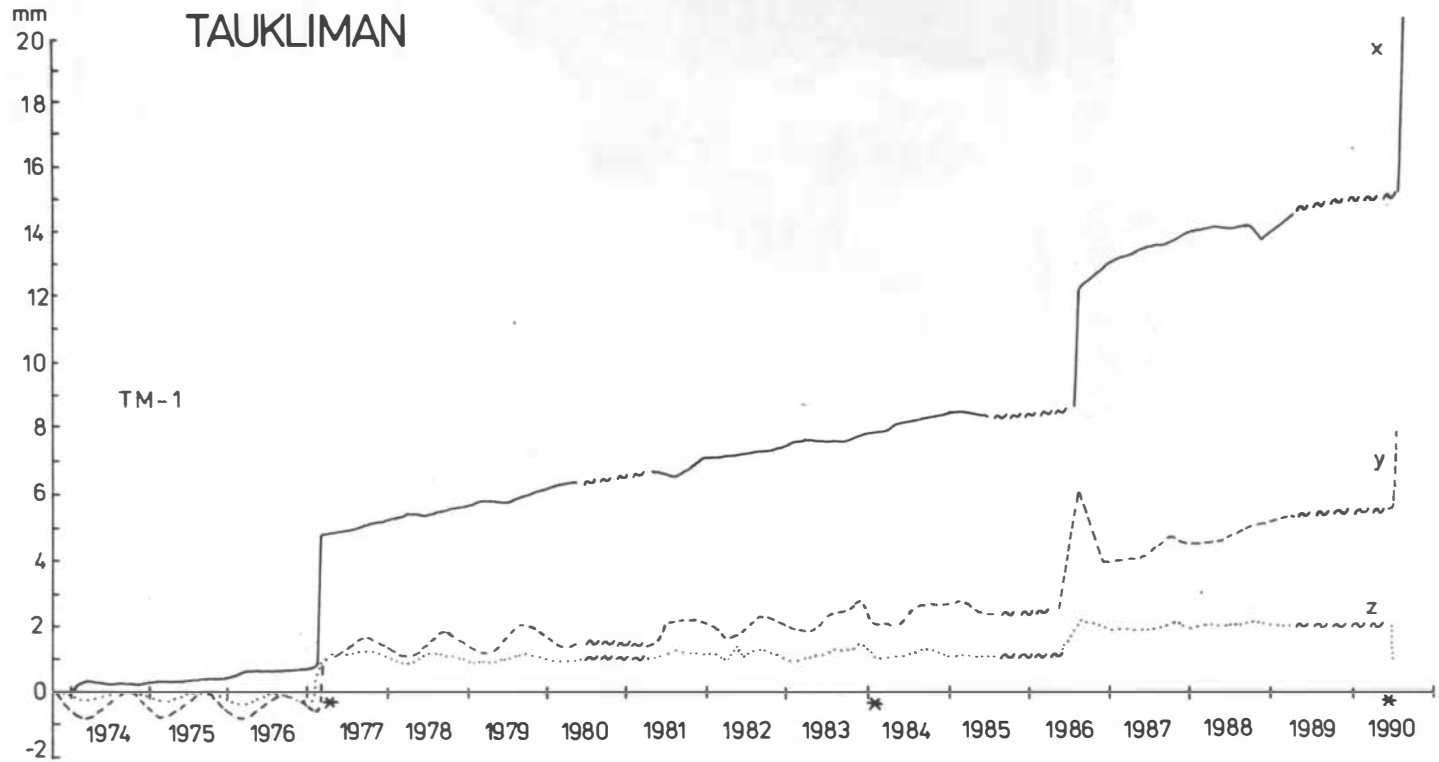
Fig. 3. Displacement diagram of the No. 1 crack gauge TM 1 at Taukliman.
Results are dominated by creep as well as earthquake (*) effects.

The instability became evident after about two years of observations (Košťák and Avramova-Tačeva, 1981). The marginal cracks of the plateau were opening at a steady rate of about $0.2 \text{ mm} \cdot \text{yr}^{-1}$. This confirmed the hypothesis of creep in Oligocene clays under the limestone blocks. Creep is manifested in the displacement diagram (Fig. 3) by the trend of the x -component, while the other two components (y and z) show a typical variation due to the climatic cycle, so well established at Tupadly.

In March 1977, the coast was hit by an earthquake with the epicentre near Vrancea, Roumania. Due to that, a permanent increase of the crack width appeared, attaining about 4 mm, and the creep continued at an increasing rate of

about $0.5 \text{ mm} \cdot \text{yr}^{-1}$. Vrancea earthquakes reappeared again in 1984, 1986, and 1990 with intensities of up to > 7 MSK. Smaller rockfalls were reported along the rockwalls and heads of narrow blocks (about 15 m high) vibrated with amplitudes > 10 mm, which induced them to find new positions.

The gauge No. 1 was placed high in a marginal crack fully affected by the seismic vibrations. The gauge was damaged but not destroyed, and allowed the event to be reconstructed. The gained experience was useful for the realization of several improvements in the device in order to cope with such vibrations. Other two gauges placed deep in the cracks registered also displacements but not the fatal vibration effects.

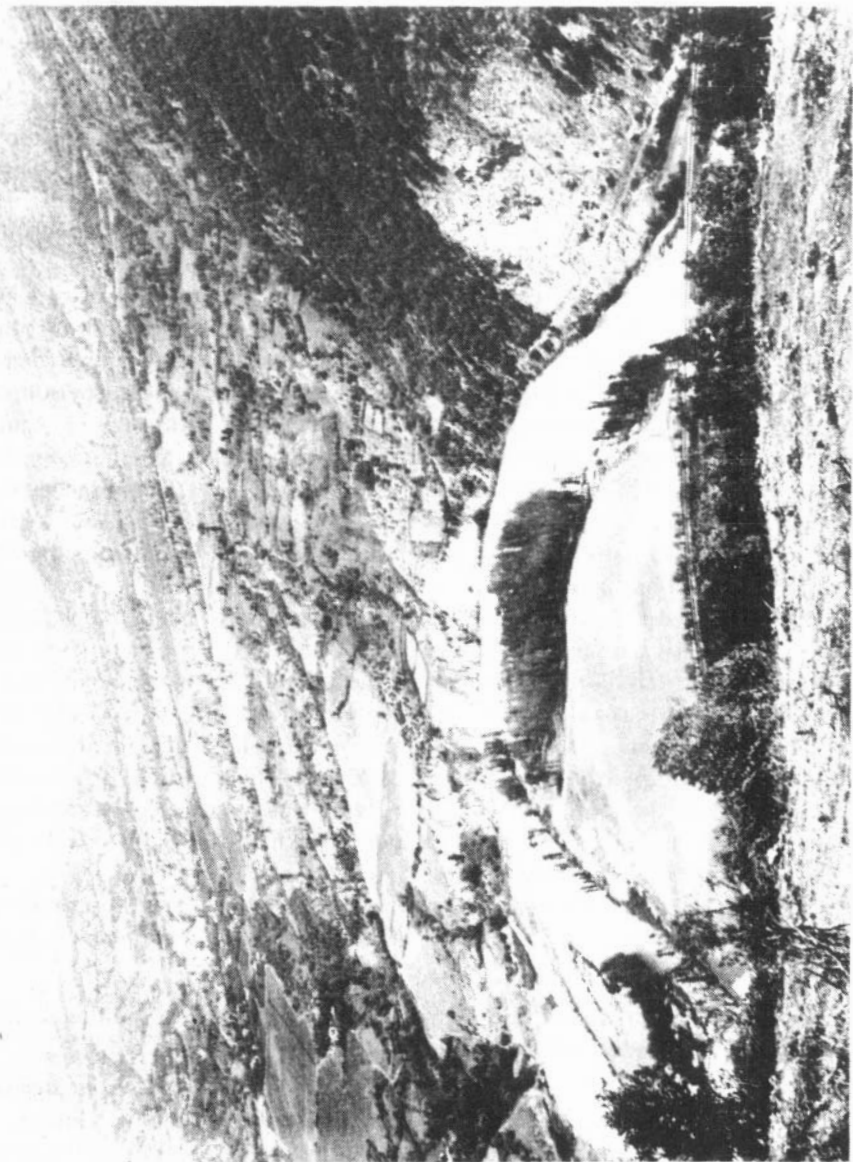
Fig. 6. The Krupnik fault as seen from west to east. The Simitli graben on the left. Here the greatest uplift took place. The observation point 6 on the contact between sediments and amphibolites. Photo B. Košťák.

The observation point No. 6 (Fig. 6) developed into one of the most difficult in operation. Seismic jitter is very high here, which appears in frequent pulses affecting the gauge. Earthquakes result in jumping slips recorded by several mm displacements in all directions. While at Taukliman a dangerous tremor may appear once in several years, tremors may hit Krupnik several times a month. The instrumentation must be adjusted to survive difficult moments. The authors did not succeed very much in automatically recorded continuous readings. They have rather collected data about resulting after-effects of tremors in intervals not longer than two months. The gauge had to be reset very frequently.

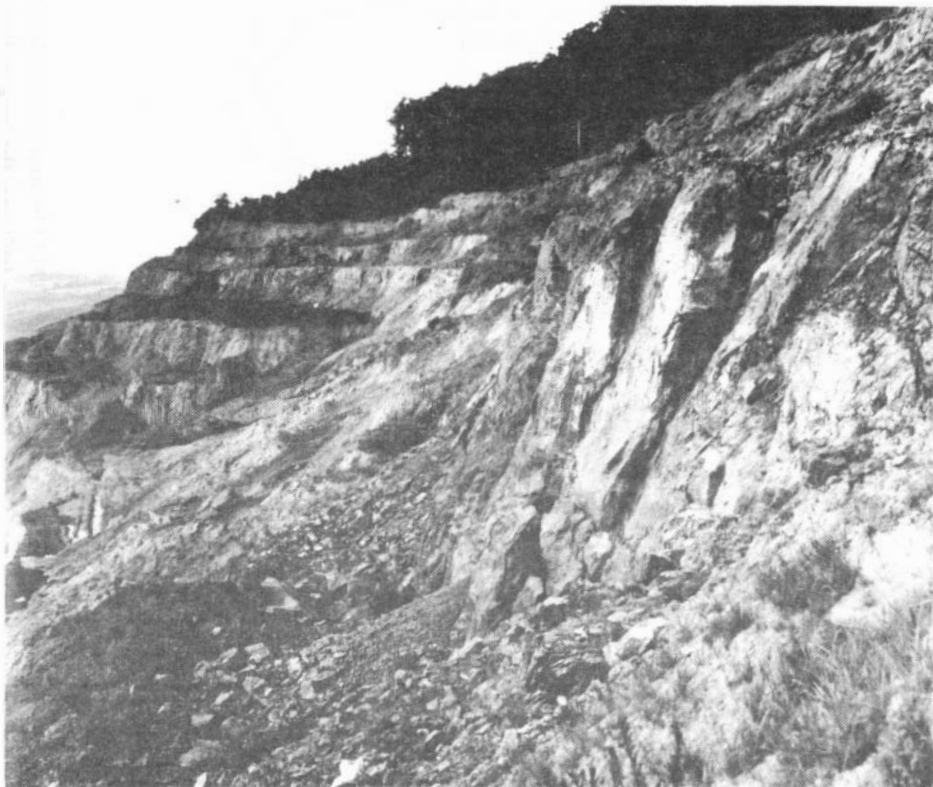
Fig. 8. Pit slopes cut to crystalline rock close to Jezeří castle in the Krušné Hory Mts.

the crystalline rock and the slope becomes threatening (Fig. 8). Stress increase is to be expected and slope stability is under question. Finite element analysis has been made (Doležalová and Rozsypal, 1987) showing effects of mining advance. Extensive geotechnical and engineering geological survey has been carried out and slope deformation monitoring has been organized.
