PRESENT DYNAMICS OF A LANDSLIDE PROCESS IN THE BLACK SEA COAST REGION N OF VARNA (BULGARIA)

ABSTRACT. Complex extensometric monitoring in the main scarp of a Black Sea coast block-type slope deformation has shown creep movements in the underlying clayey-marly beds of Sarmatian limestone blocks and also block deflections influenced by earthquakes. Prognosis of a mechanism relevant to the local geological conditions of the deformation is given. Necessary measures including monitoring are recommended to be accepted regarding the reality of extensive landslides that occurred recently here, and resulted into vast damage to this densely populated tourist and recreation area.

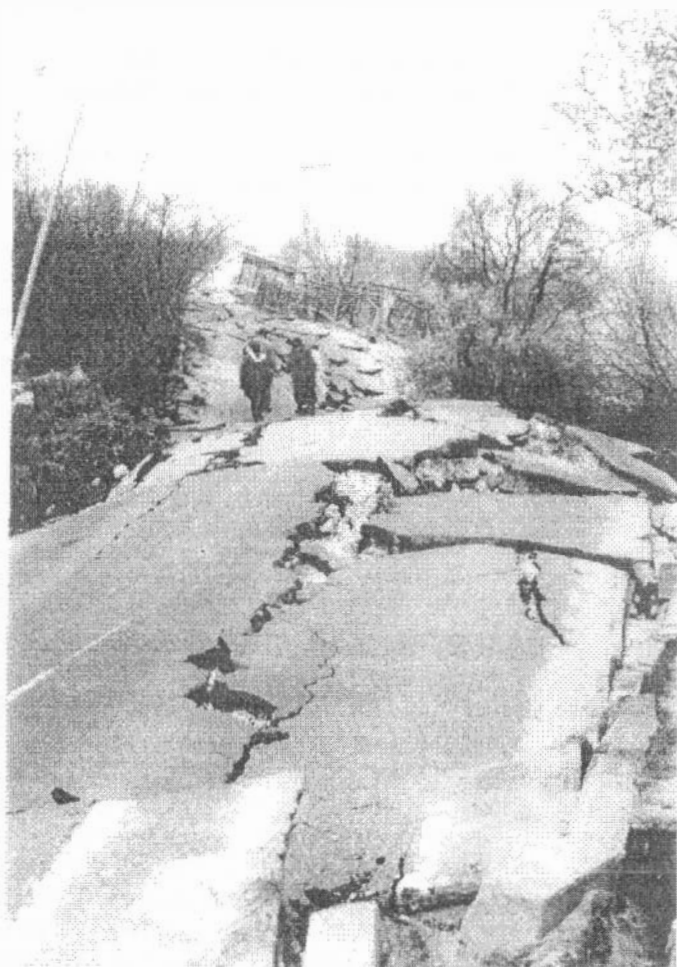
FIG. 1. Road destruction between Zlatni Piasaci and Varna near the bus station "Journalist" at the Bulgarian Black Sea coast. Landslide of April 4, 1997. Photo by G. Frangov

of April 1997 near bus station "Journalist". It interrupted the road between Zlatni Piasaci and Varna (Varbanov et al., 1997) (Fig. 1). The second one was triggered on 17th of April 1997 at a camping site "Panorama", Zlatni Piasaci (Fig. 2). It is about 200 m wide and 250–300 m long. Both the landslides reached a depth of 5–15 m. As a result many houses and the road were destroyed, power lines and local connections were disrupted, etc. (Varbanov et al., 1997; Evstatiev et al., in print). Parallel to such present deformations primal deformation processes continue to develop at several sections in the upper part of the present sea shore slope.

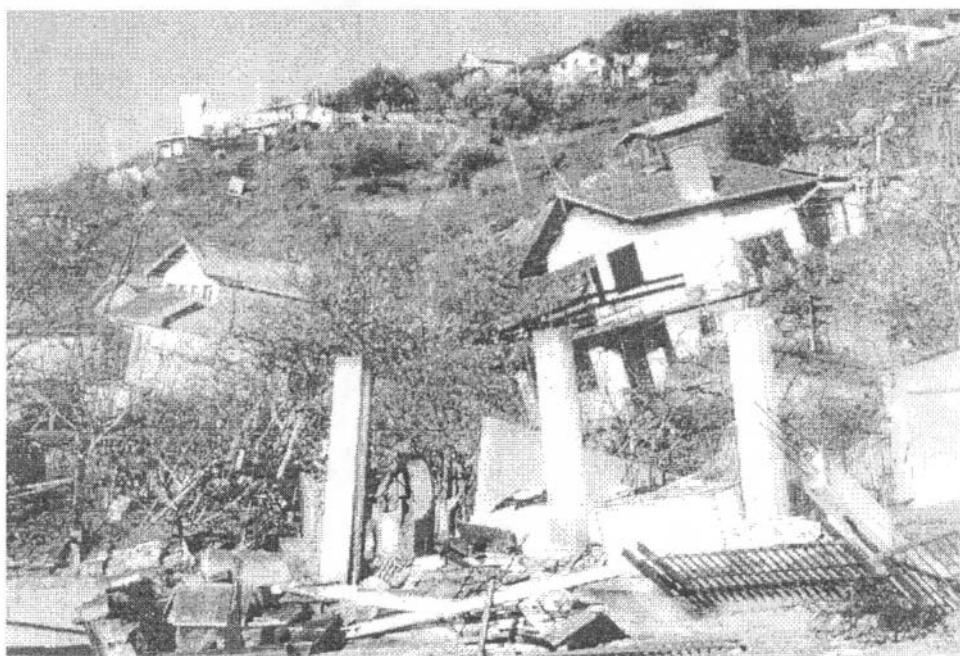
FIG. 2. Camping site destruction at the camping site "Panorama", Zlatni Piasaci, NE of Varna, Bulgarian Black Sea coast. Landslide of April 17, 1997. Photo by G. Frangov

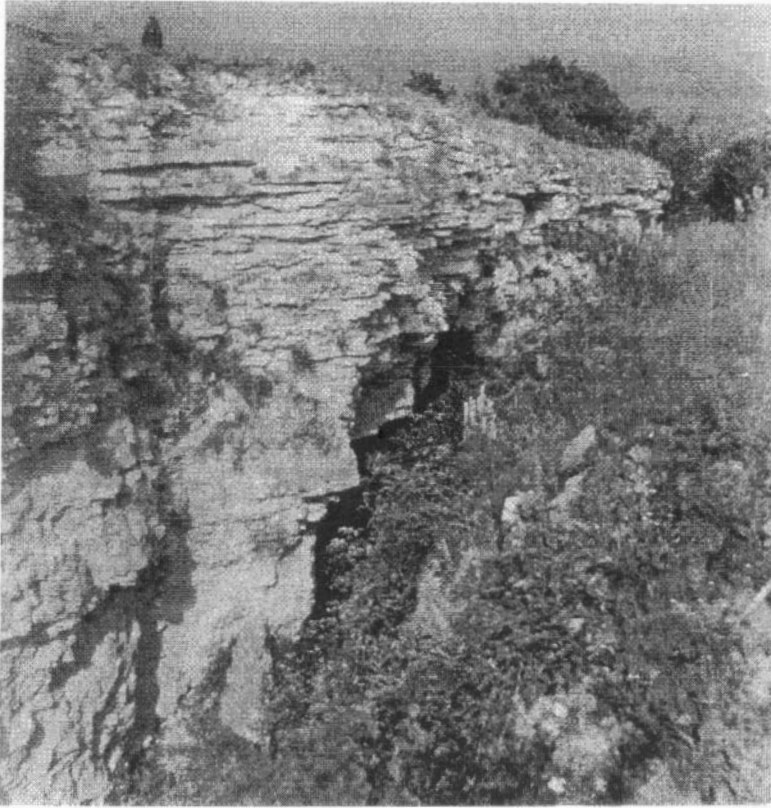
FIG. 7. The crack wall above the uppermost step of the Aladja-manastir - Zlatni Piasaci landslide. A typical example of the last stage of creep movements in a deformation described as of the blockage-consistent type - a shear plane propagating to the surface results in tensile crack formation and new step subsidence. Photo by B.Košťák

Persistent creep deformation is to be expected for a relatively long period of time. The length of this period depends on rheological properties of clayey and clayey-marly sediments found under the limestone. However, the properties are not defined, therefore the prognosis cannot go too far. Besides, it is possible to expect transitory periods of creep rate increase, as well as those of decrease. At the end of the extended present period, there should come to a phase of acceleration, after a limit shear deformation will be reached as a limit stage which mark transition to a new phase. The phase will turn to a slipping shear plane formation along the creep zone, together with cracking in the marginal zone of the plateau, and the separated step sinking into the sliding mass, then joining the landslide body of the primary deformation, which could be described as of a blockage-consistent type (after typification of Avramova-Tacheva and Voutkov, 1994). Further on, a new sliding cycle of the block-type deformation will develop in the marginal zone of the plateau, characteristic of separation of a next new marginal step from the plateau (c.f. Fig. 7).
