## SLOPE FAILURES AROUND THE ROCK CASTLE DRÁBSKÉ SVĚTNIČKY, CZECH REPUBLIC

Stability conditions in a wider surrounding of the rock castle Drábské Světničky (Drábské Rooms) near the town of Mnichovo Hradiště were investigated. The area which has been intensively disturbed by large old as well as present slope movements is located in the north-western part of Příhrazy Platform. Solid, thick bedded sandstones, well resistant to weathering, are lying on claystones apt to plastic deformations. Marginal sandstone blocks separate, move down on the slope and sink into the plastic bedrock. As a result, block fields with many crevasses develop. In rock walls that separate individual blocks, rockfalls originate and central, as well as lower parts of the slopes develop large landslides. A zone comprising up to 400 m wide rim of the high and exposed platform has been subject to a process of loosening. A local group of tower-like sandstone blocks was used in the 15th century to build a small rock castle called Drábské Světničky. An extensive landslide that destroyed a substantial part of the village of Dneboh in June 1926, reached in its separating zone up to the toe of marginal rock towers bel

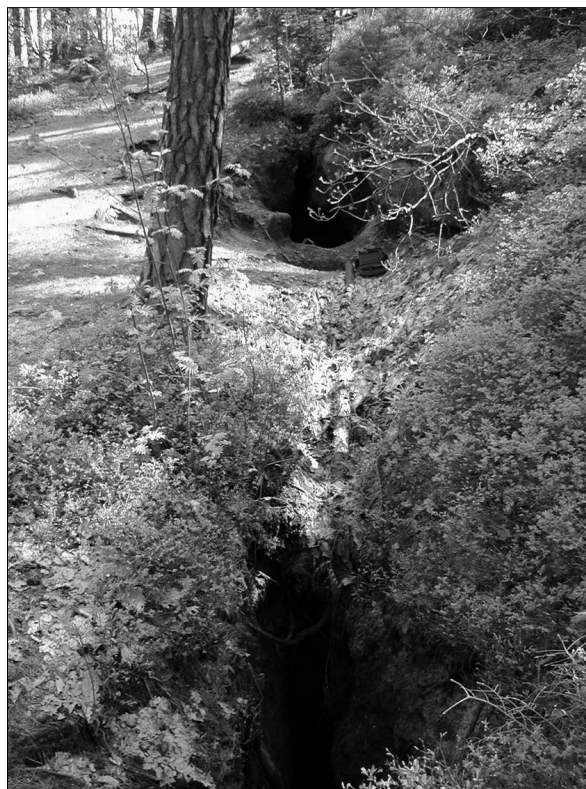
**Fig. 10** A progressing block crevasse bordering the active block-type landslide. Here, in the superficial fissure zone where movement monitoring takes place, a fresh subsidence is undergoing. The entrance to a cave can be seen in the background. Photo by J. Stemberk 2001.

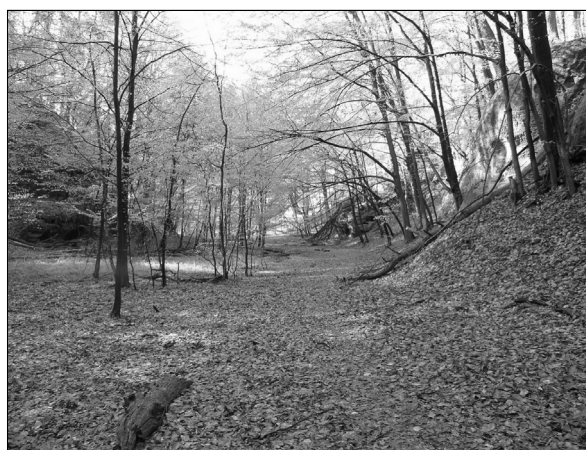
**Fig. 11** A crevasse separating Hrada Platform from the central part of the highlands. Photo by J. Rybář 2005.

dech". Together with Zvelebil et al. (2001) we assume that it is a giant sandstone block shifted to W or NW. It is separated from the central part of the platform by a crevasse up to 60 m wide (Fig. 11). The block can

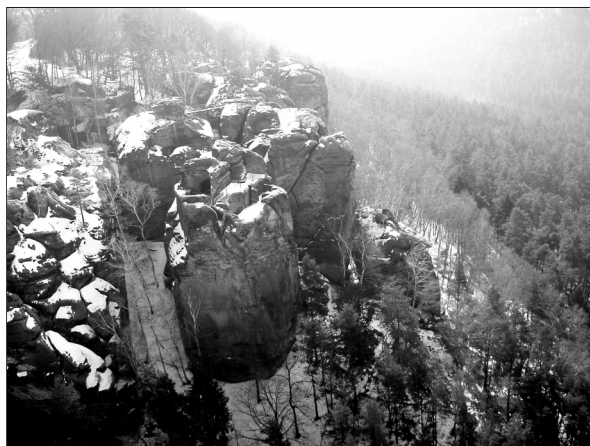
**Fig. 16** An aerial view of the rock castle Drábské Světničky from NW. The snap taken from a model aeroplane.

Fig. 16 shows an aerial view of Drábské Světničky from NW taken from a model air plane. Frontal block is the block No. V "Svatyně" (Sanctuary) and the adjacent block with the room of the priest labelled No. IV, the two containing relics of 6 rooms. On the left in the background, one finds a block of the main tower (No. I), and on the right is

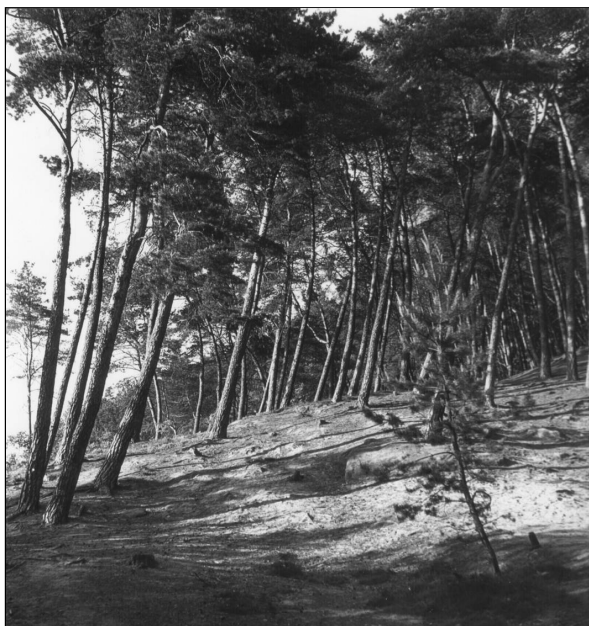
**Fig. 18** "Drunken forest" in the upper part of the landslide which destroyed a part of Dneboh Village in June 1926. Photo by P. Vácha 1963.

continuously slanted upslope due to rotational movements (Fig. 18). Similar creep movements originate even on the steep separation wall of the landslide.

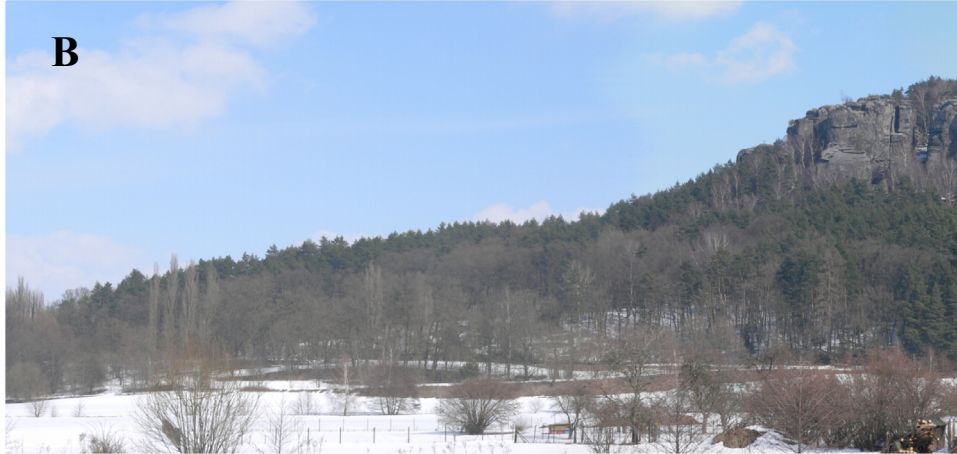
**B:** SW view of the landslide area from the year 1926 under the NW rim of Hrada platform. Photo by F. Hartvich 2005.

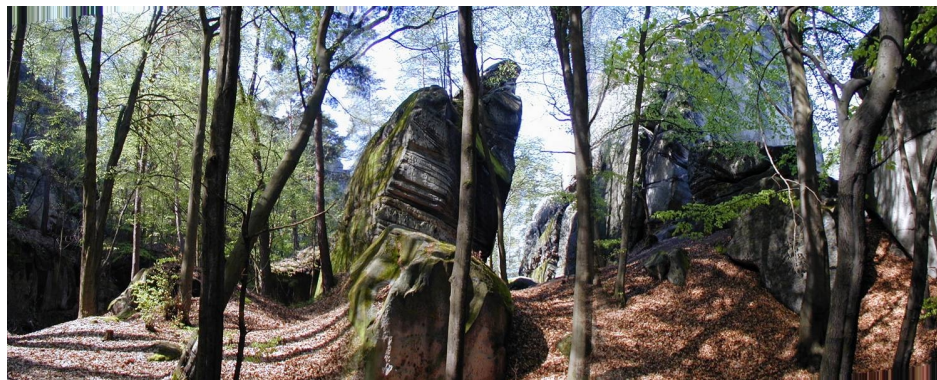
**Fig. 9**

View of a block field at the northern rim of Příhazy Platform; multiple block arrangement of sandstones with upslope inclination. Photo by J. Stemberk 2001.
