3D MONITORING OF ACTIVE FAULTS AND SLOPE MOVEMENTS IN THREE BULGARIAN SITES INCLUDED IN COST 625 PROJECT

Nikolai DOBREV * and Elka AVRAMOVA-TACHEVA

Geological Institute, Bulgarian Academy of Sciences, 1113 Sofia, Bulgaria

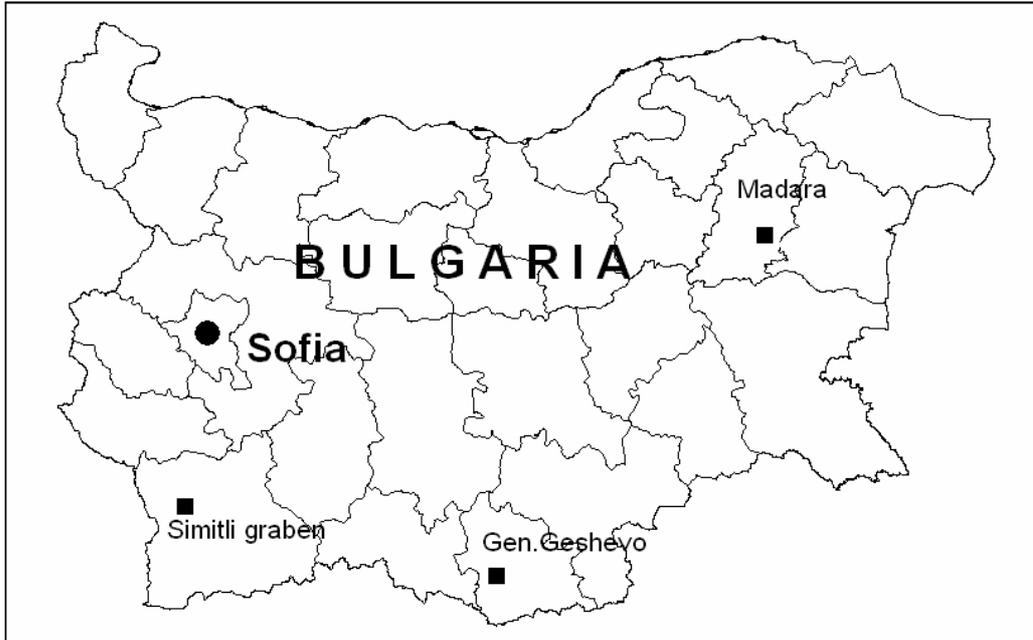
Fig. 1 Location of recent 3D monitoring sites in Bulgaria.

The instrumental monitoring in Bulgaria with use of 3D extensometers and geodetic surveying has been performed on active faults and the related slope deformations since 1982-1983. Recently GPS measurements were introduced, too. The research with the use of 3D extensometers was performed for monitoring of active faults and slope deformations in selected areas in Bulgaria (Simitli graben, Madara, General Geshevo Village - East Rhodopes; see Fig. 1).

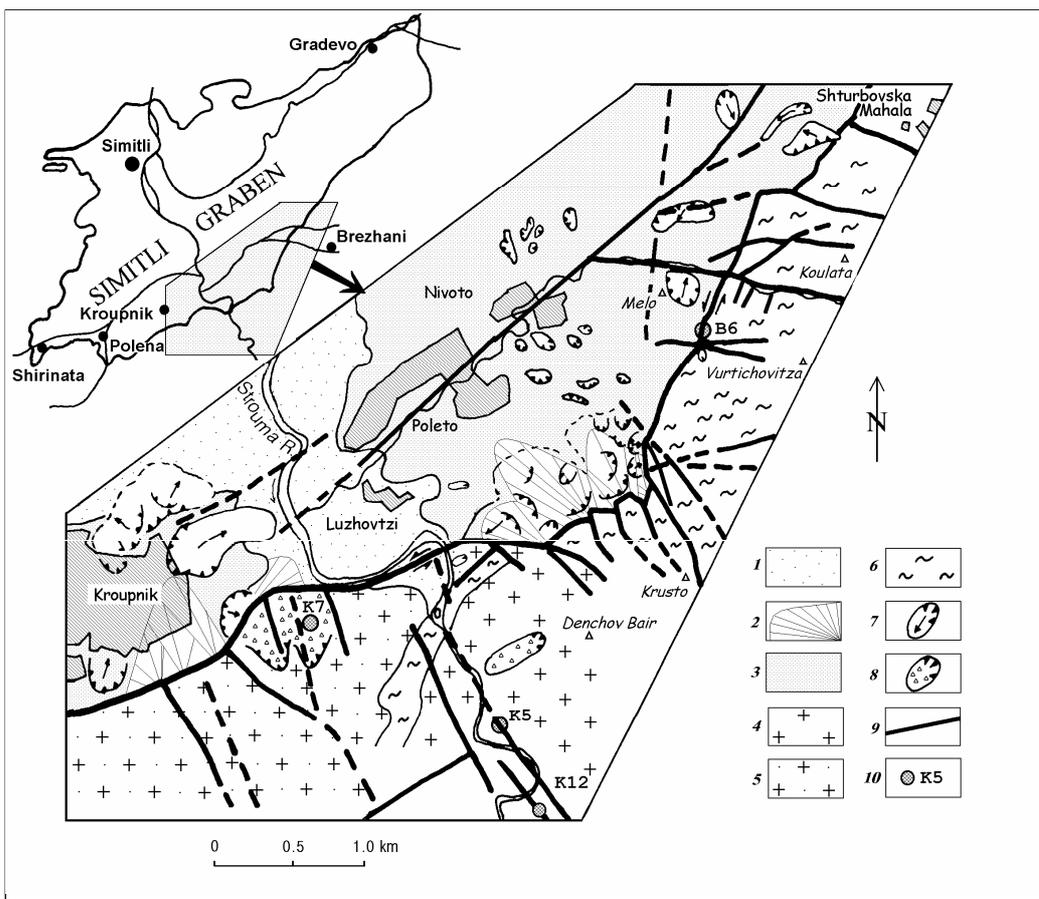
Fig. 2 Geological-tectonical map of Simitli Graben.

Legend: 1 - Quaternary: alluvium; 2 - Debris fans; 3 - Neogene: sandstones, conglomerates, clays, coal; 4 - Upper Cretaceous granites; 5 - Palaeozoic granites; 6 - Precambrian: amphibolites, gneisses, marbles; 7 - landslide; 8 - slope deformation in rocks; 9 - fault; 10 - Monitoring point No.

The Simitli graben (70 km²) is situated at the crossing point of two significant fault zones called Struma (local directions 150-170°) and Krupnik-Gradevo (40-80°). A longer part of the graben is formed along the Krupnik-Gradevo fault zone. It is crossed by the Struma fault zone, which marks the contemporary bed of Struma River. Farther to the south, the Struma River enters into the Kresna Gorge.

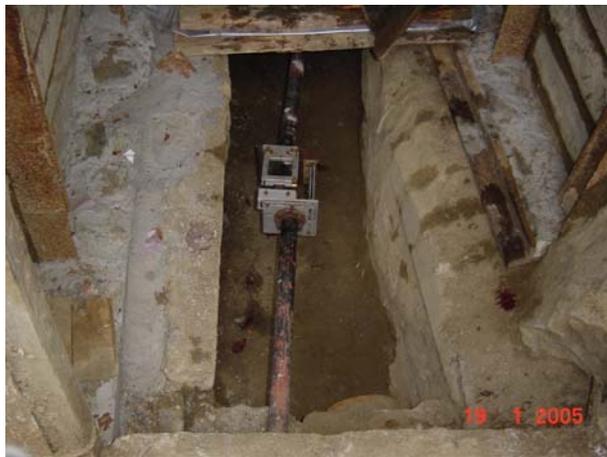
**Fig. 4** View of monitoring point 6. The left lateral displacement is obvious.

The next monitoring point (No. 6, B6 or Brezhani 6) was arranged at the Krupnik fault (Fig. 4). The measuring system bridges the contact between the Praecambrian amphibolites and the Neogene coarse-grained sediments. A special trench exposes the contact of fault zone, which width is 3.4 m at that point (Avramova-Tacheva et al., 1984; Avramova-Tacheva and Košťák, 1995).

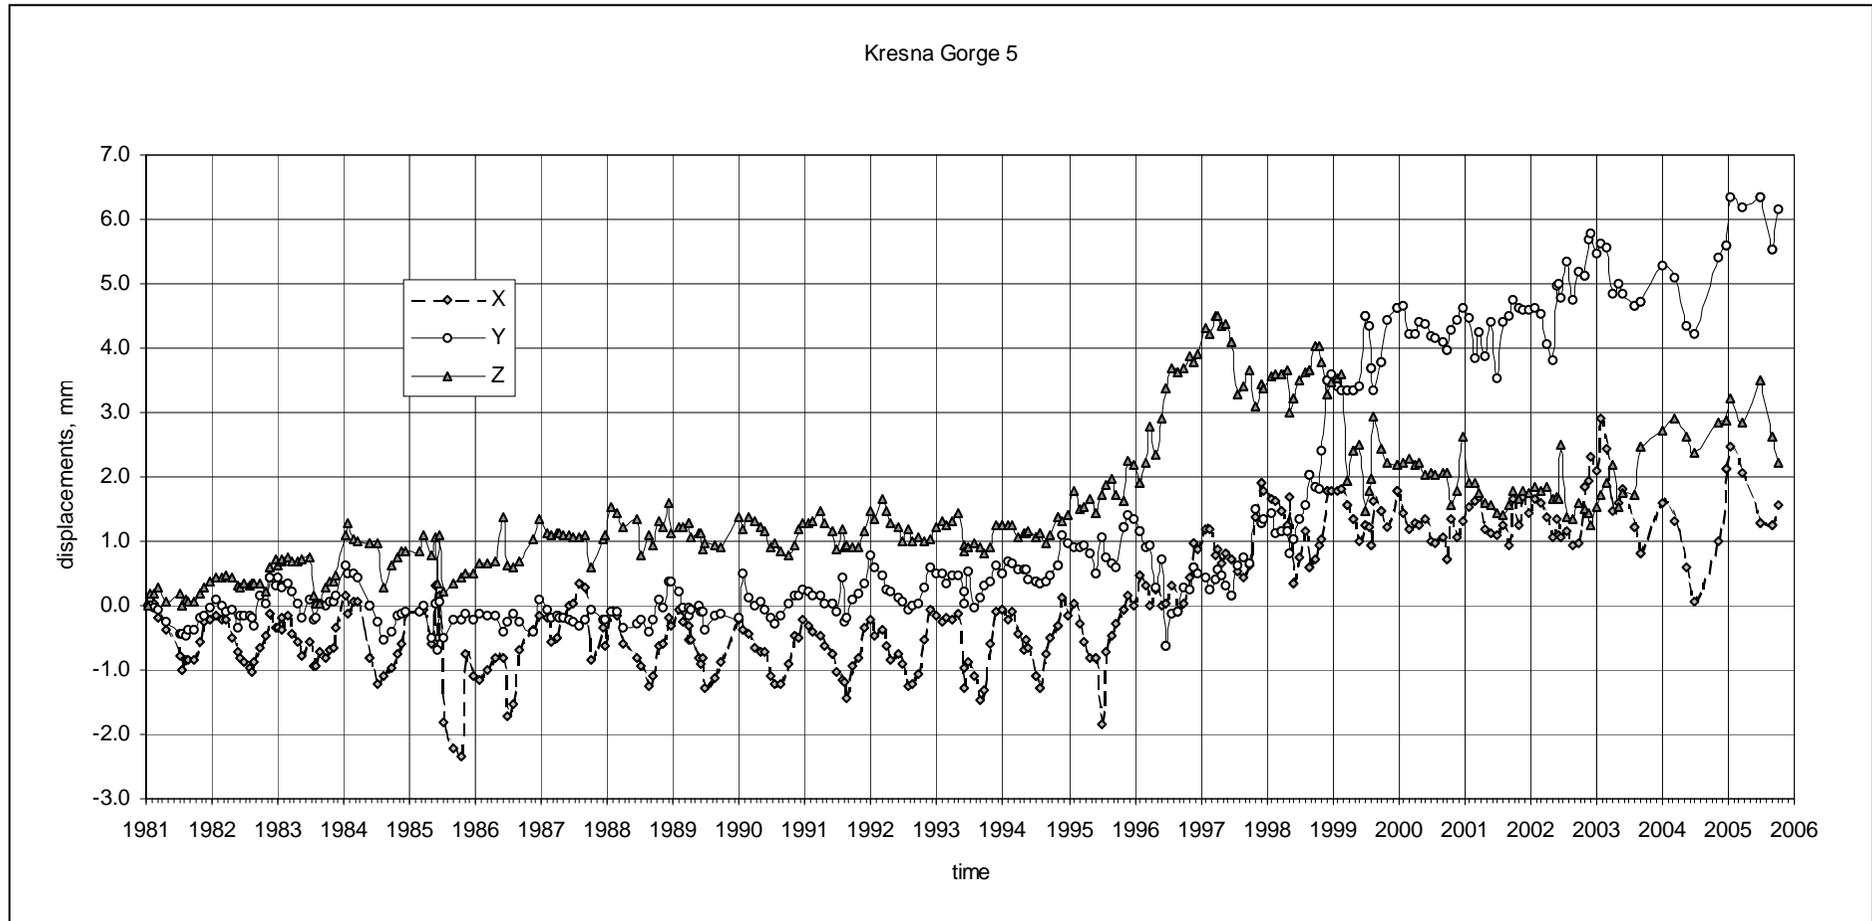
Fig. 5 Tectonic movements found at point no. 5 – Kresna Gorge.

The analysis of data from the monitoring points installed on Struma fault system (no. 5 and no. 12) shows left-lateral movements. The earthquakes rarely influence point No. 5. The rates are variable for different periods (Table 2; Figs. 5, 6). For example, the period 2003-2004 is characteristic with a slip with a rate of 0,5 mm/y for the two points. However, the results calculated from 30 measurements at point No.12 within period November 2003 – September 2005 show decreasing of the rates of movements - the normal component is 0.17 mm/y. A sharp displacement was found that resulted from a local earthquake swarm in Simitli-Predela area between 8th and 13th December 2003.

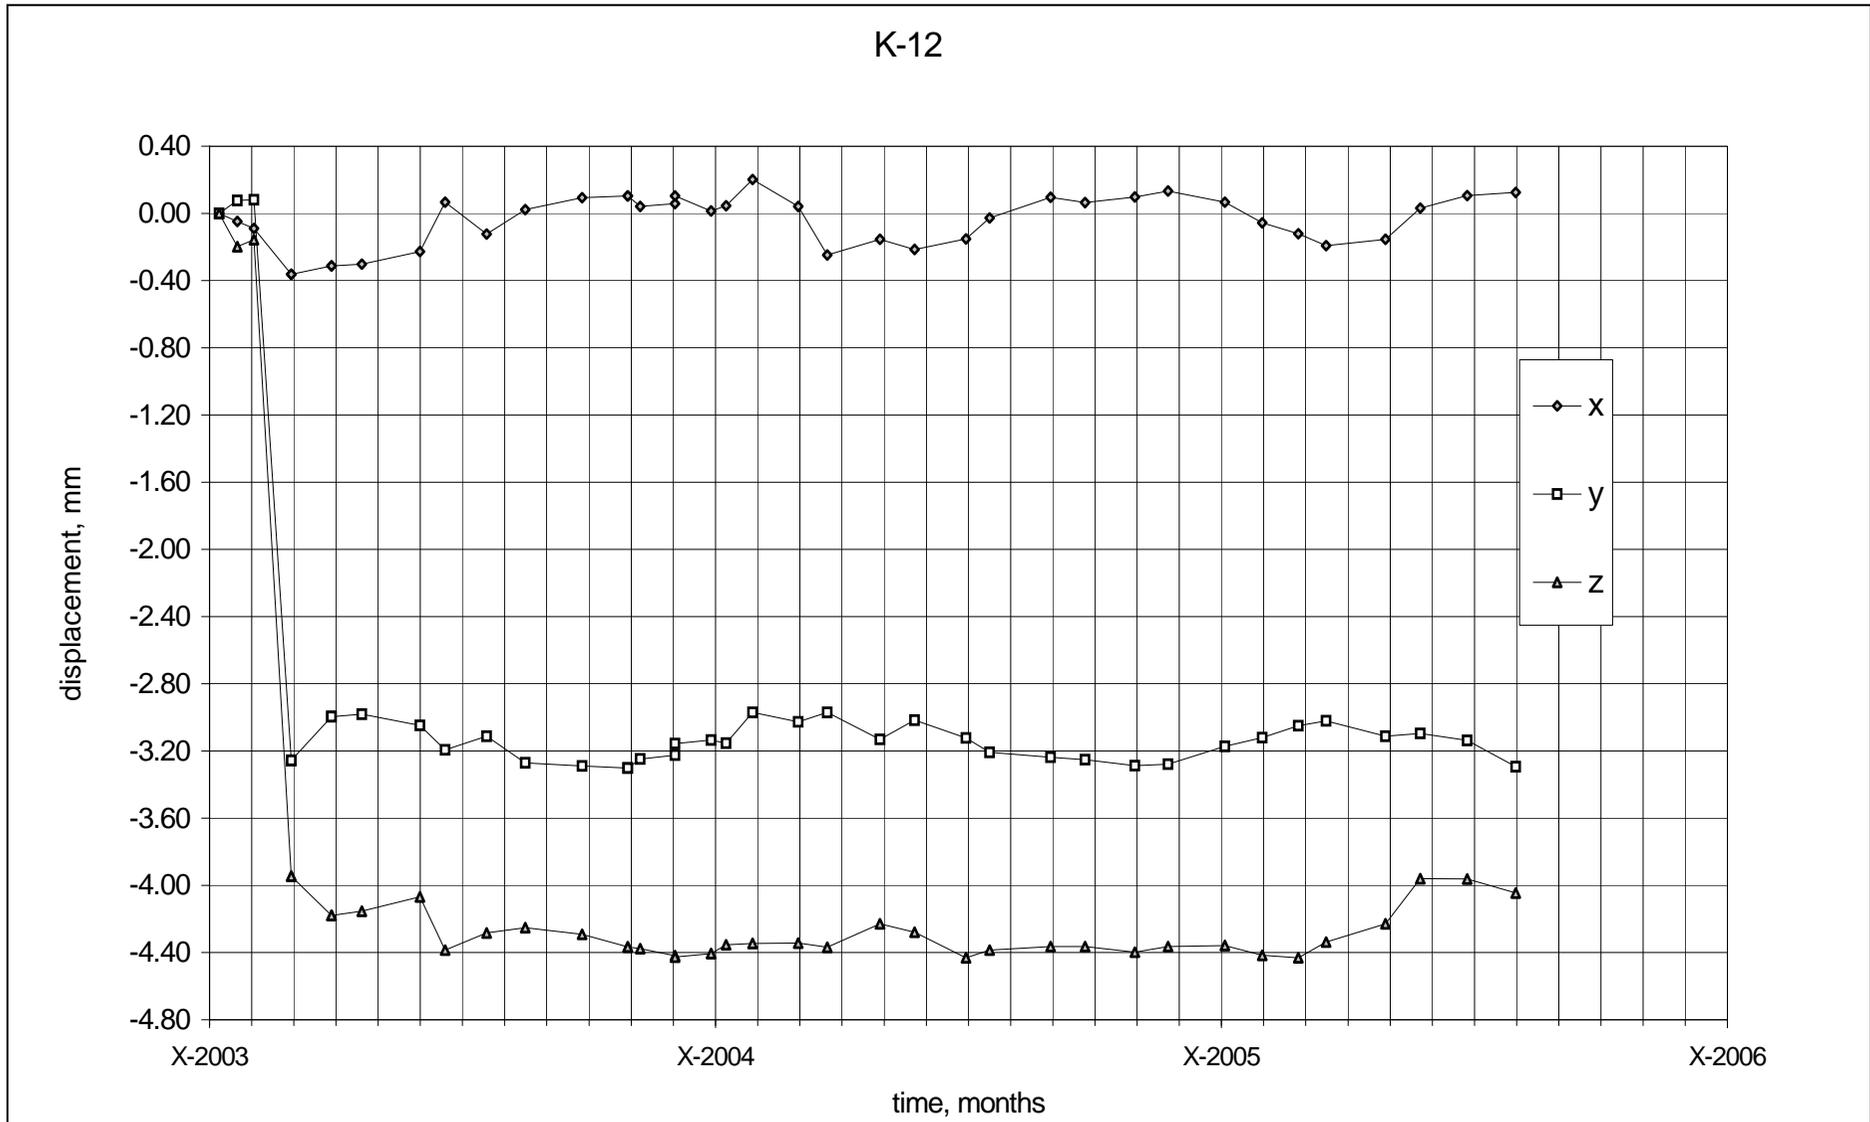
Fig. 6 Tectonic movements found at point no. 12 – Kresna Gorge.

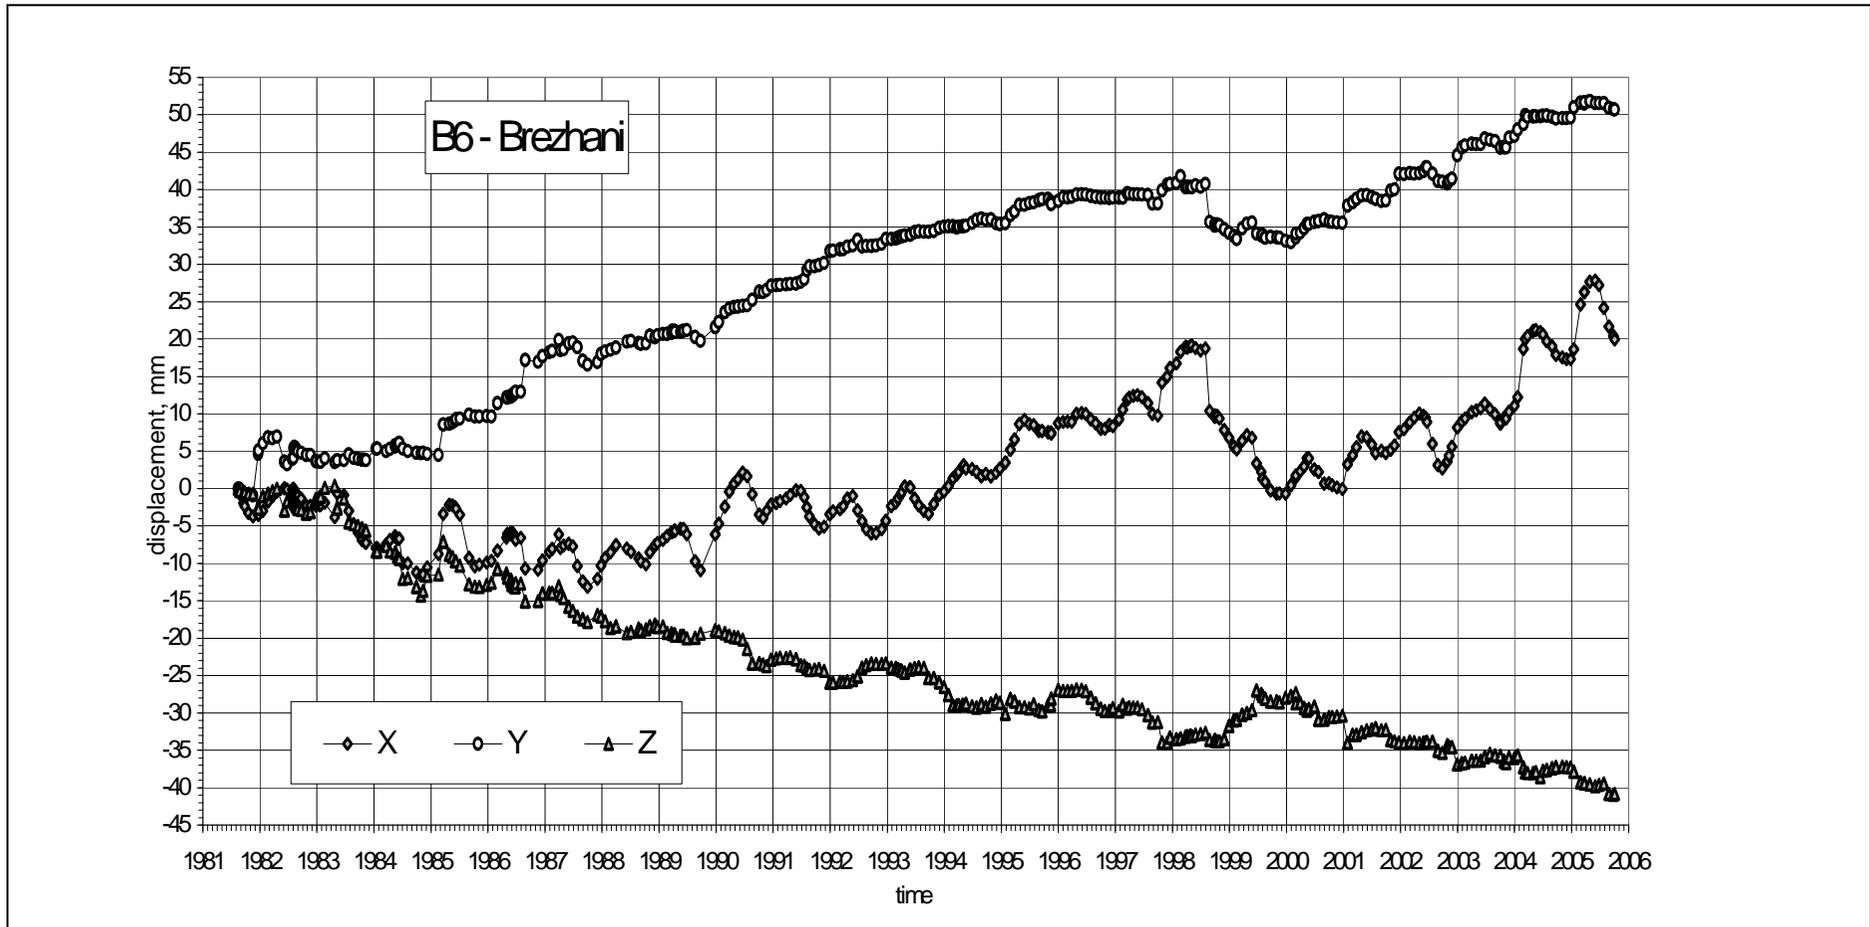
Fig. 7 Tectonic movements found at point no. 6 – Brezhani.

The last monitoring point (No. 6) observes the Krupnik fault near Brezhani Village. The left-lateral slip rate is calculated as 2.73 mm/y; the rate of reverse movements is 0.63 mm/y. The established extension of about 2.8 mm/y is a result mainly of temperature impact of the rock massif (Fig. 7). Local earthquakes located NE from this monitoring point usually influence the movements along this fault. We established acceleration of the left lateral movements during calm periods, and respectively, the movements stop (or going in opposite direction) during seismic activity in NE part of this point, i.e. at Predela-Gradevo area. An effect of stronger earthquake in south, southwest and southeast direction (in Central Greece, Turkey and Aegean Sea) with focal depth more than 20 km was found (Shanov and Dobrev, 1997).

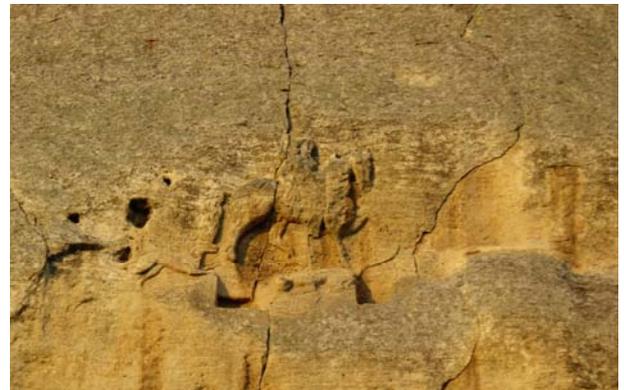
Fig. 8 A general view of Madara Horseman bas-relief.

UNESCO. The bas-relief represents a scene of a horseman, who is said to be Bulgarian khan Tervel (701-717) on his horse, piercing a lion with a spear and followed by a dog (Fig. 8). The monument is cut to a rock wall at a height of 23 m above the terrain including cut inscriptions is 7.2 m wide, and 6.5 m high.

The rock massif bearing the bas-relief is destabilised. Several characteristic rock blocks in the form of rock slices of different profiles, up to 80 or 120 m high have developed here. The state as it is comes from all different conditions and factors like geology, fissuring, physical and deformational parameters, lithology, tectonic activity, erosional processes, climatic conditions, seismicity, human activity, etc. Stability of the block with the bas-relief establishes the main problem. To solve it, there is a call for research into failure mechanism of the wall as well as of the block behind it, and of interrelations between rock blocks from the edge of the plateau above the monument to the bottom.

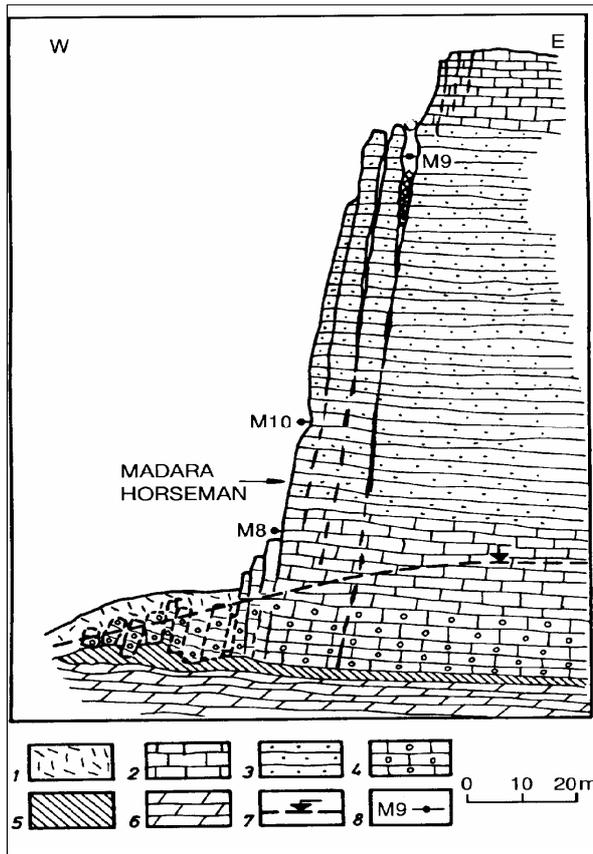
Fig. 9 Engineering Geological profile through the Madara plateau (acc. Frangov et al., 1992; Kostak et al., 1998): 1 – Deluvium; 2 – Sandy limestones; 3 – Calcareous sandstones; 4 – Conglomeratic limestones; 5 – Clay; 6 – Marls; 7 – Ground watertable; 8 – Monitoring point.

The rock wall is almost vertical built by limy-sandy complex. Downwards the slope covers marlstones by debris slope deposits sloping from 10 to 20° (Fig. 9).

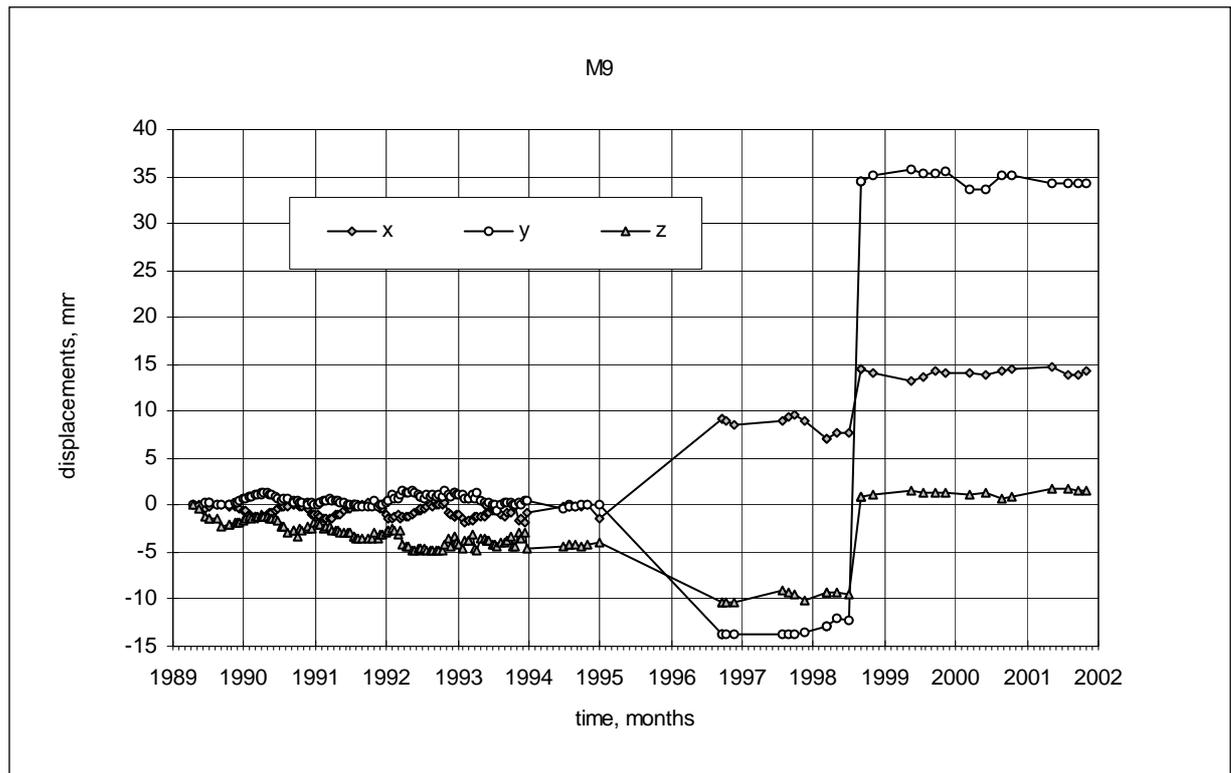
Fig. 10 Displacements found at point no.9 (M9) – Madara.

The results from the 15 years monitoring show subsidence of rock slices by 0.9 mm per year and similar rate movement of the slices to South direction. The curve of displacements has a sinusoidal course, but it is often disrupted by sharp displacements. Some of these displacements are of seismic impact (Košťák et al., 1998). Its position in territory gives way to effects alternating with moderate seismic activity from local earthquake foyers, but with relatively often influence of the strong intermediate-depth Vrancea earthquakes and more rare influence of the strong shallow Marmara earthquakes. The result is shown on Fig. 10. The large deformations were recorded after the strong Izmit earthquake ($M=7.4$) at point M9 (just below the plateau's edge). Small-size displacements were established after shallow earthquakes from Provadia source zone (about 20 km E Madara).

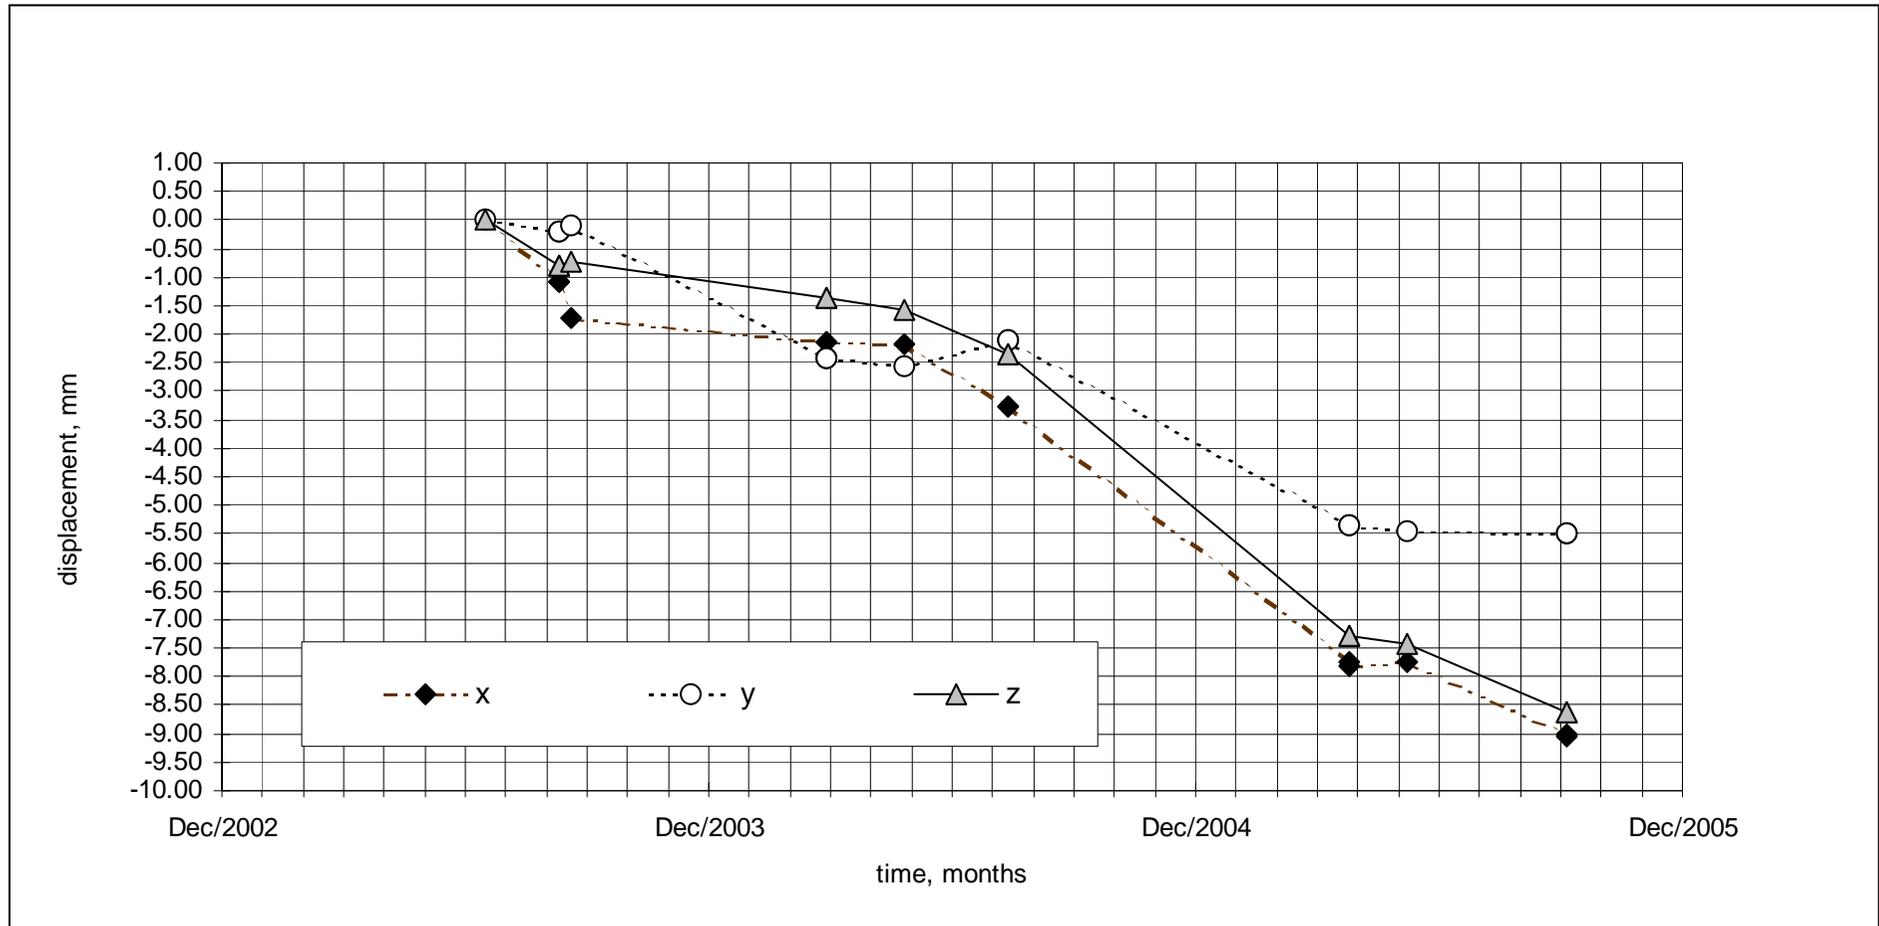
Fig. 12 Displacements recorded at point no.11 – General Geshevo.

The first results from the fault monitoring are shown in Fig. 12. The rates of the fault movements at the monitored site are preliminary till now. Generally, they could be characterized with: movements along X-axis – extension of the fault zone; movements along Y-axis – left (predominantly) and right lateral movements; movements along Z-axis – subsidence of NE block 1.5 mm/year.

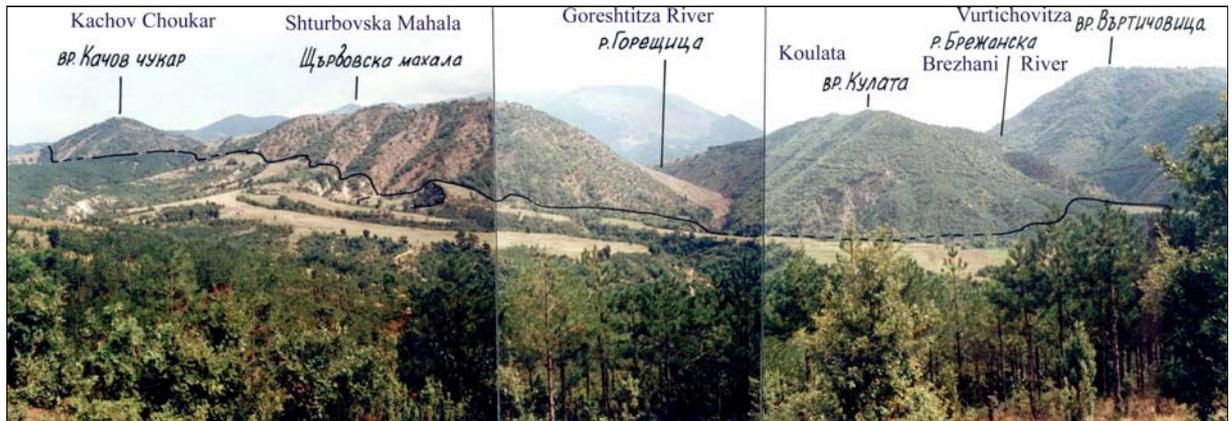
Fig. 3 The Krupnik fault on the left side of Strouma River.

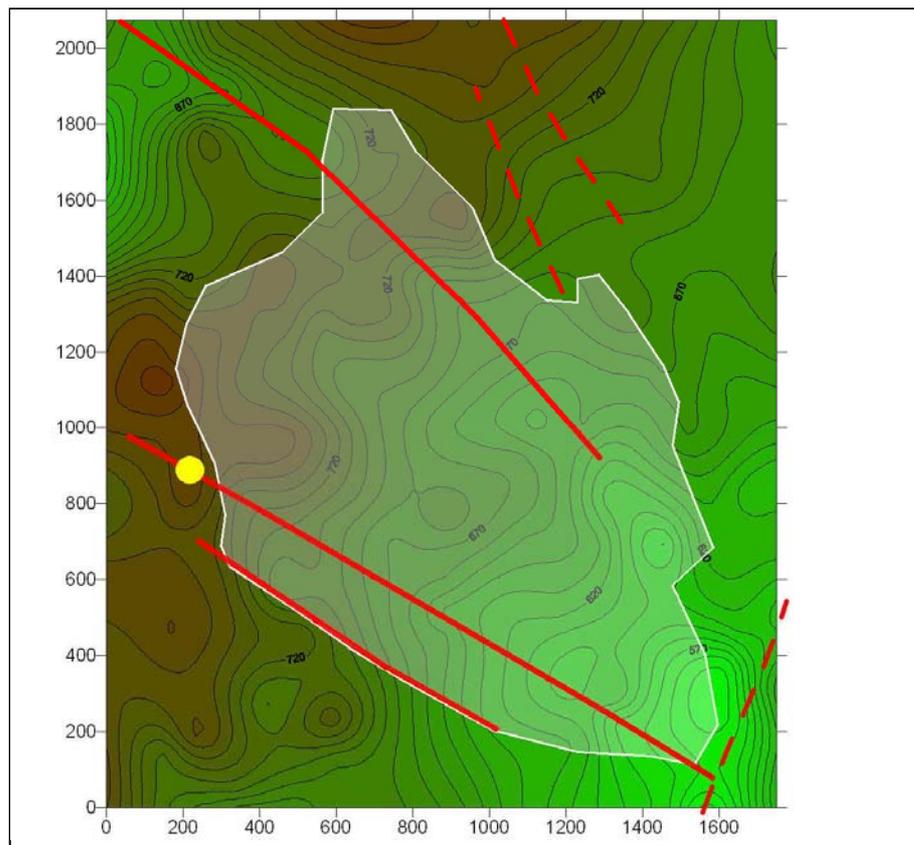
Fig. 11 Geomorphology map of the General Geshevo landslide. The borders of the landslide are shown by yellow contours; the new faults and the Dobromirtzi fault are shown by red lines; the monitoring site is shown by yellow circle.

predominant. The subsidence takes place in the northern blocks. The pitches of the strokes are of value about 70-80°. The fault is revealed between the road and the main scarp – with a length of the outcrop about 50 m. The maximal height of the fault plane outcrop is approximately 10 m. The fault follows a direction of 300° behind the scarp. Along this fault plane, some fractures could be followed approximately 20 m behind the main scarp. The faults with E-W direction are also observed in the investigated landslide territory (Fig. 11).
