LONG-TERM STABILITY MONITORING IN THE PRAGUE CASTLE AREA

The static analyses and assessment of the technical condition of historical buildings in the Prague Castle Area are based on observational methods to gather the basic information about the behaviour of structures. The monitoring involves a combination of different methods of surveying, crack, inclination and temperature measurements together with the monitoring of dynamic effects of traffic and nearby tunnelling activities. These methods were enhanced by line-wise measurements using a high-precision sliding micrometer and inclinometer to assess the role of subsoil and to discover potential very slow slope movements in inclined parts of the area. The problems connected with long-term stability of historical buildings are further studied with the use of static analyses and numerical models of selected buildings in the area.

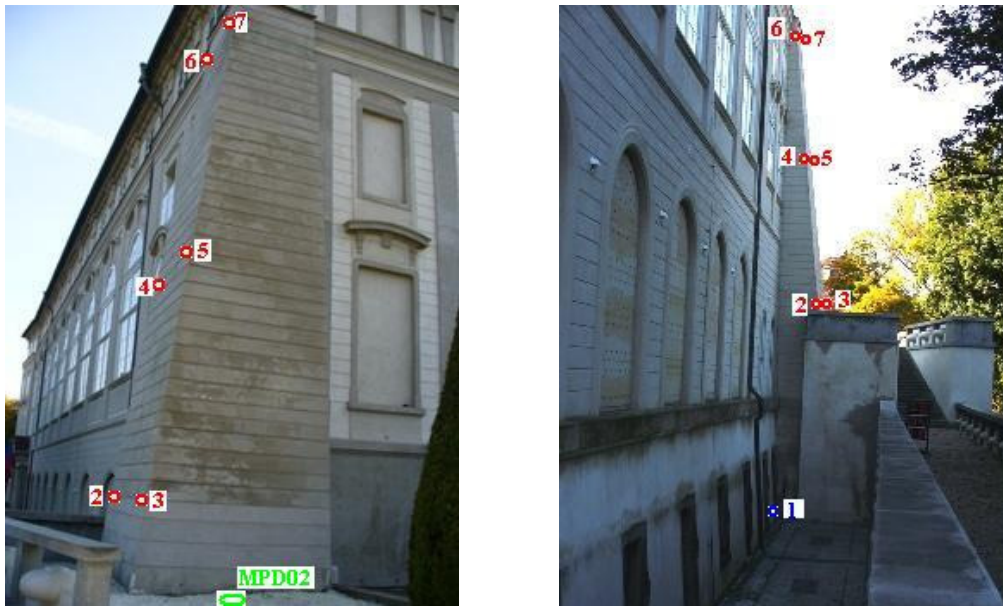
Fig. 6 Front view of Mathey buttress (in eastern direction) and side view (in western direction).

Figure 6 illustrates horizontal shifts of observed points nos. 6 and 7 towards reference point no.1, which is placed approximately 8 m under the level of the upper terrace on the north side of the building and it is therefore exposed much less to temperature changes. Horizontal shifts measured in individual stages are plotted with respect to increasing temperature. The shifts of point no. 6 are illustrated with a blue zigzag line and no. 7 with a green one. There is an obvious proportionality of the size of shifts with temperature. Horizontal shifts of observed points nos. 4 and 5 (in the middle of the overground part of the buttress) and observed points nos. 2 and 3 (just above ground – Fig. 10) are, however, very similar. They are therefore not caused by the tilt of the structure, but rather by thermal expansion of the buttress masonry above the level of the terrace.

The embedment depth of the casing is 5 m in the rock base below the footing. It was not possible to drill deeper because of the shale quality and the capacity of the boring machine. The capacity of the machine was limited by the difficult transport to the place of instrumentation (Fig. 6).

This is another reason for a parallel application of GPS besides surveying and geotechnical line-wise measurements. The location of the instrumented borehole MPD 02 is presented in the Figure 6 together with the measuring point for surveying.

In the case of temperature changes ranging from 3 °C to 27 °C the horizontal shifts measured in five years are about 2 mm. The accuracy of the horizontal shift characterized by the standard deviation σ_p is expected to be approximately 0.2 mm, i.e. the shift can be taken as proven for values higher than approx. 0.4 mm. The course of horizontal shifts is illustrated in Figure 6.

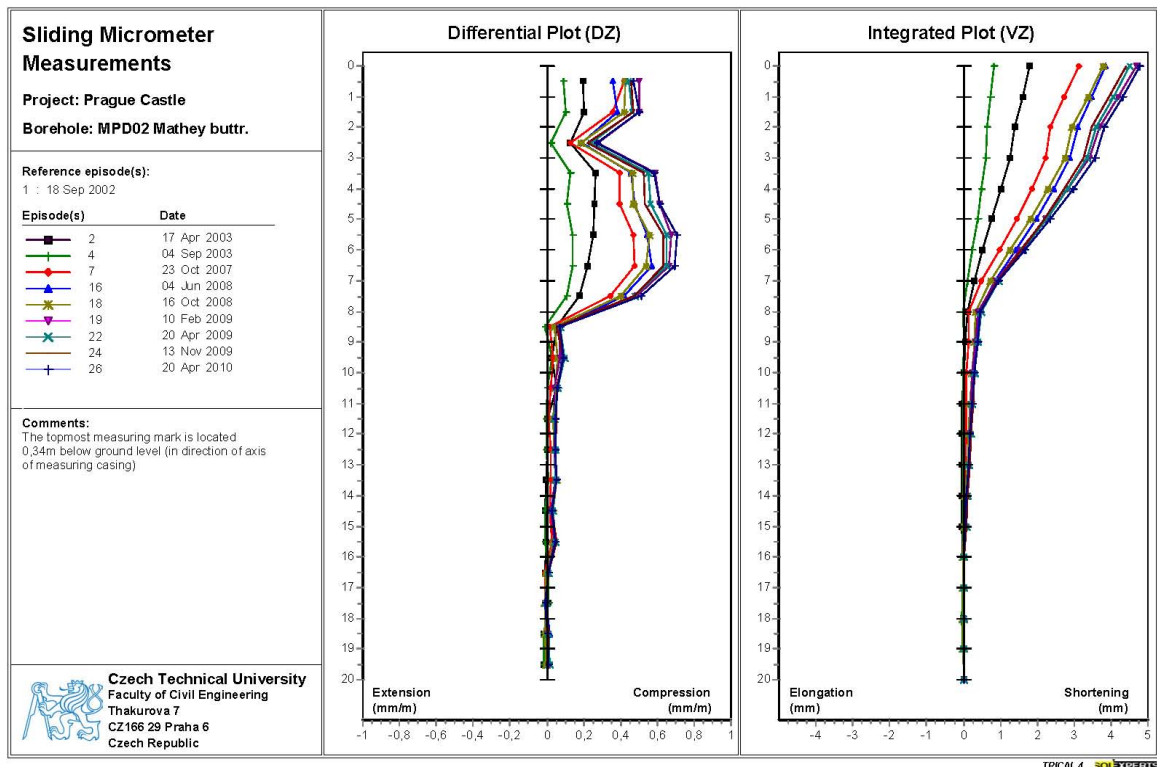
The differential plot in Figure 5 represents local changes related to a 1.00 m measuring base length of the sliding micrometer. The integrated plot describes the evolution of the vertical displacement – compression of the whole soil and rock sequence. The compression of the backfill was expected, but the slight and long term development of the footing body compression (about 0.5 mm in 6 years) shall be further monitored.

Fig. 5 Development of vertical displacements with use of sliding micrometer – Mathey buttress.

The condition of the fixed bottom of the casing is confirmed by almost no deformation in the embedded part of the casing below the buttress footing, Figure 5. The courses of transformations of long-term geodetic monitored values of shifts confirm the above assumption, too. We assume that the embedment of the MPD02 casing into the system of stabilized points of the local geodetic network is justified.

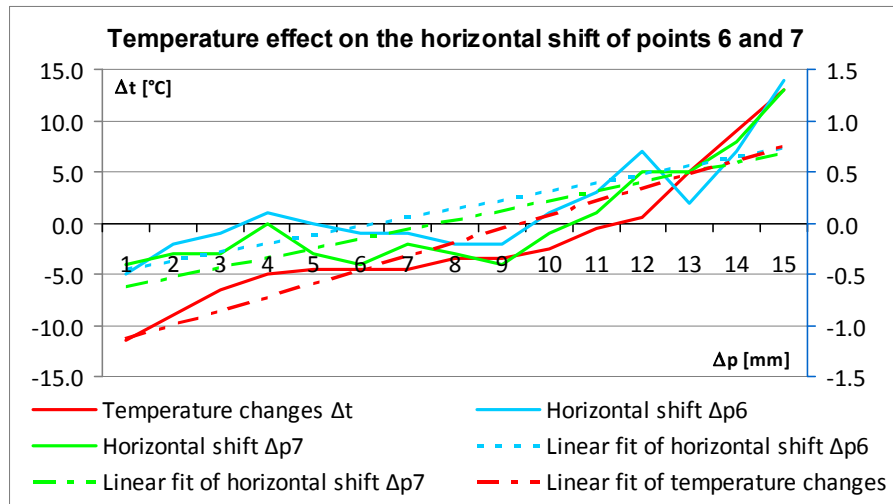
The results presented in Figure 7 seem to confirm the reasoning about the expansion of the buttress masonry above the upper terrace. This is proved by the locations of fitted lines, which are close to be parallel to the horizontal axis. This was observed within 5 years and in a temperature range of 24 °C. We suppose it is possible to state that the tilt change of Mathey buttress has not been determined during about 5 years of the monitored period.

Fig. 7 Illustration of horizontal shifts of upper points of the buttress with respect to point no.1.

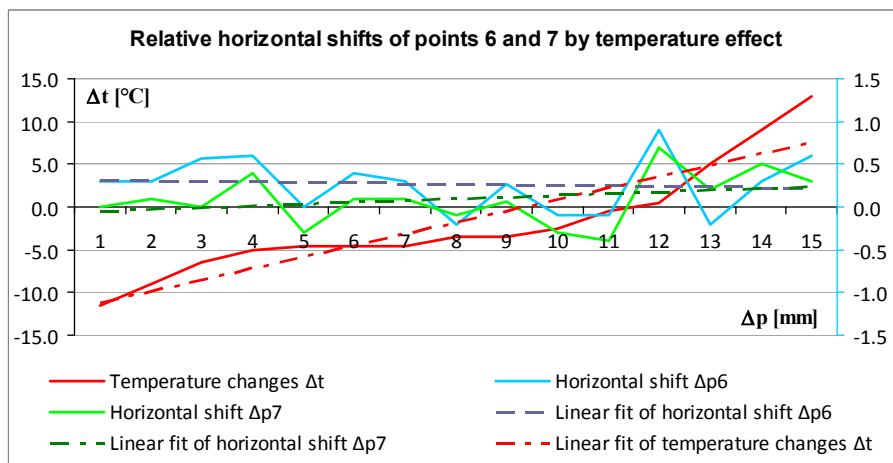
Fig. 8 Plot of relative horizontal shifts of upper points of the buttress related to points 2 and 3.

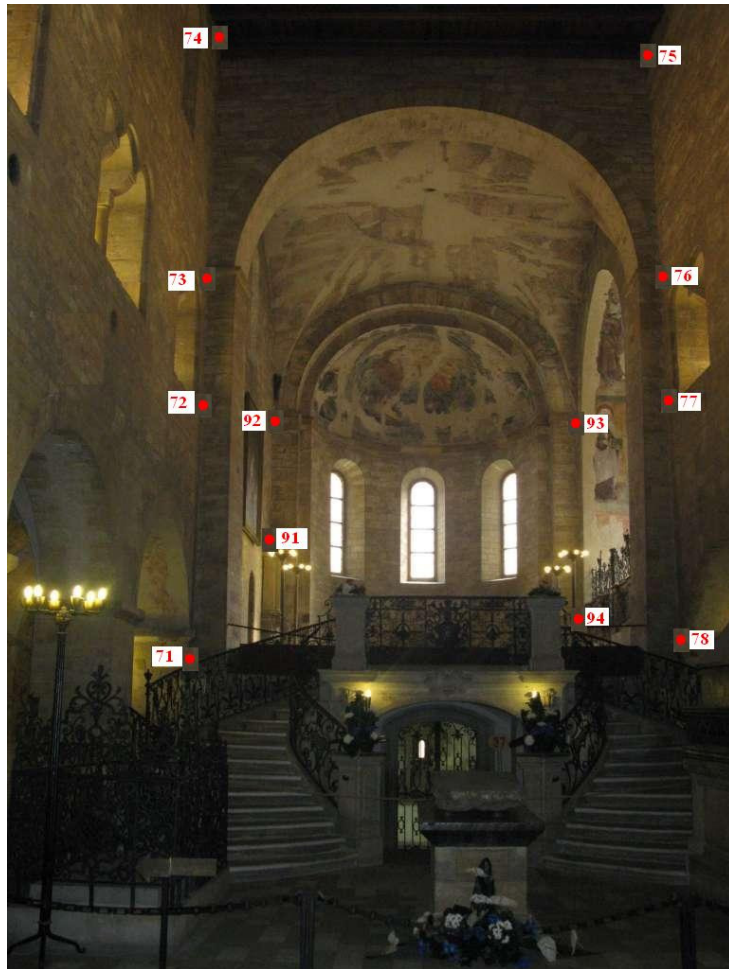
two basilica towers and the walls of the nave are presented in a simplified N-S section and layout, Figure 17. The observed points of cross-sections nos. 4 and 5 are presented in Figure 18.

Fig. 18 Illustration of measured points in vertical sections nos. 4 and 5 – as seen from the west.
