## LONG-TERM SLOPE DEFORMATION MONITORING IN THE HIGH MOUNTAINS OF THE WESTERN CARPATHIANS

### ABSTRACT

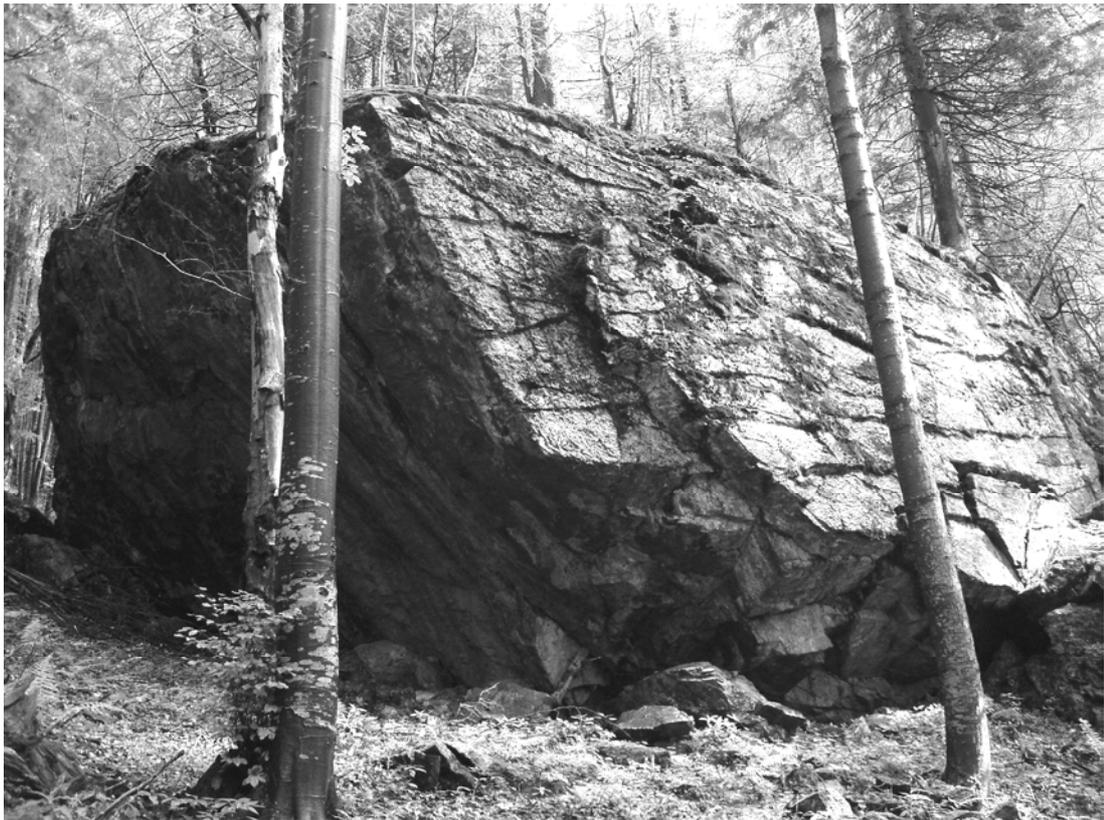
**Fig. 5** A limestone block of a significant size found in the toe accumulation (photograph: M. Briestenský).

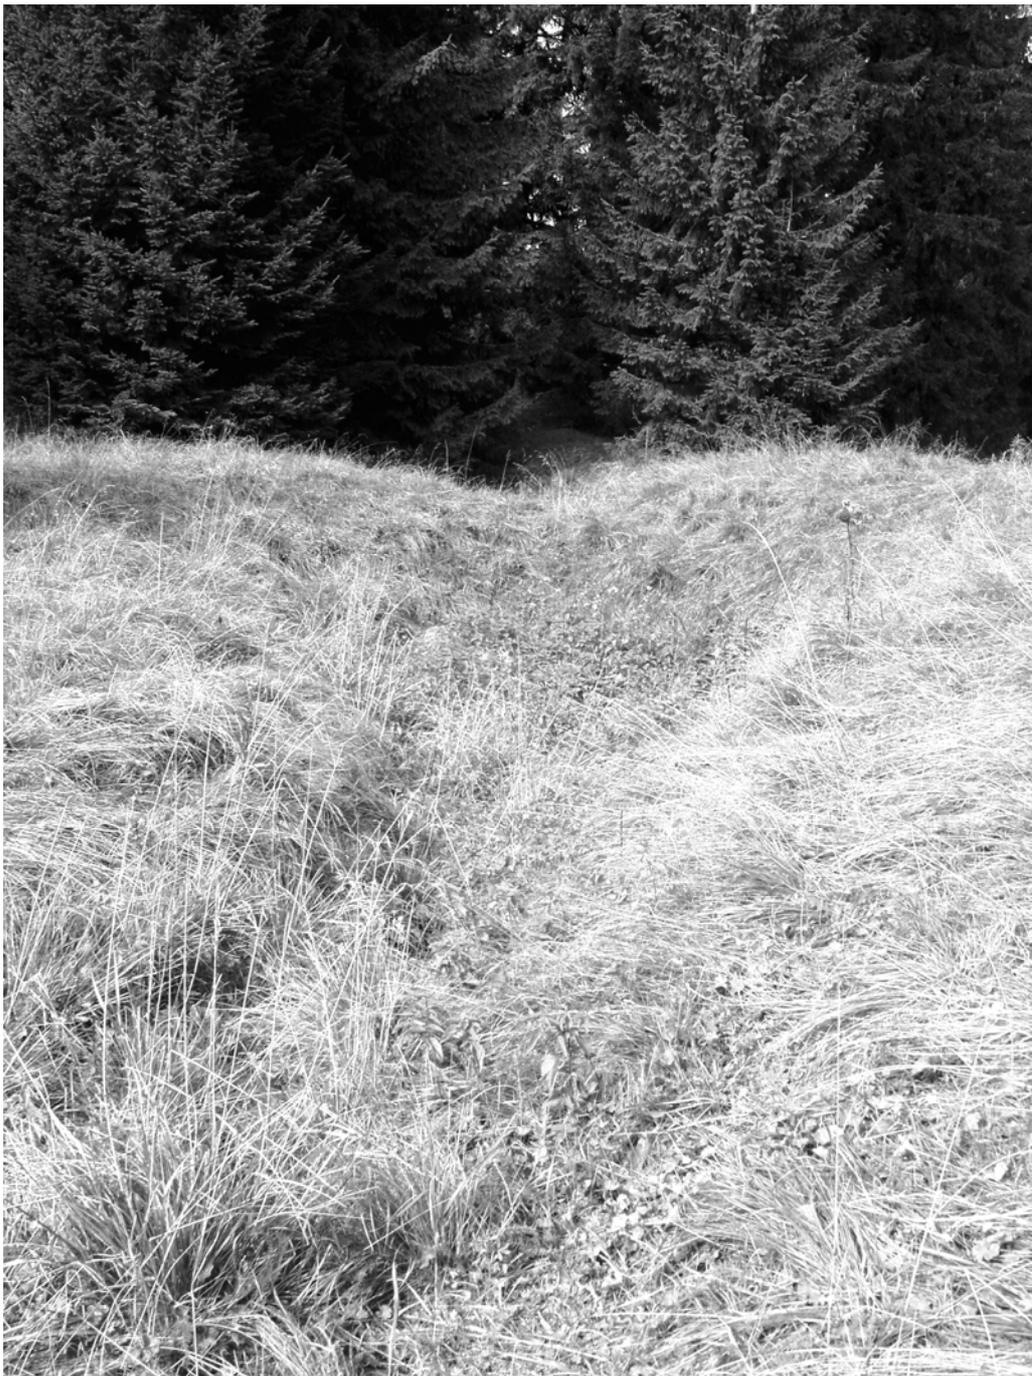
**Fig. 11** A sinkhole above the Štrochy Abyss. This reflects subsidence of the cave ceiling due to active fracture opening (photograph: M. Briestenský).

In addition, fissure opening is displayed at the surface. The linear sinkholes above the cave show active subsidence of the cave ceiling (Fig. 11) as well as possible active flexural toppling (*sensu* Dikau et al., 1996). According to our survey, the cave developed
