MONITORING OF STAND-AND-ROOF-BOLTING SUPPORT: DESIGN OPTIMIZATION

Zbigniew NIEDBALSKI *, Piotr MAŁKOWSKI and Tadeusz MAJCHERCZYK

AGH University of Science and Technology, al. Mickiewicza 30, 30-059 Krakow, Poland

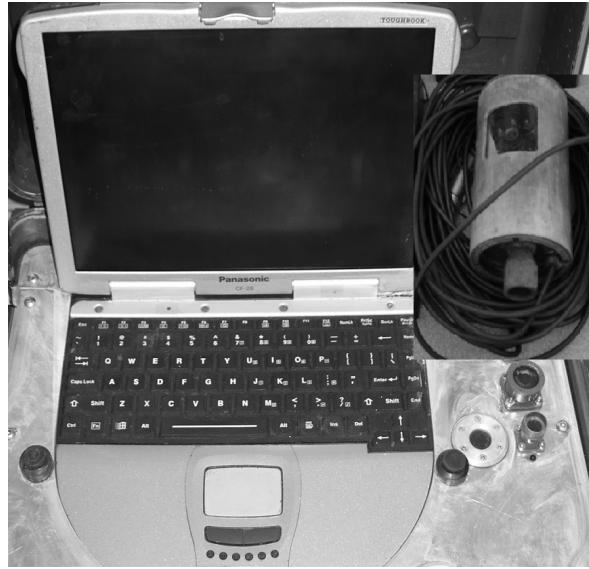
Fig. 2 The borehole endoscope.

lution additionally allows the researchers to carry out remote readings in a given time interval. Endoscopic measurements seem to be most effective in terms of the obtaining results (Fig. 2), as the endoscopes allow for the precise determination of location and volume of roof or floor strata separation based on observations of borehole walls (Małkowski et al., 2008b), (Sosna et al., 2009). What seems to be of crucial importance in this case is that such a method allows for the evaluation of the initial state of strata separation, which is impossible with the measurements carried out using telltales and extensometers. On the other hand, it should be stated clearly that endoscopic measurements are time-consuming and require insertion of the device into a borehole for every single test.

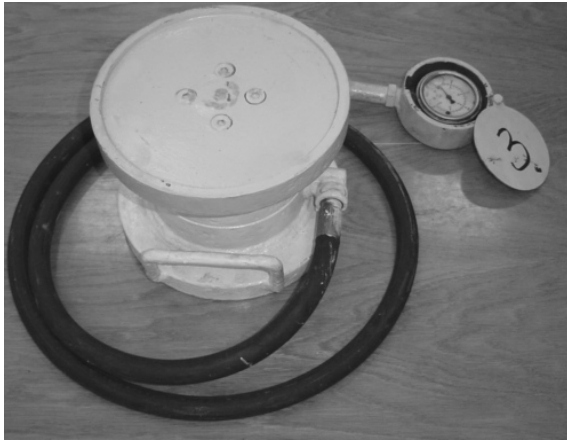
Fig. 3 Hydraulic dynamometer.

The application of hydraulic dynamometers (Figs. 3 and 4) or tensometric dynamometers allows for the researchers to determine the loading of particular elements of steel arch supports. Dynamometers are installed in the roof between rock

mass and support frames to estimate the loading coming from the rock mass. In order to determine the axial forces in wall arches, the dynamometers can be installed under the arches instead of support footings. In the case of using close support sets, dynamometers can also be built-in between the floor arch and the rock mass. A series dynamometer allows for the measurement of support loadings on its perimeter (Fig. 4).

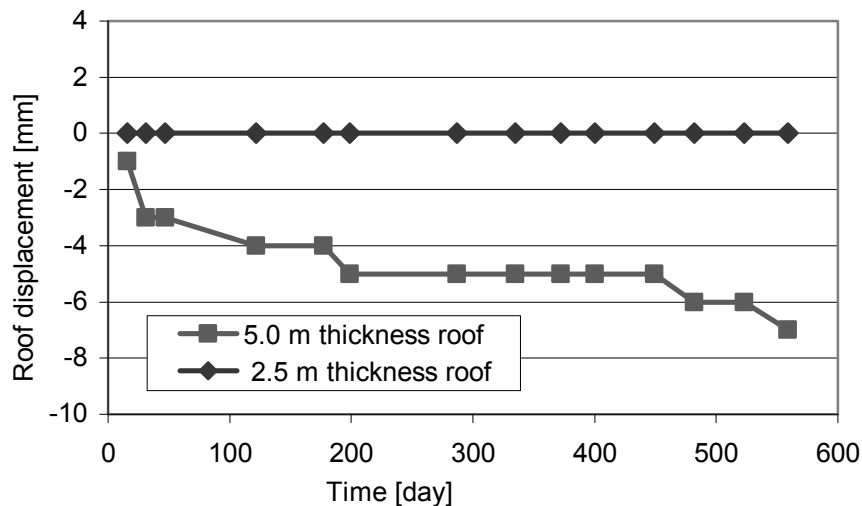
Fig. 15 Convergence in the connection roadway Z3.

Low telltales were installed in the working's roof in order to determine the changes in the immediate roof strata packet with a thickness of 3.0 m, whereas high telltales were to perform a similar role in the roof strata packet with a thickness of 6.0 m. During almost 700 days of measurements, only a minimal dislocation (separation) of roof strata towards the working was observed (i.e. reaching only 7 mm) in the roof packet with a thickness ranging between 3 and 6 m (Fig. 15).

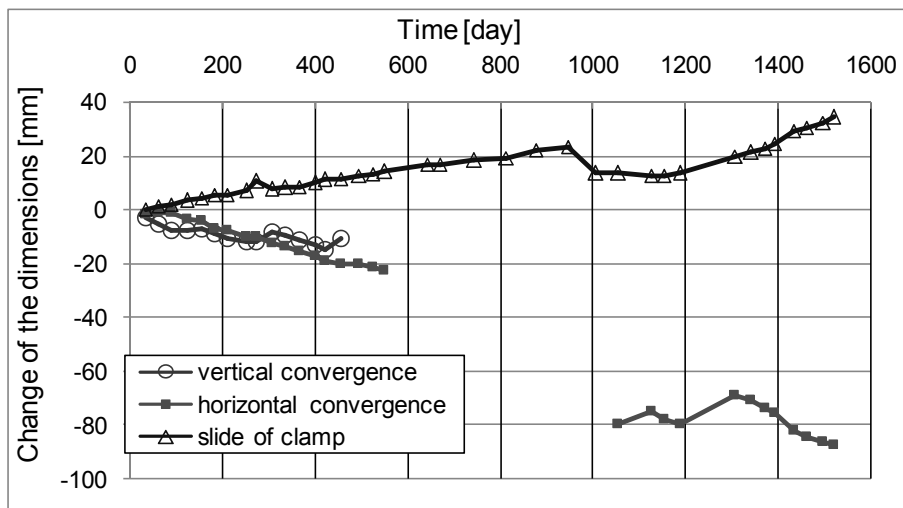
Fig. 16 Convergence in the connection roadway Z3.

The results of convergence measurements corroborate a proper interaction between the support and the rock mass. The maximum values of height change and width change reached approx. 2 cm after 550 days, which seems to be an extremely low and unimportant rate in terms of providing stability of the working (Fig. 16). In the case of width change, the measurements were carried out over almost 3 years. It has shown that a width change increase to -87 mm and the slide of clamps, connected with the roof and side arches, reached a value of 34 mm. The analysis of the overall dimension changes in the connection roadway Z3 carried out during a period of almost 1500 days

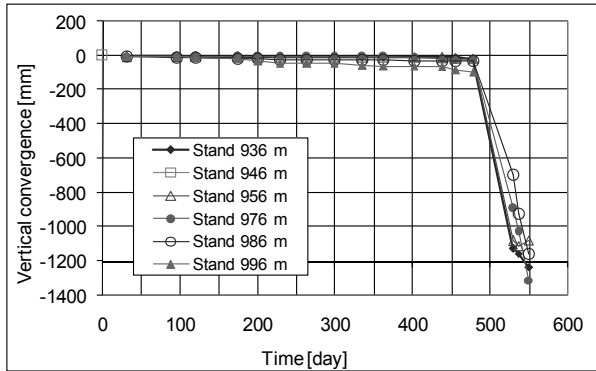
Fig. 19 Vertical convergence in the roadway B-7.

Convergence measurements indicated that the values were insignificant and did not exceed several centimeters until the influence of the working face was revealed (Figs. 19 and 20). The only passage of the face resulted in step vertical convergence reaching 1.3 m and horizontal convergence reaching 0.7 m. Although the obtained values of convergence were significant, it was possible to re-use the roadway for the neighboring longwall panel.
