## THE EFFECT OF THE SODIUM SULPHATE SOLUTION EXPOSURE ON PROPERTIES AND MECHANICAL RESISTANCE OF DIFFERENT KINDS OF RENDERS

**Keywords:** Sulphate attack, Renders, Mechanical resistance, X-Ray CT, Chemically induced damage

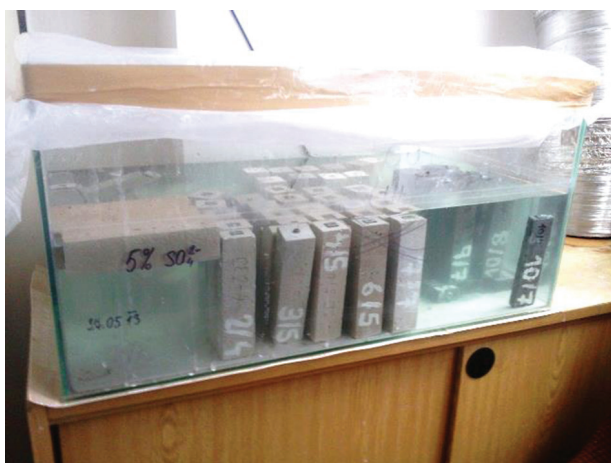
Figure 1. Tested samples in the sulphate solution environment.

The rod shaped samples were exposed to the conditions simulating the sulphate aggressive environment. For the particular materials, 20 samples were placed in a glass vessel containing 5 % water solution of  $\text{Na}_2\text{SO}_4$  (33.8 g of  $\text{SO}_4^{2-}$  in 1 l of distilled water). Remaining 15 samples were exposed to the reference environment of distilled water. See Figure 1

for the experimental arrangement. The tested samples were oriented vertically in the vessel in order to get maximal contact of the specimen surface with the salt solution. The concentration of sulphate solution was continuously monitored and maintained on the desired level. The maximal time of samples exposure to the both environments was 168 days at temperature of  $23 \pm 1^\circ\text{C}$ . The selected salt concentration was based on the range of salt contents found in the analysis of case studies [25]. Similar  $\text{Na}_2\text{SO}_4$  concentration was used for example by Lubelli et al. [26] that studied hygroscopic behavior of Dutch red bricks specimens contaminated with salts.

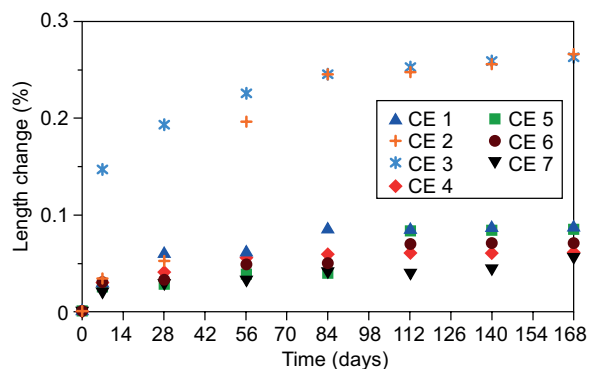
Figure 2. The relative length changes measured for renders stored in water.

Time development of length changes measured for samples immersed in distilled water is presented in Figure 2. The given data represents average value from measurement on free samples, whereas the measurement was realised for samples stored in water up to 168 days. The highest length change exhibited materials CE2 and CE3, whose relative length change was approx. 0.26 %. The lowest length change was observed for render CE7 that yielded the maximum relative length change of 0.06 %. Similar low length deformation exhibited also materials CE1, CE4, CE5, and CE6.

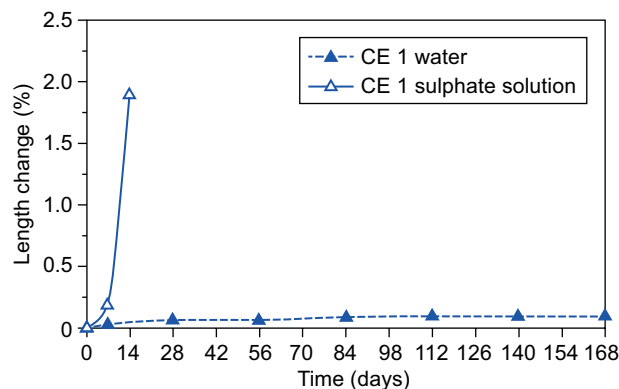
Figure 3. The relative length changes measured for render CE1 stored in sulphate solution.

As the length change of samples CE1 stored in sulphate solution was distinctively higher compared to strain of other examined renders, the resulting length changes were split in Figures 3, 4.

Action of  $\text{Na}_2\text{SO}_4$  water solution on materials length changes was in a most visible for render CE1. Its maximum relative length change measured after 28 days exposure to sulphate solution was 1.91 %, what is approximately 20 times higher compared to data measured for CE1 samples stored in water. Additionally, during first week we observed for CE1 samples cracks formation up to the depth of 5 mm along the sample length and in side areas. These cracks have continuously propagated and after exceeding of 28 days of sulphate solution exposure, we were not able to perform measurements of the length and mass changes because of samples disintegration. The damage of CE1 samples induced by sulphate action is displayed in Figure 5.

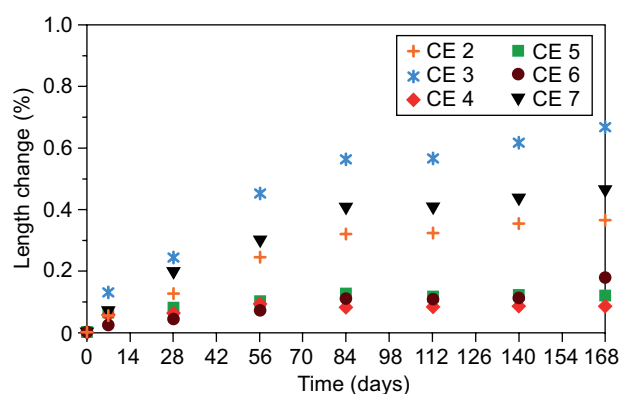
Figure 4. The relative length changes measured for renders stored in sulphate solution.

As graphed in Figure 4, the highest length changes exhibited render CE3 (CE1 was entirely damaged), what is lime-cement base coat mortar. Its length change measured after 168 days of sulphate exposure was 0.66 %. This is more than 2 times higher compared to data measured for water cured samples. Material CE3 was partially damaged by formation of ettringite and gypsum, what documents also data on mechanical properties. From the practical point of view, one can assume more significant damage in long-term sulphate solution exposure. The lowest length changes exhibited material CE4. This material due to its high porosity (81.2 %) has sufficient space for accumulation of sulphate corrosion products, what resulted in relative length change of 0.09 %. Similar behaviour exhibited renovation renders CE5, CE6 (porosity > 50 %) that had after 168 days of sulphate solution exposure relative length changes 0.12 % and 0.18 %, respectively. The maximum relative length changes accessed for materials CE2 and CE7 were 0.36 % and 0.46 %.

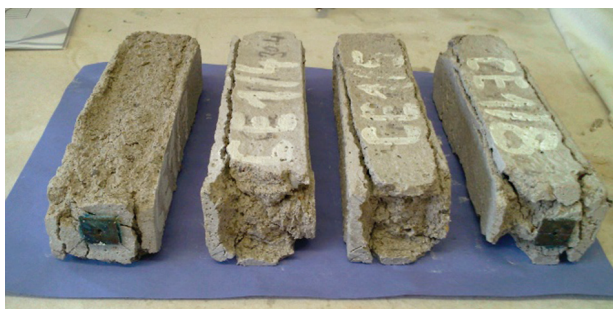
Figure 5. Disintegration of CE1 samples stored in sulphate solution.

The binders of render CE1 were lime hydrate and metakaolin, whereas no exact information on their exact dosage was available. However, taking into account the above given data, we assume that metakaolin is represented in low amount only, because of high amount of portlandite that reacted in sulphate environment and formed high volume crystals of gypsum. Also ettringite formation increasing the material damage can be anticipated. Similar findings were published for example by Khatib and Wild [33]. They concluded that clay systems stabilized by lime hydrated are less binding

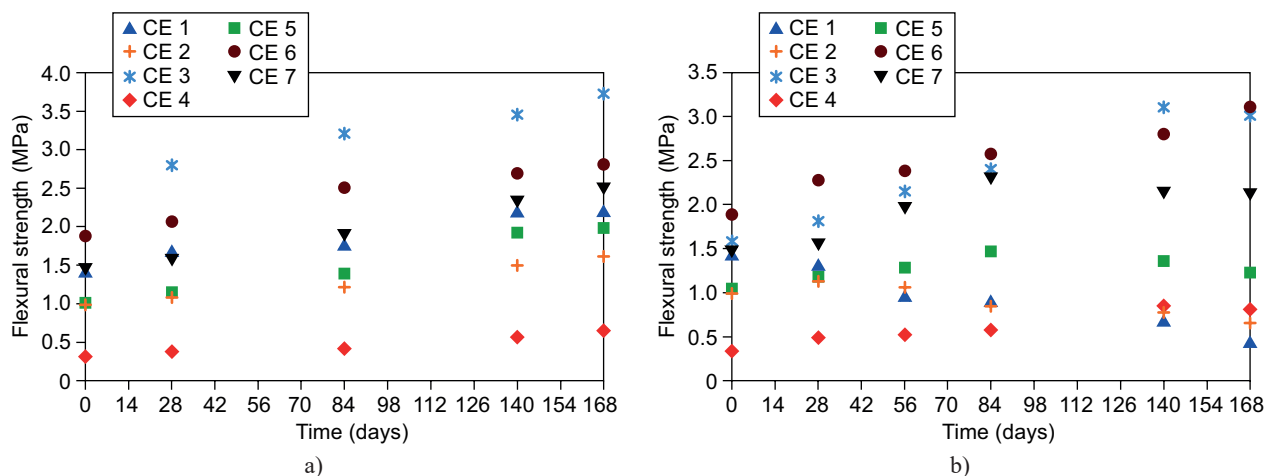
Figure 8. Time development of the flexural strength – samples stored in distilled water (a), samples stored in sulphate solution (b).

The propagation of sulphate corrosion was observed also on the basis of changes in mechanical strength induced by the formation of new sulphate substances. These corrosion products can in certain extent positively affect the materials mechanical resistance. On the other hand, after the full filling of porous space, the crystallization pressures cause the decomposition and disintegration of the interior structure of composite material. The time development of the flexural strength measured for materials stored in distilled water is given in Figure 8a.

The test specimens immersed in sulphate solution yielded initial improvement of the flexural strength until the structural changes caused by the formation of sulphate corrosion products appeared (see Figure 8b). The initial improvement of the flexural strength was observed up to 84 or 140 days of samples exposure to the sulphate environment depending on the type of render. Renovation render CE6 proved its applicability on salt laden masonry, since its sulphate solution exposure and

formation of corrosion products in its open porous space led to the improvement of the flexural strength for all tested samples. The lowest resistance against sulphate action exhibited mortar CE1 that lost its flexural strength already after 28 days of sulphate environment exposure. This material exhibited after storage in sulphate solution for 168 days 30 % of the original flexural strength only. This feature must be taken into account in a practical application of mortar CE1, and its usage for sulphate laden structures must be avoided.

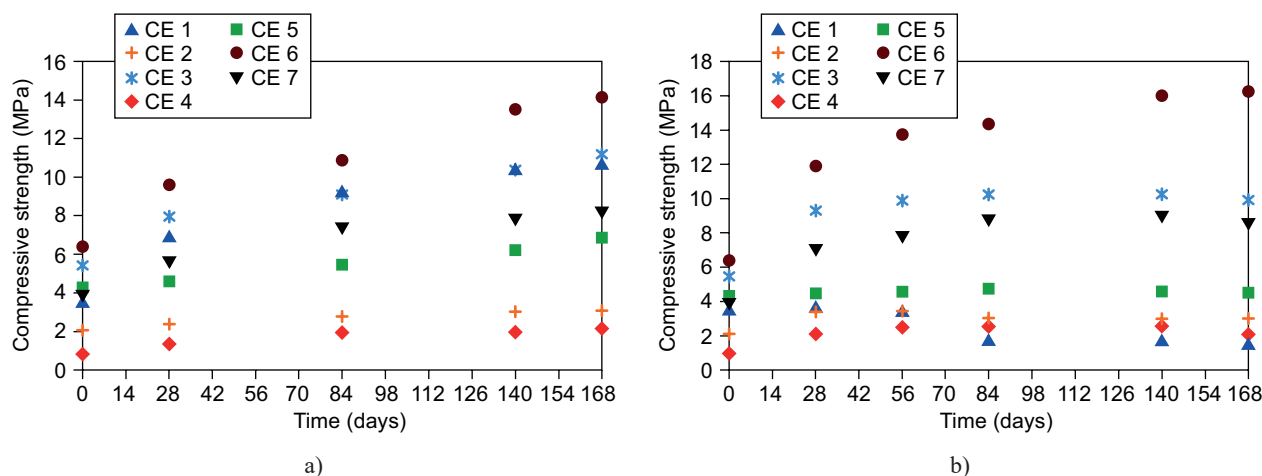
Figure 9. Time development of the compressive strength – samples stored in distilled water (a) samples stored in sulphate solution (b).

The initial increase in the compressive strength is in agreement with the flexural strength data, and is caused by the increase in materials specific density. Here, not only propagation of portlandite, C–S–H and C–S–A–H phases took place. Also chemical reactions of hydrated products with sulphate solution contributed in this phase to the formation of renders matrix by filling the porous space by the newly formed corrosion products. However, after 84 or 140 days of samples exposure to the sulphate solution, the porous space was fully filled by the newly formed substances, and the harmful crystallization pressures decreased the mechanical resistivity of re-

ched mortars. Similar performance of cement-based plaster observed e.g., Łukowski and Salih [44] who studied durability of PC mortars in acid and sulphate environment. The decrease in compressive strength was visible for all the studied materials except mortar CE6 that maintained its excellent mechanical properties even after 168 days exposure to the sulphate environment. The lowest resistance to the sulphate corrosion exhibited material CE1, whose samples were largely damaged by salt action. This material had after 168 days storing in sulphate environment the compressive strength of 1.7 MPa what represents approx. 53 % decrease in the compressive strength compared to the initial reference value.

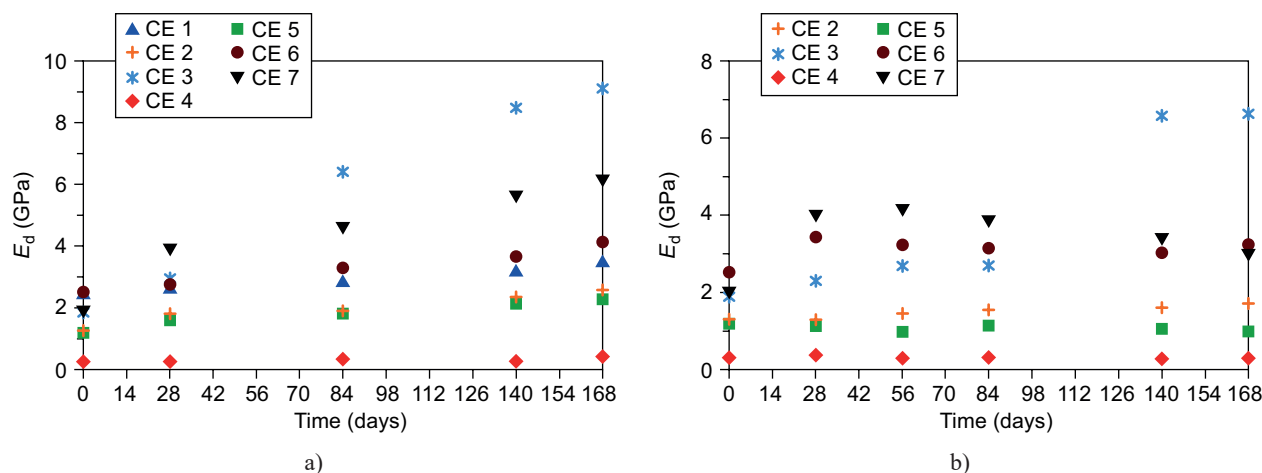
Figure 10. Time development of the dynamic Young's modulus – samples stored in distilled water (a), samples stored in sulphate solution (b).

The time development of the dynamic Young's modulus measured for samples stored in distilled water is given in Figure 10a. Accordingly as in the case of the compressive and flexural strength data, the water curing supported the hydration process leading to the increase in renders density and thus to the decrease in porosity (see data presented in Figures 7a, b and Tables 2 and 3. With the increasing densities values, the dynamic Young's modulus simultaneously increased. Similar results were published e.g., by Rozière et al. [45] who tested durability of mortars and concretes made of different cements, namely PC CEM I 52.5 R, sulphate resisting PC CEM I 52.5 N PM ES, and sulphate resisting blended cement CEM III I 42.5 N PM ES. Authors stated, the resistance to sulphate attack can be improved by substitution of high- $\text{C}_3\text{S}$  PC by 30 % of fly ash.

The highest improvement and values of the dynamic Young's modulus with increasing time of water curing exhibited cement-lime render CE3 that had the maximum Young's modulus of 9.2 GPa. This material had also high compressive strength, and together with render CE6 highest flexural strength. The lowest development and values of the Young's modulus exhibited render CE4, because of its lightening by perlite and high total

The data of the dynamic Young's modulus measured for samples stored in sulphate solution is given in Figure 10b. Here, we observed initial improvement of the Young's modulus, typically up to 56 days, and after that followed its decrease. Certain exception represents render CE3 that improves its Young's modulus from 2.8 GPa (measured for 84 days of sulphate exposure) to 6.6 GPa (140 days). This feature is caused by crystalline new products that filled the porous space as in the case of water curing. However, after 168 days of samples storing in the sulphate solution, no increase in the Young's modulus was found, and one can assume its significant decrease in longer time of sulphate attack. The lowest values of the Young's modulus were obtained again for render CE4, where no measurable effect of sulphate action was identified. This material of high total open porosity is less sensitive to the changes of porous structure due to the formation of the hydration and sulphate corrosion products because of high accumulation capacity of

its porous space. The results for render CE1 were not measured, because of samples damage that occurred after 28 days of sulphate solution exposure. Renders CE 2, 4, and 5 exhibited only small elasticity changes, and the measured values of the Young's modulus corresponding to specific time of samples exposure to sulphate action differed in measuring accuracy range only. From the quantitative point of view, the values of the dynamic Young's modulus were for samples stored for longer time in sulphate solution exposure significantly lower compared to the results obtained for samples cured in water.

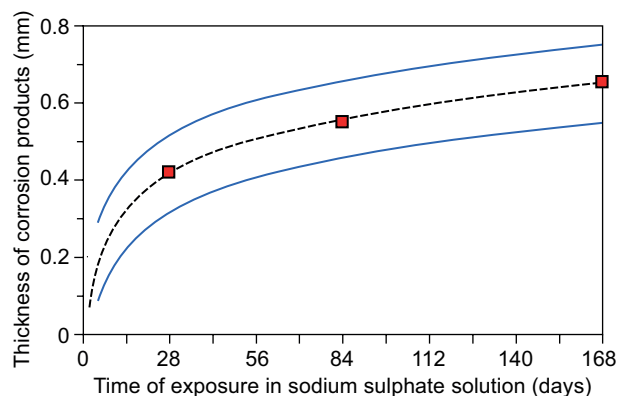
Figure 12. Time development of increasing sulphate corrosion products layer thickness in open macropores.

Formation of sulphate corrosion products in pore space of render CE1 monitored by X-Ray CT is presented in Figures 12, 13, 14. Here we identified formation of sulphate corrosion products in render porous space, whereas first the smaller air voids (Figure 15) were practically completely filled by these new mineral phases

after 168 days of sulphate action. In Figure 12, the red squares represent the arithmetic mean of 10 individual measurements of sulphate salts layer thickness, newly

formed inside the open pores with diameter of approx. 1-2 mm. The blue continuous lines define the area of standard deviations of measured values. Looking at this figure, the progressive increase in volume of corrosion products in open pores during 28, 84 and 168 days lasting exposure in sulphate solution is well visible.

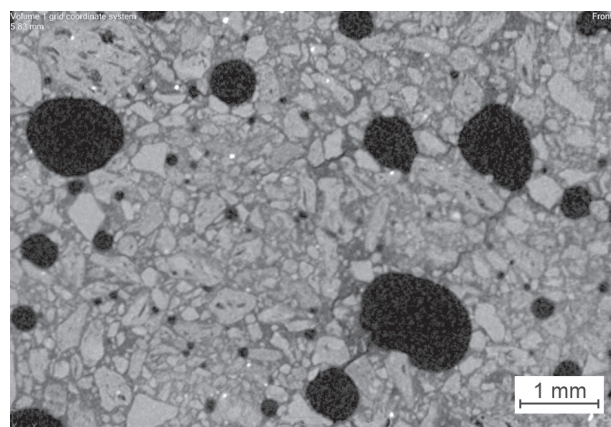
Figure 13. Large open pores in the inner structure of render CE1 – reference sample without sulphate solution exposure.

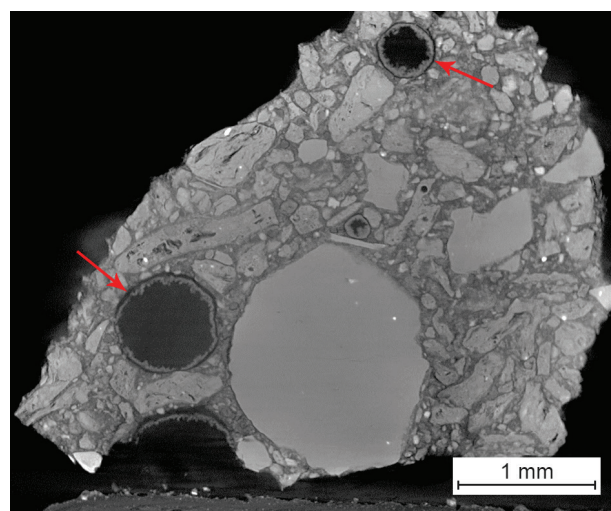
Figure 14. Macropores in render CE1 stored 168 days in sulphate environment with well-visible sulphate corrosion products layer of about  $0.05\ \text{mm}$  thickness.

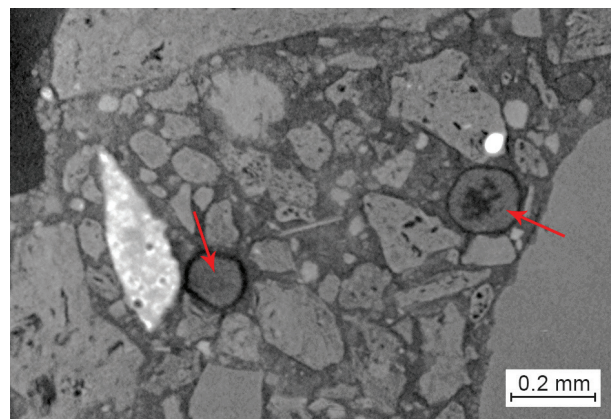
Figure 15. Smaller air voids (marked by red arrows) almost completely filled by corrosion products after 168 days of sulphate solution attack.

- The X-Ray CT method applied on CE1 samples allowed in dependence on time of samples storing identification of newly formed corrosion products in render porous space. This made the method an effective non-destructive tool for the characterization of porous microstructure of building materials and for monitoring continuous formation of salt corrosion products. Due to its non-destructive character, this method allows studying the time-dependent progression of salt crystallization in a pore space of one and the same sample. Using X-Ray CT, we observed rising of sulphate corrosion products in open pores. First, single surface layer of corrosion substances was identified even in the samples stored in sulphate solution for 28 days. Then we monitored the growing of the corrosion products and their accumulation in porous space. The measured thickness of sulphate salts layer, newly formed in open macropores of render CE1 was growing from the average value of approximately 0.04 mm after 28 days of exposure to approx. 0.065 mm after 168 days of samples storing in sulphate solution. In samples exposed six months to the sulphate action, smaller pores (of size up to

ca. 0.1 - 0.2 mm) were in most cases fully filled by the corrosion products.
