EFFECT OF GRAPHENE AND CARBON FIBER ON REPAIRING CRACK OF CONCRETE BY ELECTRODEPOSITION

QINGKUAN YANG, JINBANG WANG, LIANWANG YUAN, #ZONGHUI ZHOU

Shandong Provincial Key Laboratory of Preparation and Measurement of Building Materials, University of Jinan, Jinan 250022, China

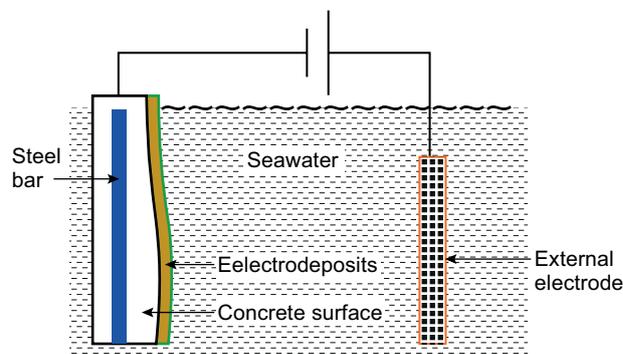
Figure 1. Application of electrodeposition in marine engineering.

to previous studies, electrochemical deposition can be accomplished by applying an electric current between the steel reinforcement in concrete structure and an electrode placed in seawater (Figure 1). Steel reinforcement inside the concrete structure was used as the cathode, and the platinum electrode was placed inside the sea-water as the anode. After applying an electric current between the anode and the cathode, the cation and the anion move toward the two electrodes in response to a potential difference. Ions undergo a range of reactions and eventually formed precipitation on the surface and in the cracks of the concrete to heal the cracks and cover the surface [10, 11, 13].

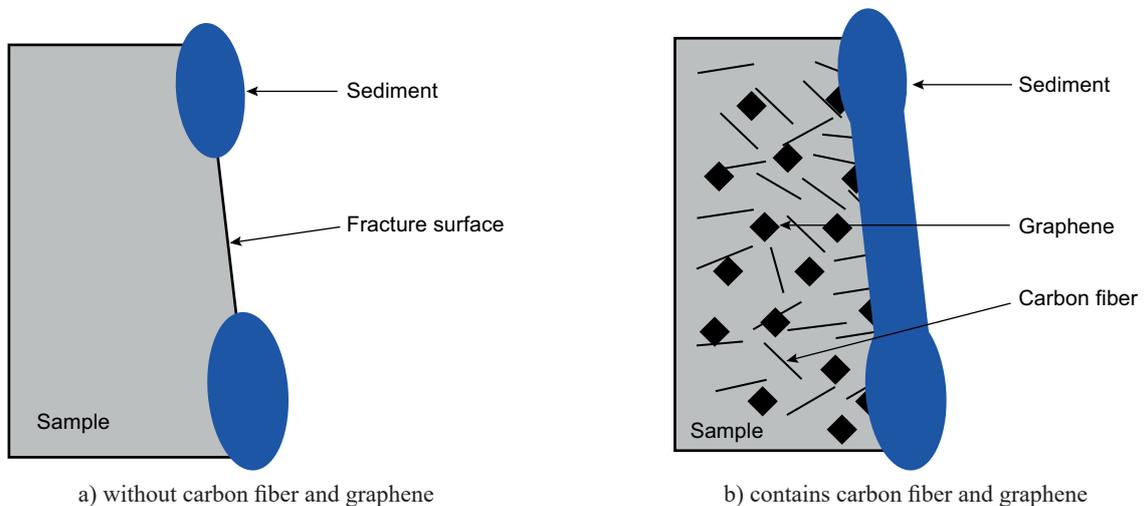
Figure 2. Particles deposition model of electrodeposition.

Graphene and carbon fibers have excellent mechanical, electrical and thermal properties, which not only improve the physical properties and durability of concrete, but also enhances the effect of electrodeposition. The process of repairing concrete cracks by electrodeposition, it was found that the resistivity of concrete with carbon fiber and graphene was reduced [17, 18], thereby allowing the crack surface to manifest a greater current density. What's more, carbon fibers and graphene dispersed with ultrasonic dispersion instrument before concrete is formed, thus the exposed carbon fiber and graphene at the crack face were uniformly distributed along the fractured surface, which promoted consistency of the repair. The particles deposition models of electrodeposition are shown in Figure 2.

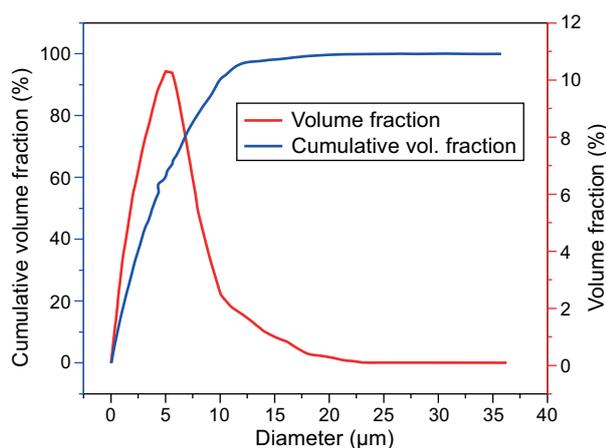
Figure 3. Particle size distribution of graphene.

Test specimens were prepared using ordinary Portland cement of strength grade 42.5 produced by Shandong Shanshui Cement Group Co., Ltd. The physical properties are shown in Table 1 and the chemical compositions are shown in Table 2. The fine aggregate used in the specimens was an ISO standard sand. The carbon fiber was PAN-based chopped carbon fiber, and its physical properties are shown in Table 3. The graphene was produced by Changzhou Sixth Element Materials Technology Co., Ltd., where the physical properties are shown in Table 4, and the particle size distribution is shown in Figure 3. The particle size distribution of graphene is concentrated with particle sizes ranging from 4 to 10 μm, and the median diameter at 5.1 μm.

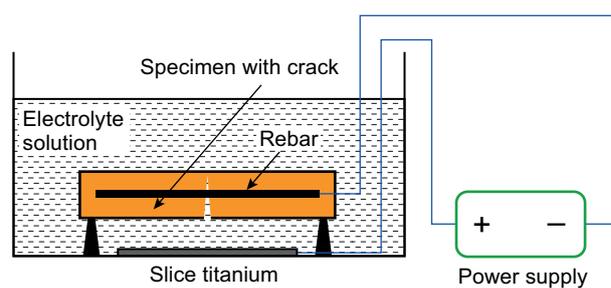
Figure 4. Schematic diagram of the experimental device.

The size of the samples used in the test program were $40 \times 40 \times 160$ mm and $\Phi 100 \times 50$ mm. The water-cement ratio was 0.5. The diameter of the steel reinforcement was 6 mm. Curing the samples for 28 days under standard curing environment (Temperature 20 ± 2 °C, Relative Humidity > 95 %). The samples were loaded by Electronic Universal Testing Machines to produce cracks which had the width of 0.3 to 0.5 mm [19, 20]. In order to ensure the sample crack width is unchanged, except for the cracked side, the others five sides of each sample were sealed with a resin with the samples of $40 \times 40 \times 160$ mm, and the flanks of the samples of $\Phi 100 \times 50$ mm was also wrapped with a resin. The electrolyte solution was a mixture of ZnSO_4 solution and absolute ethanol. The concentration of ZnSO_4 solution was $0.05 \text{ mol}\cdot\text{l}^{-1}$, and the volume fraction of anhydrous ethanol was 25 %. Anhydrous ethanol was an additive,

which weakens the hydrogen evolution reaction in the electrolyte solution [21, 22], and maximizes the deposition of ZnO while ensuring a certain amount of OH^- . The concentration of the electrolyte solution should be kept stable in order to reduce the experimental error, so the electrolyte solution was changed every 5 days. Powered by a direct current regulated power supply for 20 days, and the voltage was stabilized at 5 volts, which is much lower than the human body safety voltage and provides a certain current density. The experimental setup and mixing ratio are shown in Figure 4 and Table 5 respectively.

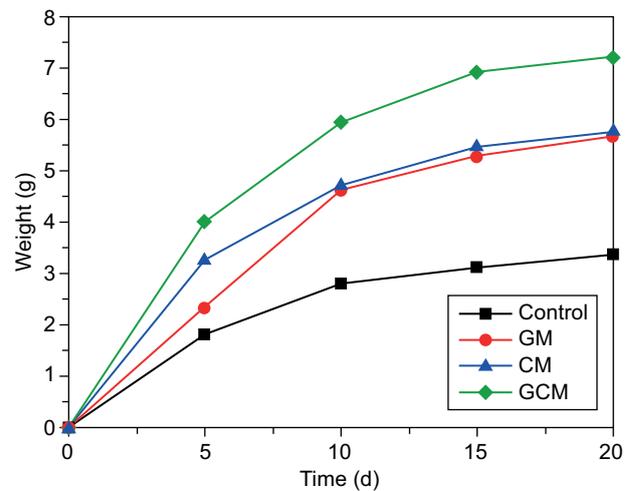
Figure 6. Mass change of sample.

Figure 6 shows the mass change of the different samples after applying the electric current for 20 days.

The mass of the Control sample increased by 3.36 g, GM by 5.67 g, CM by 5.75 g, and GCM by 7.22 g. The mass increase of GM, CM and GCM increased by 68.8 %, 71.1 % and 114.9 %, respectively, compared with the Control sample. This is due to the samples with graphene and carbon fiber give mortar a smaller resistivity, therefore the surface of the crack has a larger current density, which leads to more sediments were generated. Moreover, the exposed graphene and carbon fibers on the fracture surface increase the surface area of the fracture, which making sediment easier to deposit on the fracture surface. The chemical reactions in the electrolyte solution are shown in Table 6.

- After applied electric current for 20 days, the mass of the GCM sample increased by 7.22 g (114.9 % relative to the Control sample) and the total charge passed was 894 coulombs (reduced by 74.4 % relative to the Control sample). With the resistance to chloride ion penetration: Control sample < GM < CM < GCM.

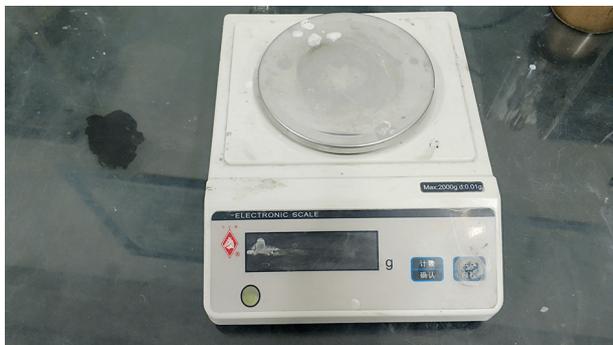
a) electronic balance

Electronic balance with 0.01 g precision is shown in Figure 5a. After pre-cracking, the sample was weighed M_0 . After applying electric current for 5 days, the sample was taken out from electrolyte solution and dried for 24 hours, then the mass the sample was weighed M_i . The mass change of the sample was: $R_m = M_i - M_0$. The sample was weighed every 5 days.

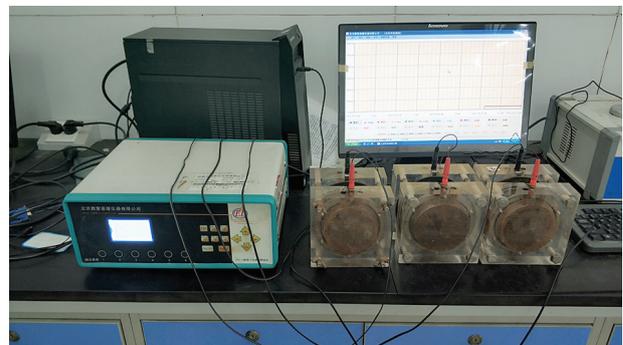
b) RCPT instrument

Rapid Chloride ion Penetrability Test (RCPT) was implemented on the basis of the requirements of ASTM C1202-97 [23]. $\Phi 100 \times 50$ mm sample was processed with a vacuum saturation apparatus and then placed in a standard fixture. The solutions placed in standard fixture was sodium hydroxide solution at a concentration of $0.3 \text{ mol}\cdot\text{l}^{-1}$ and sodium chloride solution with a mass fraction of 3 % respectively. The positive and negative ions migrate under the action of electric field when 60 V direct current was applied to the sample. The impermeability of the concrete was reflected according to the total charge passed in 6 hours. The experimental device is shown in Figure 5b.

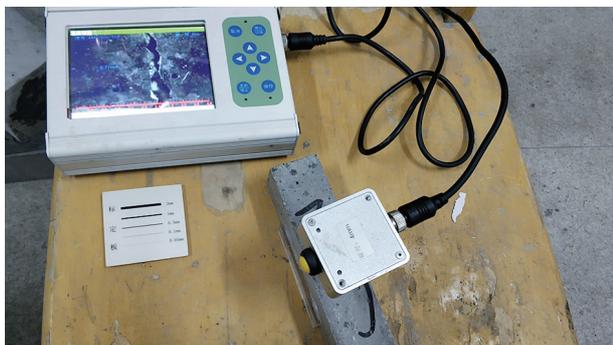
c) crack width meter

The width of cracking was measured using the intelligent crack width meter [24], which measurement range is 0 to 4 mm with an accuracy of 0.01 mm. When the probe was aimed at the crack, the magnified crack image could be seen on the LCD screen. Fine-tune probe to make the image clear and save it. The experimental device is shown in Figure 5c.

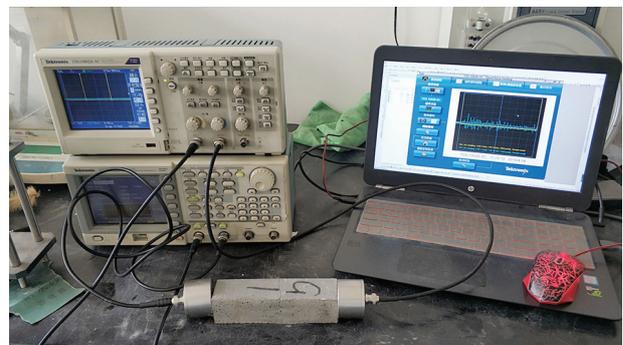
d) ultrasonic instrument

The change of ultrasonic wave can reflect the internal defects a concrete specimen [25, 26]. Tektronix AFG3022B arbitrary waveform generator and Tektronix

TDS1002B-SC was used as the digital oscilloscope in this testing. The ultrasonic frequency was 50 kHz and the input voltage 10 V. The amplitude values, transmitting times, and waveform of the ultrasonic was recorded. The experimental device is shown in Figure 5d.

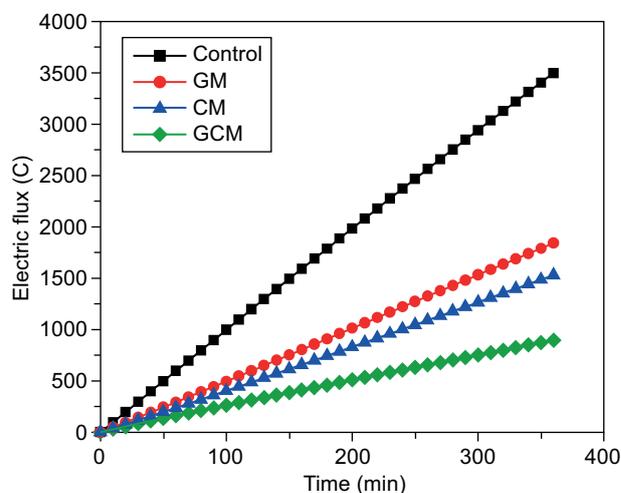
Figure 7. The total charge passed of the sample.

Figure 7 shows the total charge passed in 6 hours through each sample after repaired for 20 days. The total charge passed of the Control sample, GM, CM and GCM were 3491 coulombs, 1840 coulombs, 1529 coulombs and 894 coulombs respectively. The total charge passed of GM sample, CM and GCM were reduced by 47.3 %, 56.2 % and 74.4 %, respectively, compared with that of Control sample. GCM has the smallest total charge passed and the best resistance to chloride ion permeation. Depending on the mass change, the GCM sample produced more sediment. Besides that, the uniform distribution of graphene and carbon fiber at the crack resulted in greater uniformity of the sediment.

A characteristic of the repair was a decrease in total charge passed and an increase in impermeability of the mortar.

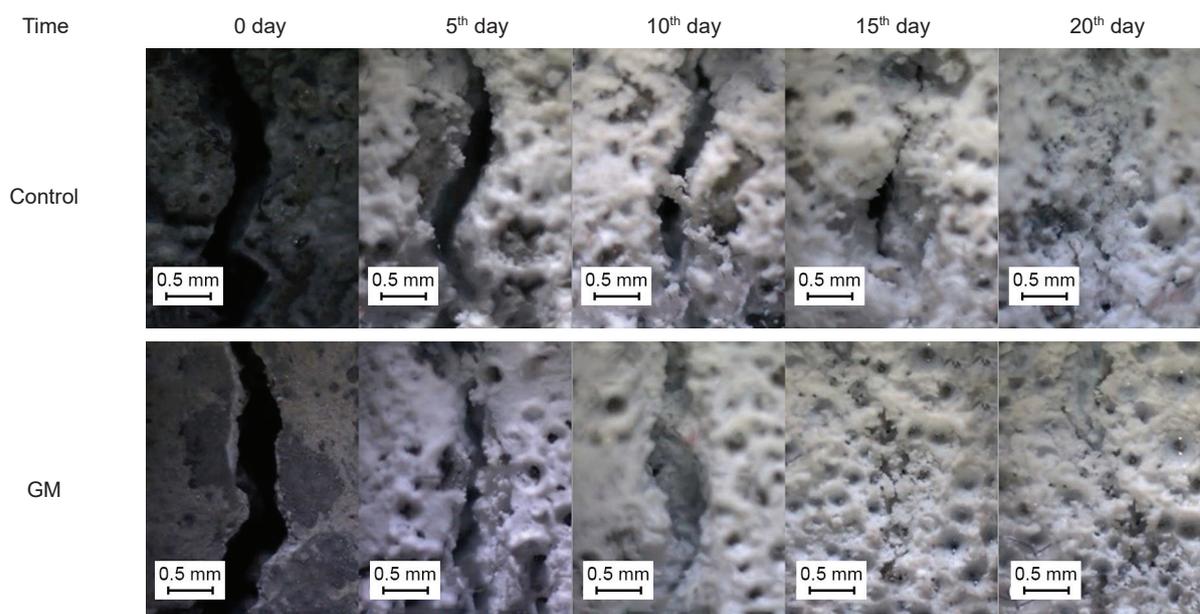
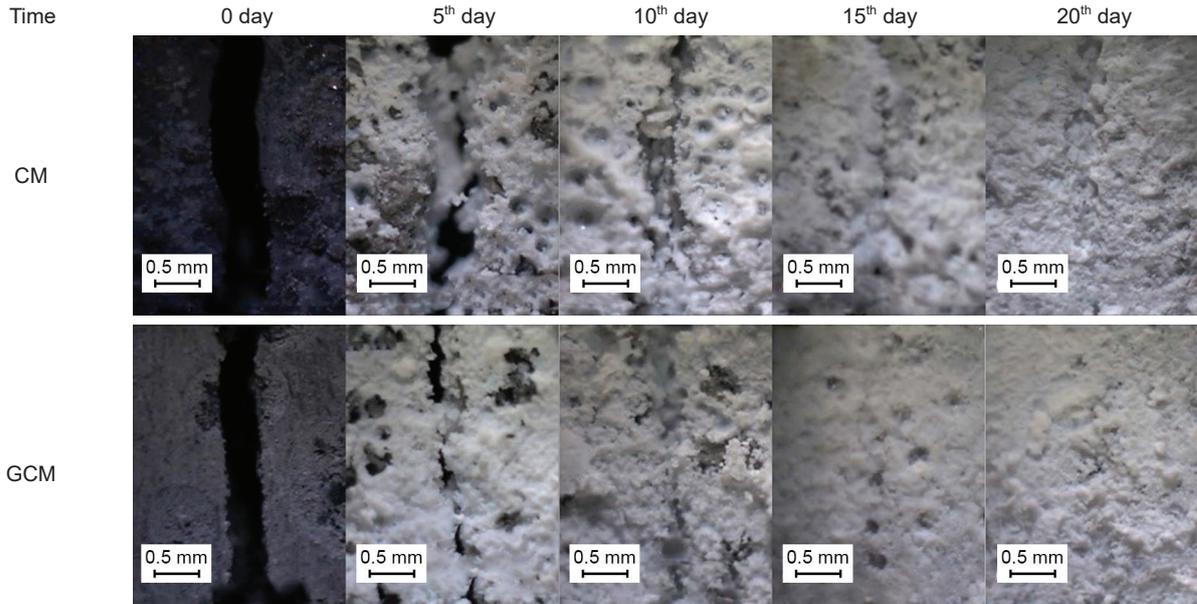
Figure 8. Crack microscopic image of the sample. (Continue on next page)

Figure 8 shows the microscopic images of cracks in four samples at different healing times. It was noted that the width of the cracks ranged from 0.3 - 0.5 mm in the stages of pre-cracked, and white sediment was generated after the electric current was applied. This white sediment filled the cracks and formed a protective layer on the surface of the sample. After applying the electric current during 20 days, the cracks of all the samples were completely healed. The cracks of the Control sample healed slowly, and there are still obvious cracks on the 15th day. The GM sample and CM healed

slightly faster than Control one, and the crack healed well on 15th day with only slight cracking. The best repair was GCM sample, which was completely healed in 15th days. The law of crack healing is consistent with the law of mass change and the law of anti-permeability.

- After the application of electric current, the crack was eventually healed regardless the composition of the mortar, and the repairing speed of cracks was the maximum in the first 5 days.

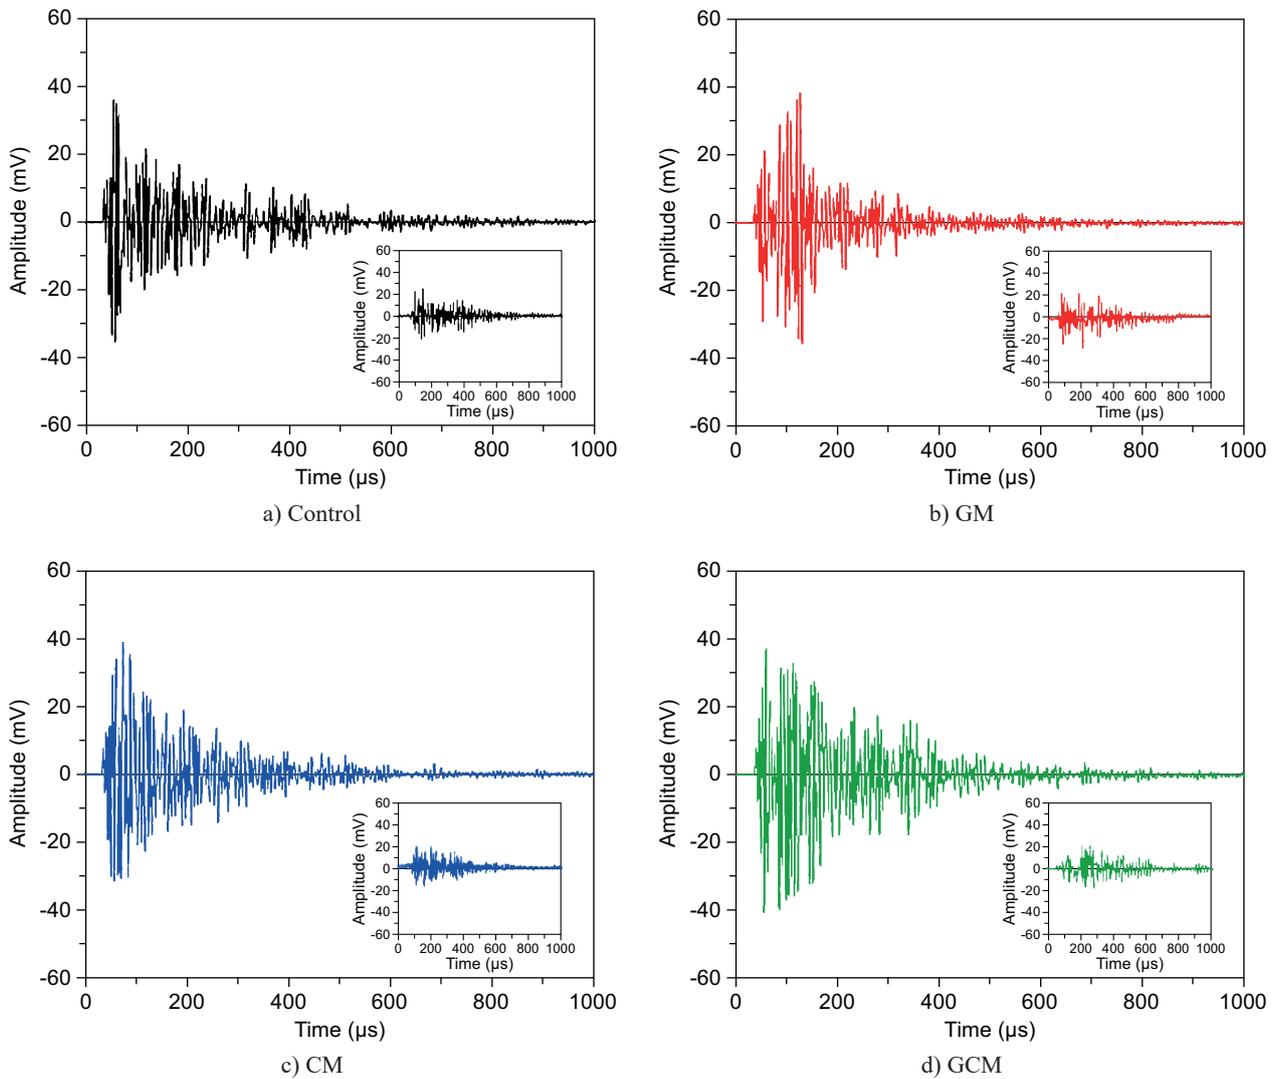
Figure 9. Ultrasonic waveforms before and after the test piece is destroyed.

When concrete cracks are generated, some features of the crack can be expressed by the waveform changes, amplitude value and the transmitting time of ultrasonic wave [27, 28]. Figure 9 displays representative ultrasonic waveforms for the Control sample, GM, CM and GCM obtained in the stages of pre-cracked (small picture) and healed for 20 days (large picture) respectively. The transmitting time and amplitude values were acquired from the head wave of the ultrasonic waveform. When these samples get cracked, the transmitting times of Control sample, GM, CM, and GCM were 66.9 μ s,

63.4 μ s, 69.1 μ s, and 67.8 μ s, respectively, and the amplitude values were 2.8 mV, 3.1 mV, 2.5 mV, and 2.7 mV, respectively. This is due to the crack that has a strong interference with the propagation of the ultrasonic wave, which lead to ultrasonic with a large transmitting time, small amplitude values, and unstable waveform. After 20 days of repairing, the transmitting times of Control sample, GM, CM and GCM were reduced to 53.4 μ s, 46.5 μ s, 44.8 μ s and 40.7 μ s, respectively, and the amplitudes values increase to 5.1 mV, 6.5 mV, 6.9 mV and 7.3 mV, respectively. The deflection inside the samples were obviously reduced and the cracks repaired, so that the transmitting times of the ultrasonic wave was reduced and the amplitude values increased. The GCM sample has the smallest transmitting time and the largest amplitude value, which indicates that the defects inside the GCM sample was the least, and the repair effect was better than the Control sample, GM and CM.

- Ultrasonic diagrams analysis shows that the transmitting time, amplitude value and waveform of Control sample, GM, CM and GCM are mainly affected by cracks. The crack width of all samples is close after pre-cracking, therefore the difference was not large. After repairing 20 days, the transmitting times of the samples decreased and the amplitude value increased, suggesting that the cracks of the samples has been repaired to some extent. GCM has the best repair effect, the transmitting time is reduced from 67.8 μ s to 40.7 μ s, and the amplitude is increased from 2.7 mV to 7.3 mV (increased by 170.4 %).

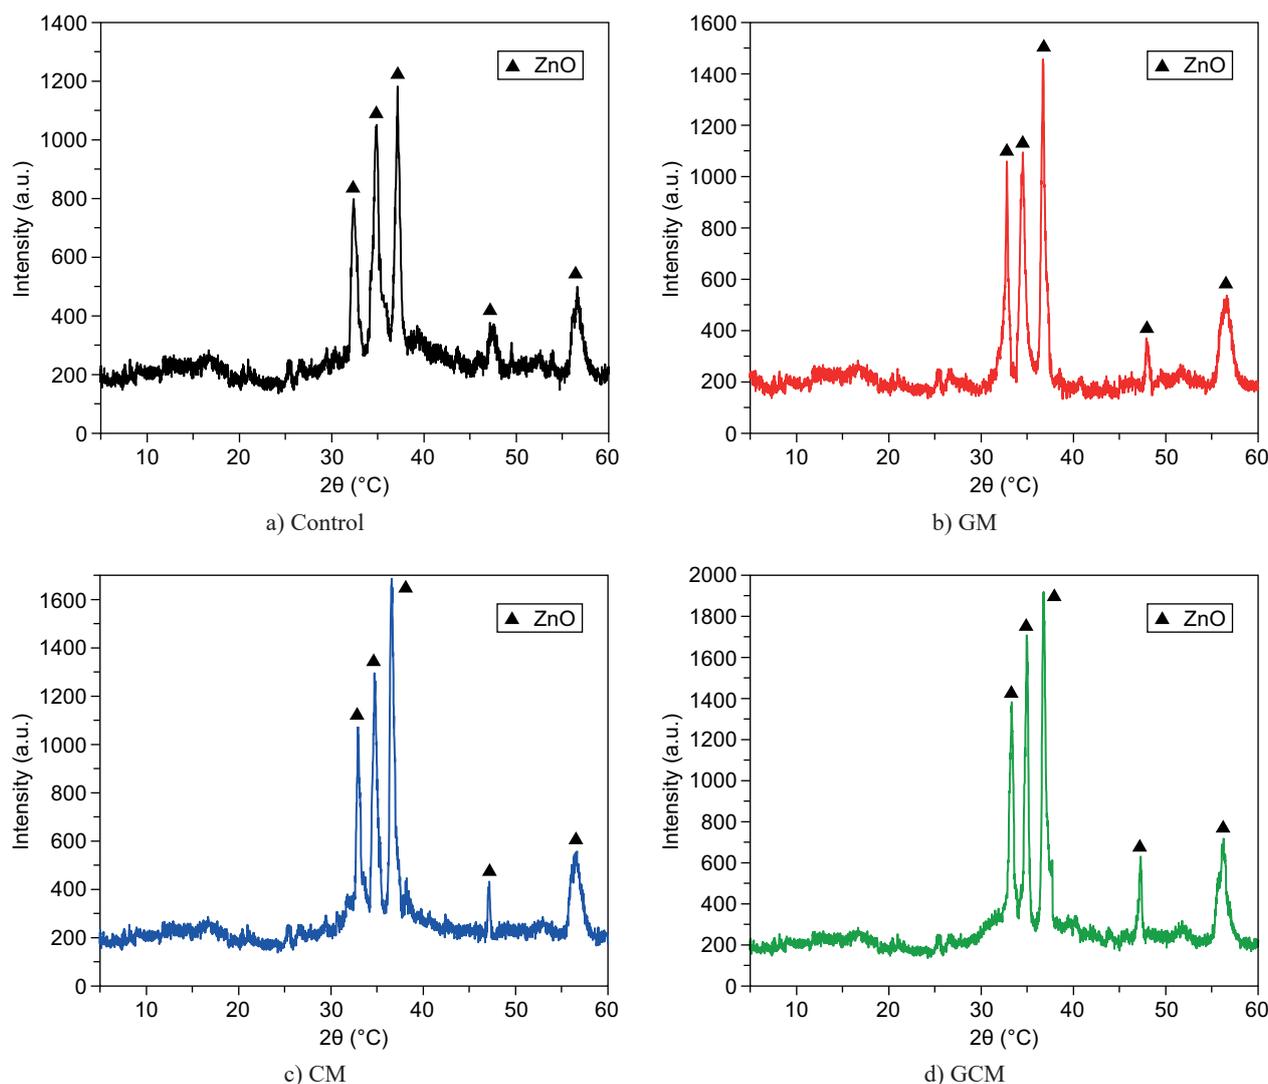
Figure 10. XRD spectrums of the white sediments inside the cracks.

The XRD spectrums of the white sediments formed on the cracks of the samples after repaired 20 days as shown in Figure 10. Comparing Figure 10 with the JCPDS card, the spectrum on the surface of the diffractive crystal corresponds to the standard diffraction peak of ZnO, and there are extremely few impurity peaks, which indicated that the sediments produced by electrolytic deposition are ZnO crystal with higher purity and graphene and carbon fiber are not affecting the composition of the sediments. Narrow and sharp diffraction peaks shape were found in XRD spectrums of all the samples, which proved that the ZnO crystals generated have larger size and good crystallinity. At the diffraction angles of 32°, 34°, and 37°, the intensity of the diffraction peak of GCM sample was higher than that of other samples, which demonstrated that the ZnO crystal formed in GCM samples is more than the ZnO crystal formed in other samples.

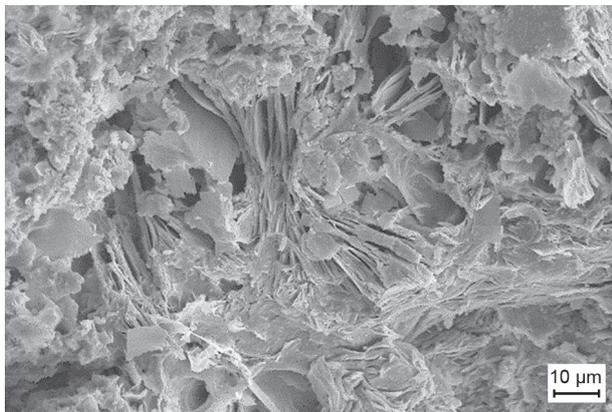
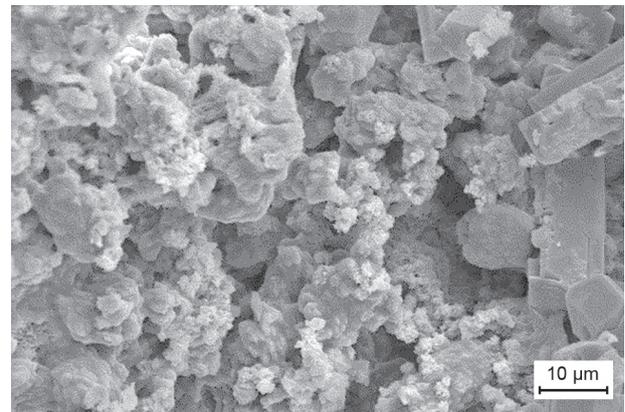
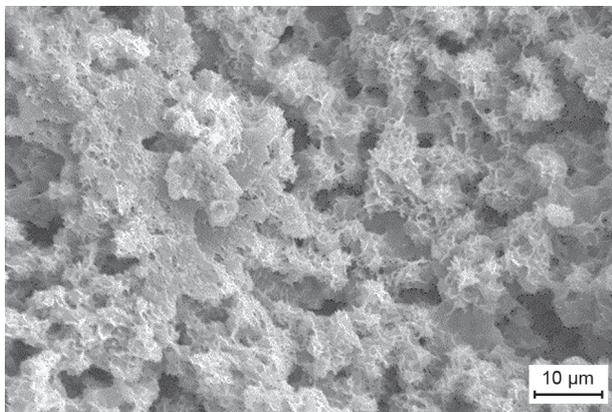
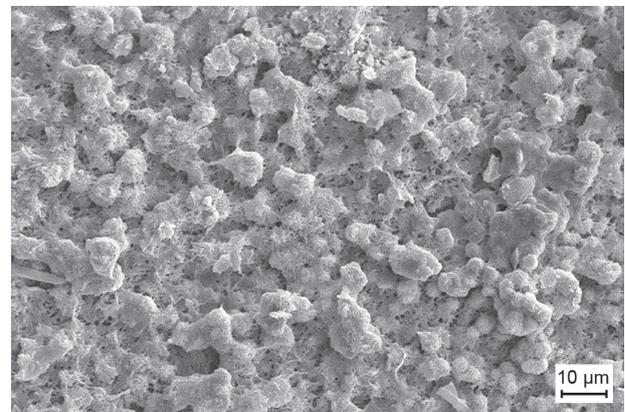
Figure 11. SEM images of sediments inside the cracks.

The SEM images of the sediments inside the cracks are shown in Figure 11. It can be seen from the figure that the morphology of the ZnO crystal changes

with the composition of the mortar. Most of the ZnO crystals inside the crack of Control sample are slice-like structures, which are loosely arranged and have no regularity causes poor impermeability and strength of concrete. Most of the ZnO crystals in GM sample presented grain-shaped. There are numerous flower-like ZnO crystals in the CM sample, and these crystals have a certain continuity. The ZnO crystals in the GCM sample was closely intertwined to form a continuous structure with less pores, which owing to the uniform distribution of exposed carbon fiber and graphene on the fracture surface increased the contact area between electrolyte solution and sample. As consequences ZnO crystals grown uniformly on the surface of the crack to form a uniform and compact structure, thereby the mortar strength improved and the permeability reduced.

- Control sample contains numerous slice-like ZnO crystals, which are arranged loosely and have no regularity results in weak impermeability and mechanical properties. Most of the ZnO crystals in GM presented grain-shaped. Flower-like ZnO with a certain continuity in CM, improving the impermeability and mechanical properties. The ZnO crystals in the GCM samples are intertwined to form a uniform and compact structure, which leads to a good macroscopic performance of concrete.
