COMPRESSIVE STRENGTH OF RAPID SULFOALUMINATE CEMENT CONCRETE EXPOSED TO ELEVATED TEMPERATURES

Keywords: Sulfoaluminate cement concrete, High temperatures, Change strength characteristics, Compressive strength

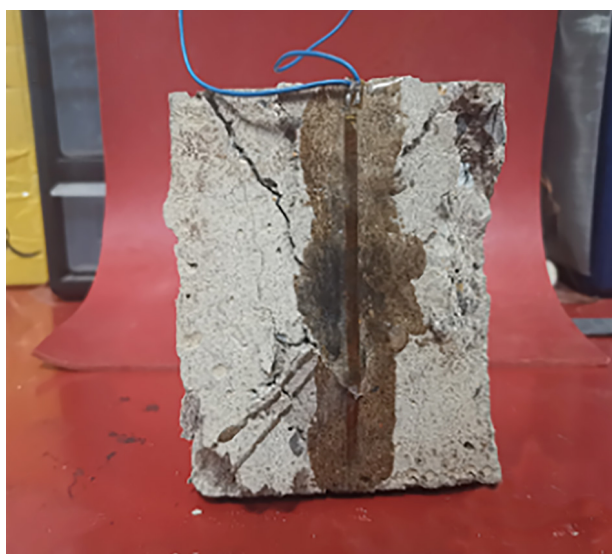
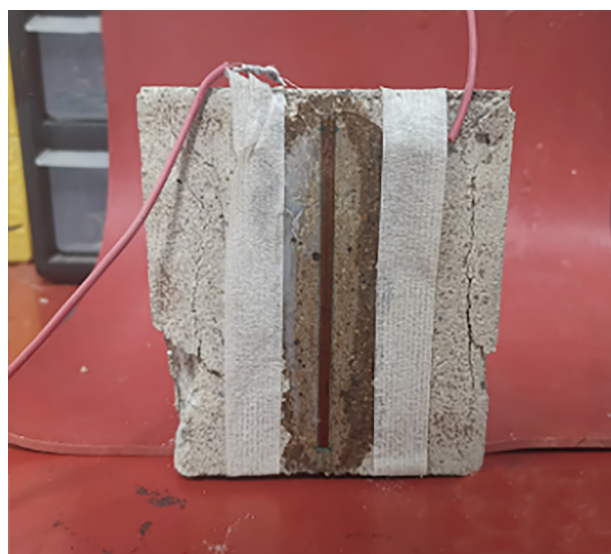
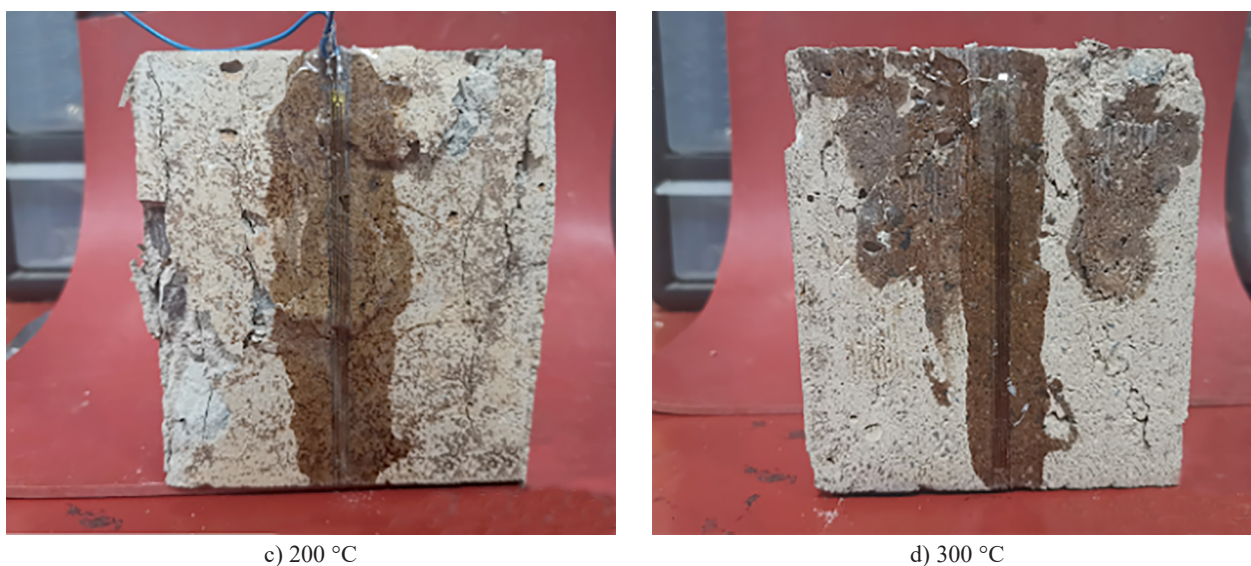
Figure 1. The SACC samples showing the installed strain gauge and characteristics of the crack patterns 30 minutes after the removal from the furnace and loaded, at temperatures of 20, 100, 200 and 300 °C. (Continue on next page)

Figure 1. The SACC samples showing the installed strain gauge and characteristics of the crack patterns 30 minutes after the removal from the furnace and loaded, at temperatures of 20, 100, 200 and 300 °C.

- The failure pattern of the SAC concrete samples at 100, 200 and 300 °C was not similar to that at the normal temperatures, see Figure 1a. When the testing temperature was between 100 and 300 °C, as shown in Figure 1b, c and d, an inclined main crack distinctly materialised on the surface of the samples, the inclination angle was wide, the area of cracking was long and drawn out, and irregular cracks were dispersed on the other parts of the surface. The SAC concrete exposed at 400 °C was completely destroyed by an explosion inside the furnace. The damage was not because of the higher density of the SAC alone, but also because of its poor mineralogy disintegration of the AH_3 gel strengthening the ingredient's compartment and weakening the bond with the aggregates by its dehydration and the effect of vapour pressure development inside the tested specimen (a function of a specimen's dimension).

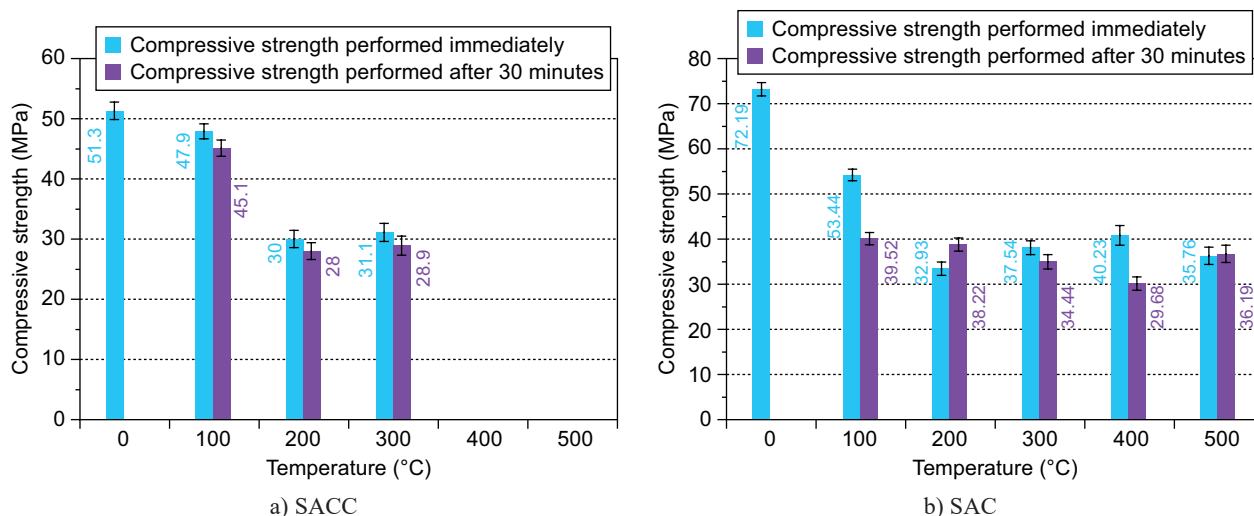
Figure 2. The compressive strengths of the sulfoaluminate concrete and paste vs. the temperature.

The results (calculated as an average for each set of samples) show that the compressive strength decreased as the temperature increased, and after an additional cooling time of 30 minutes, the decrease was greater, as shown in Figure 2. Cooling for 30 min introduces a temperature gradient with a relatively lower temperature

outside than the core temperature for both the concrete and paste specimens. This temperature gradient creates a stress differential between the core and surface of the specimen, which is fatal for the concrete specimens because of their greater size. Additionally, the concrete specimen displayed stress concentrations, see Figure 3, at the interfacial transition zone, again more so than the paste because of its different thermal behaviour of the sand and cement paste. These stress concentrations could lead to micro-crack formations and a strength reduction for the concrete specimens. As a result, the concrete specimens, after 30 min of cooling, always showed lower strength levels than the specimens tested before the cooling.

However, the paste specimens actually showed an increase in strength at 200 °C after cooling and no difference in strength at 500 °C. As the paste specimens

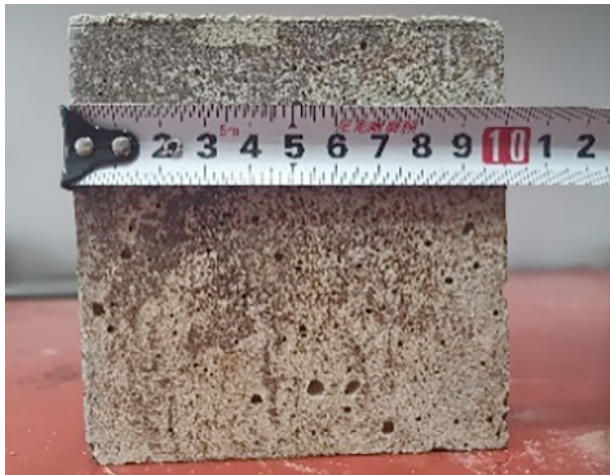
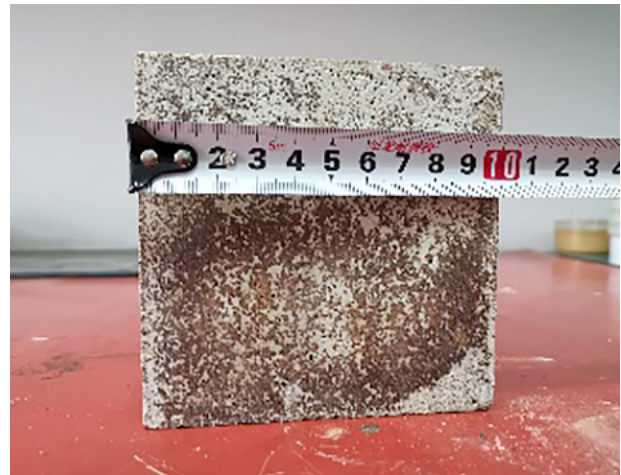
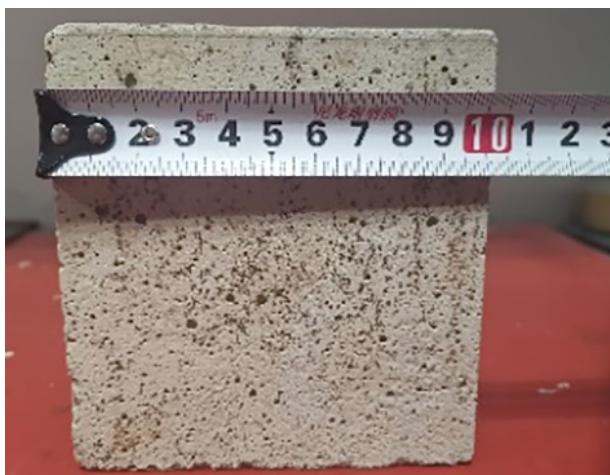
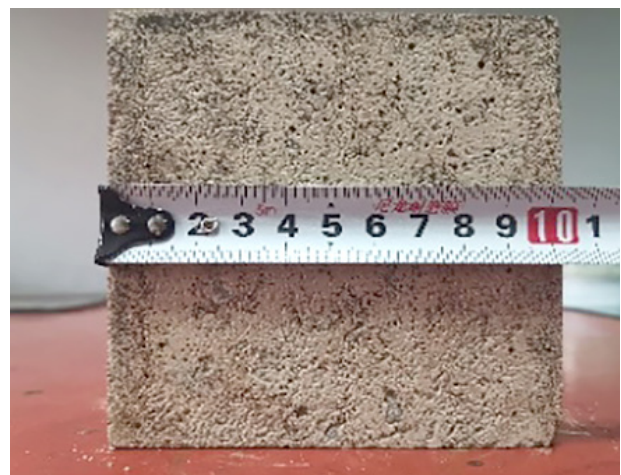
Figure 3. The appearance of the SACC specimens immediately after removal from the furnace.

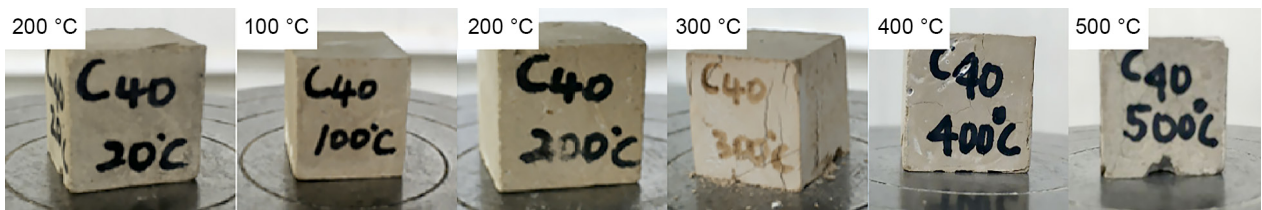
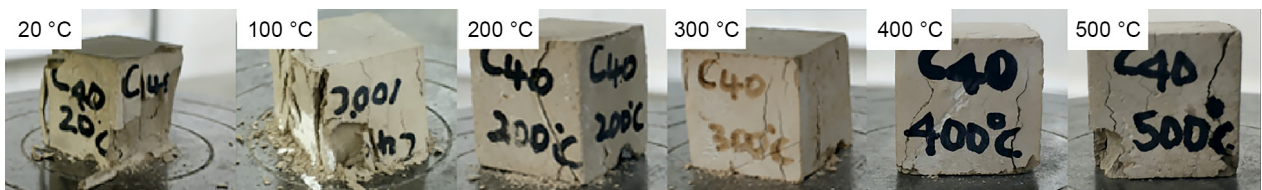
a) the appearance of the SAC paste specimens immediately after removal from the furnace

b) the appearance of the SAC paste specimens immediately after removal from the loaded corresponding

Figure 4. The appearance characteristics of the crack pattern 30 minutes after removing the SAC paste specimens from the furnace and loaded corresponding to 20, 100, 200 and 300 °C.

were smaller in size, see Figure 4, and there were no aggregate effects, the temperature difference may not have caused any consistent change in strength. The overall decrease in strength with the increasing

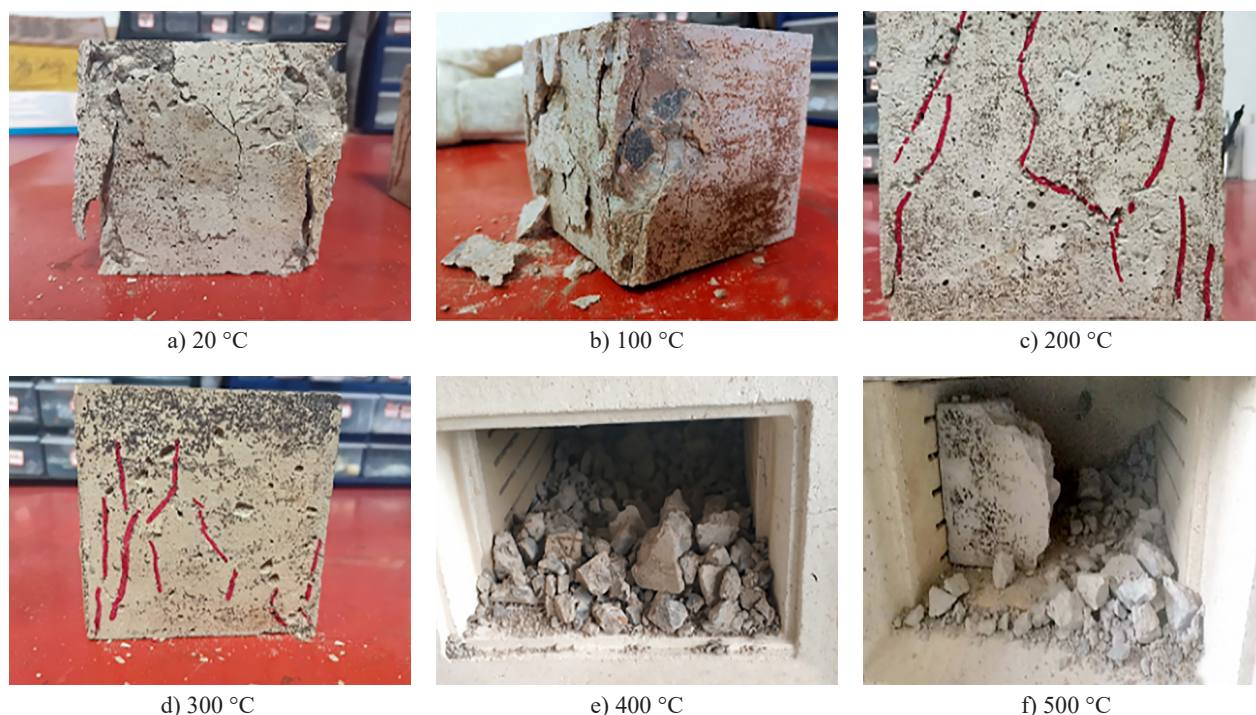
Figure 5. The nature of the damage (crack pattern) of the SAC concrete specimens after immediately being removed from the furnace and loaded, at temperatures of 20, 100, 200, and 300 °C.

The compressive strength of the sample tested at 20 °C had the highest compressive strength with large cracks, spalling, and support failure, see Figure 5a and b, because of the cracks resulting from the dry shrinkage of as much as 1 % of the volume and the applied load, whereas the samples heated to 200 °C and 300 °C had a lower compressive strength with narrow cracks, yet they held up despite the damage, see Figure 5c and d. Nevertheless, the initial thermal crack caused by the heat decreased the stress span of the first straight line. At 400 °C, all the SACC specimens broke explosively, as shown in Figure 5e and f, inside the electric resistance furnace. As indicated by Wanga and Chen [20, 21, 22], SAC has an unstable density, adding to the vapour pressure evolution inside the tested specimen. For this reason, as observed with the samples at 400 °C, a complete collapse can result. The elevated temperatures caused the volume of the samples to shrink, leading to cracks. When the crack force stopping the volume change can no longer apply sufficient resistance, wide cracks occur. This is the reason for the observed phenomenon.

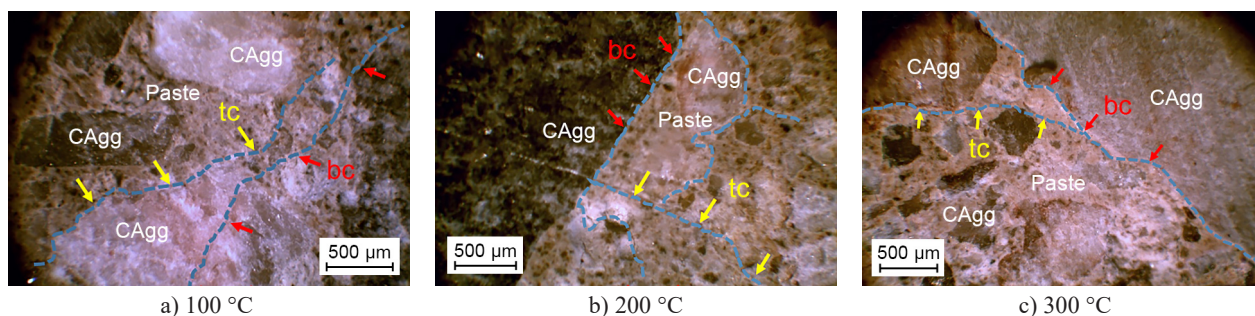
Figure 6. The stereo microscopic appearance of the SACC sample after removal from the furnace following exposure to the different temperatures for 4 hrs. The images show heated induction microcracks; BC = boundary crack, TC = transgranular crack.

The average thermal expansion coefficient of the quartz river sand and limestone gravel used for the experiments at the different temperatures were also calculated [23, 24]. Figure 6 shows the stereo microscopic

appearance image of the SACC samples immediately after removal from the furnace, following exposure at the different temperatures for 4 hrs. The images show the propagation of micro-cracks through the coarse aggregate and the paste, displaying a pattern of the cracking at the interfacial transition zone with changes in the crack widths. The expansion of the limestone as the temperature increased varied from 1.00×10^{-3} to $2.5 \times 10^{-2}/^{\circ}\text{C}$; this was less pronounced than the expansion of the quartz sand, which ranged from 2.4×10^{-3} to $6.00 \times 10^{-2}/^{\circ}\text{C}$ from 100 °C to 300 °C. The rising temperature caused the limestone to grow in size, resulting in the shrinkage of the SAC paste bordering it, due to the imbalance of the thermal stresses between the limestone, quartz, and very dense SAC paste [25, 26]. The average mass changes (in grams) of the SACC were 0.119 at 100 °C, 1.302 at 200 °C, and 1.573 at 300 °C; for the SAC paste, they were 0.67 at 100 °C, 2.73 at 200 °C, 3.7 at 300 °C, and 3.71 at 400 °C, relative to the initial mass at 20 °C. Therefore, a comparative assessment between the paste and the concrete provides a better way to understand the changes in the strength.

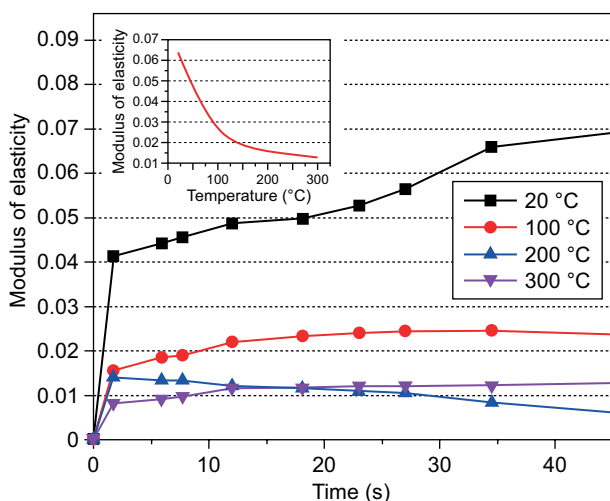
Figure 8. The modulus of elasticity of the SAC concrete vs. the heated temperatures.

The modulus of elasticity (E), was determined by dividing the stress by the strain obtained while loading the specimens that were equipped with a strain gauge. Its variations over the average wide range 68.69×10^{-3} MPa to 12.61×10^{-3} MPa consequently decrease nearly 85 % over the range of temperature exposures, as shown in Figure 8. Therefore, as illustrated, at the different temperatures, the SACC became deformed. The lowest values of the moduli of elasticity testify to the flexibility of the SACC between 100 °C and 300 °C, as its shape changed considerably.

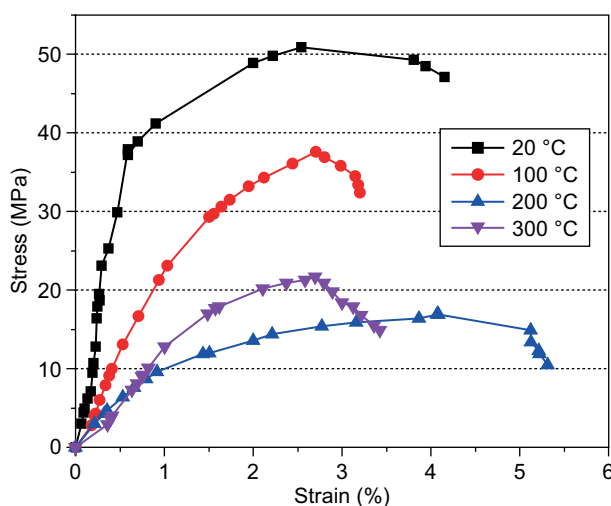
Figure 9. The compressive stress-strain curve of the SAC concrete after being heated and loaded.

The temperature exposure has a notable impact on the stress-strain relationship; the slope of the stress-strain deformation curve decreases with an increasing temperature. For the control (at 20 °C), linear elastic behaviour (initially steep slope, followed by shallow slope) is followed by plastic deformation before reaching the peak stress prior to failure. At 100 °C and 300 °C, the characteristic trend is elastic behaviour starting with a shallow slope (shallower than at 20 °C) followed by a gradual decrease in the slope till it fails (similar to the visco-elastic behaviour). However, at 200 °C, the initial elastic behaviour was similar to that at 300 °C, but then changed promptly to a very low slope (i.e., the large change in the strain with a smaller change in stress,

The stress-strain curve of the SAC concrete at 100 °C, 200 °C, and 300 °C distinctly shows that the strain has a tendency to decline and its peak evidently descends and moves toward the right-hand side as the testing temperature increases. The variations in the stress-strain curves can be partially attributed to the increased occurrence of micro-pores and capillary voids with a diameter of between 2 and 50 nm caused by the thermal changes to the microstructure as discussed previously in Section “Pore structure analysis “. These pores act as stress concentrators as they open under the applied load affecting the degree of cracking at the aggregate-paste interfaces and increasing the crack widths in the paste (See, Section “SEM analysis and XRD”). In addition to the development of micro-pores and capillaries, the elevated temperature exposure causes differential strains due to the mismatched thermal expansion of the constituents of the concrete and the elevated internal stress within the pore spaces due to vapour pressure resulting in a significant residual stress, residual strain, and micro-cracking throughout the specimen. When considered together, these effects explain the trend of the stress-strain curves, which are perceptibly flatter when the specimen is exposed to higher temperatures as observed in Figure 9.

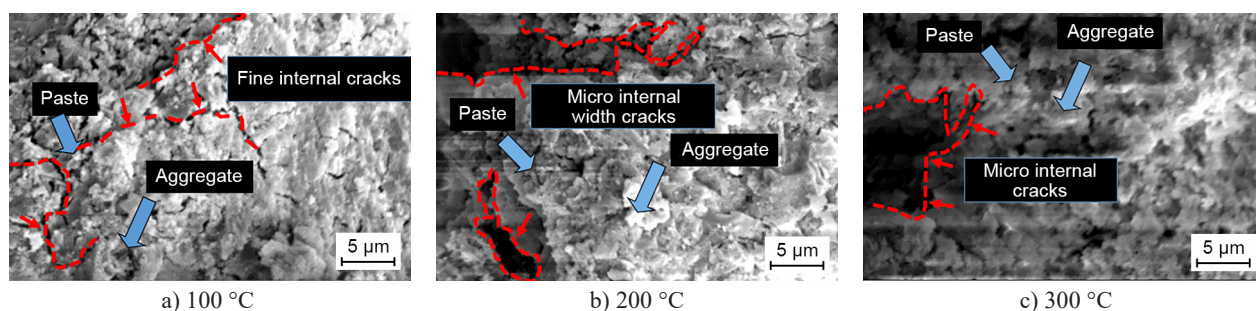
Figure 10. The SEM patterns of the different samples after removal from the furnace following exposure of the SAC concrete to different temperatures for 4 hrs.

sample exposed to the different temperatures showed a clear trend of an increasing numbers of wide cracks with increasing temperatures up to 300 °C. Loannou [27, 28] argued that this kind of cracking might be formed during heating at the different temperatures because of the imbalanced internal stresses between the disproportionately expanding limestone and quartz sand, which compress the SAC paste that surrounded them. The performed SEMs, see Figure 10, display a pattern of different compacting at different temperatures. Between 100 °C and 200 °C, we observed pores connecting with a diameter of between 2 and 50 nm, fine cracks by location and large wide cracks. At 300 °C, better compactness is observed, with fewer cracks of large width, which correlated with the small gain in strength recorded at 300 °C.

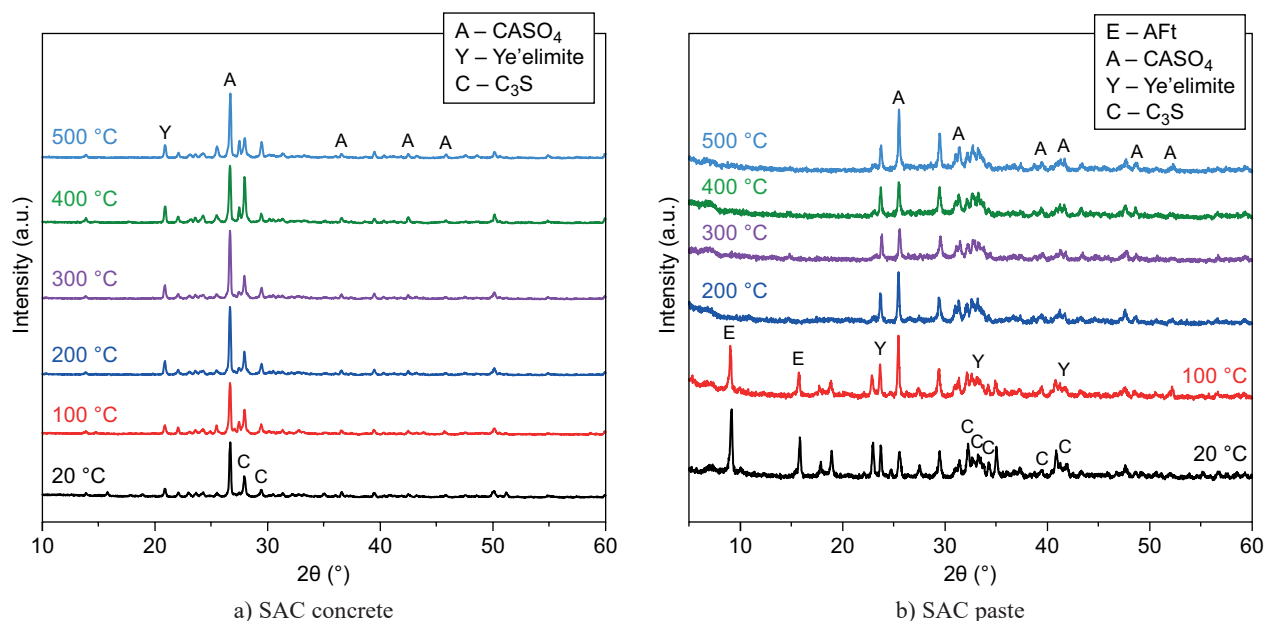
Figure 11. The XRD spectra of the diffraction patterns of the hydrated SAC concrete (a) and SAC paste (b) at the different temperatures.

The X-ray shows that, as the temperature increased, the element of each sample was different. Figure 11 shows that between 100 °C and 200 °C, one can remark the dehydration of the AFt inside the SAC paste and AH_3 gel, which breaks them into an unreactive mineral inside
