# Century-long history of rural community landslide risk reduction

The study documents the more than century-long history of community-based landslide risk reduction of a small rural community in the village of Maršov, the Outer Western Carpathians, Czech Republic. The village is characterized by a high landslide hazard shown by repeated, rainfall-triggered, landslides, which have been inventoried and described using the available historical documents and field investigation. Although the occurring landslides are rather shallow (from 2 m to 10 m) and small (up to 37,000 m<sup>2</sup>), two of them seriously impacted the life of the community. Available historical data were used to describe direct as well as indirect damage caused by the landslides and the community's response to their occurrences. The first documented landslide (1911) caused no direct damage, but it alarmed the community and played an important role in the initiation of extensive land drainage works. Destruction of one third of the houses in the village by the 1967 landslide was swiftly resolved by relocation of the landslide affected families to the nearby town. This measure accelerated the decline and marginaliz

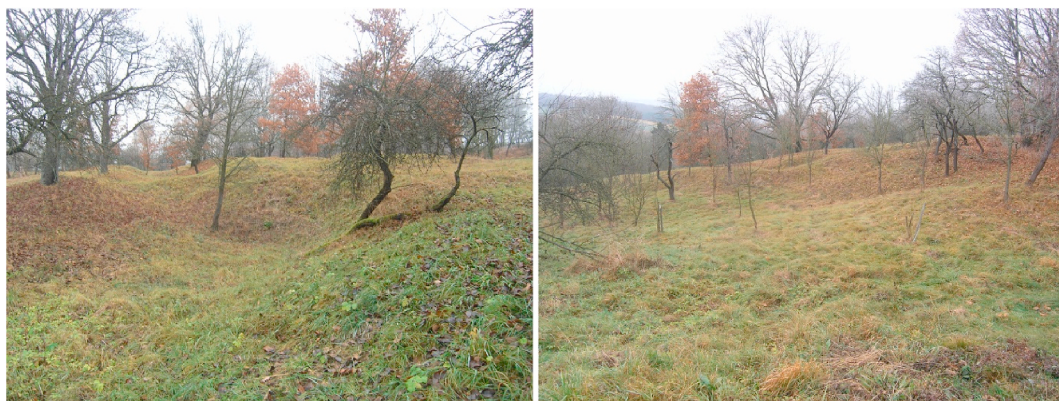
**Fig. 4.** Recent morphology of the central transport part (left) and side limit in the scarp area (right) of the major landslide from 1967 (for location of the photos from March 2018 see Fig. 6).

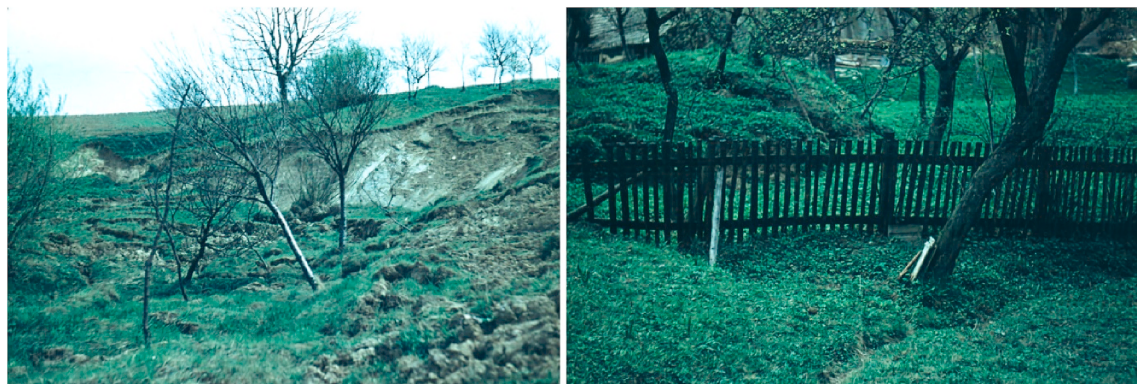
**Fig. 8.** The main scarp (left) and accumulation (right) of the 1967 landslide taken during geological field works in 1967 (photographs from the Quido Záruba's Photo Archive [43]).
