# The geopolymer composition for restoration, construction and substitution

Tomas Hanzlicek, Ivana Perna, Michaela Steinerova

The Institute of Rock Structure and Mechanics of the  
Academy of Sciences in collaboration with  
Sculpture and restoration school of prof. P.Siegel  
City of Adršpach,  
and Museum of Decorative Arts in Prague

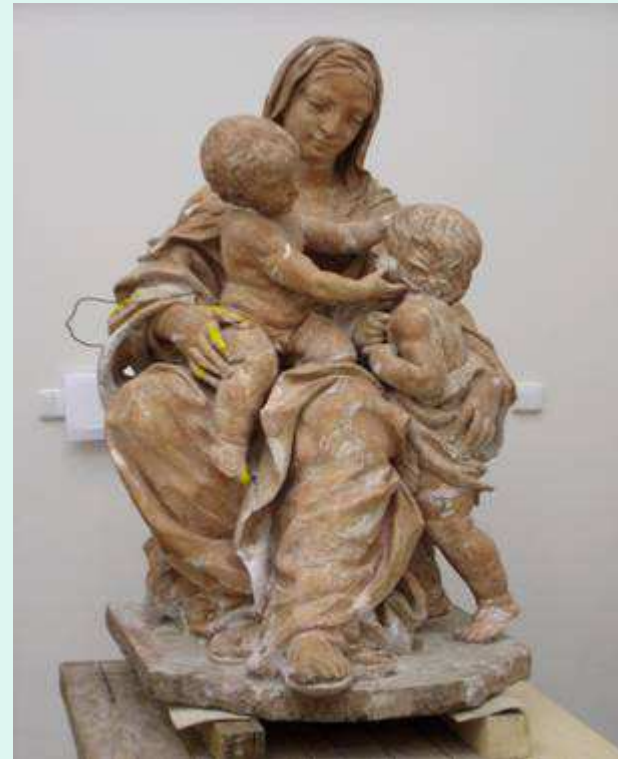
# Guiseeppe Mario Mazza (1653-1741)

- The front view „Virgin Maria with child Jesus and John Baptist“
- High 1.42 m
- Material - terracotta
- Support – sandstone

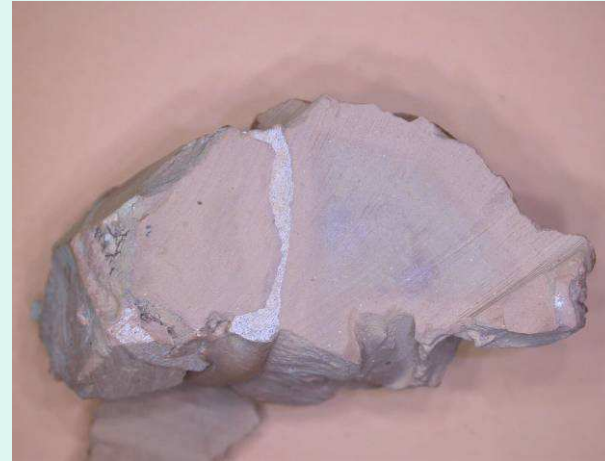
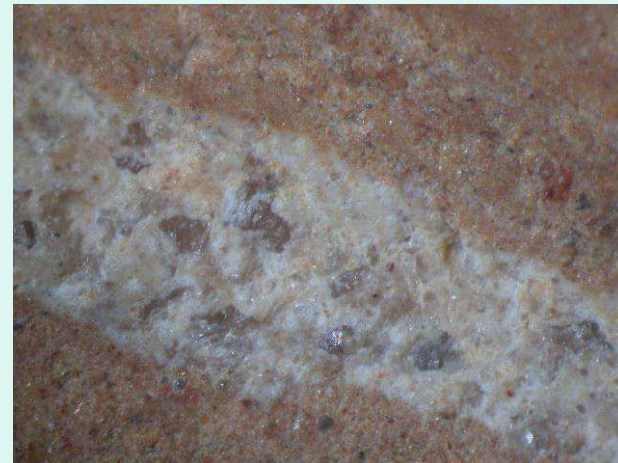
# Possibility to use geopolymer binder

- Joint of two original pieces of terracotta by geopolymer composite with calculated amount of non plastic additives.
- Outside coloration repeating the color of terracotta and done by combination of colored clays (content of natural iron oxides in used clays).

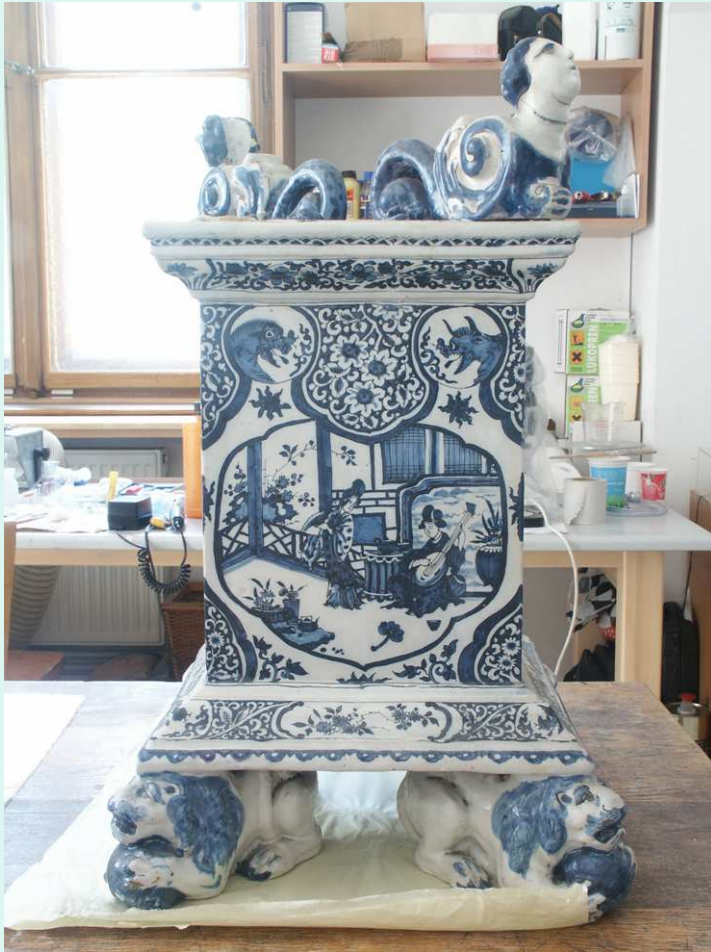
General view on pedestal

Delft Faïence: step-like vase for flowers in  
shape of multilevel pagoda carried by four  
sphinxes
