ANALYTICAL AND EXPERIMENTAL STUDY OF WATER SEEPAGE PROPAGATION BEHAVIOR IN THE FAULT

Water inrush through fault

Water injection test

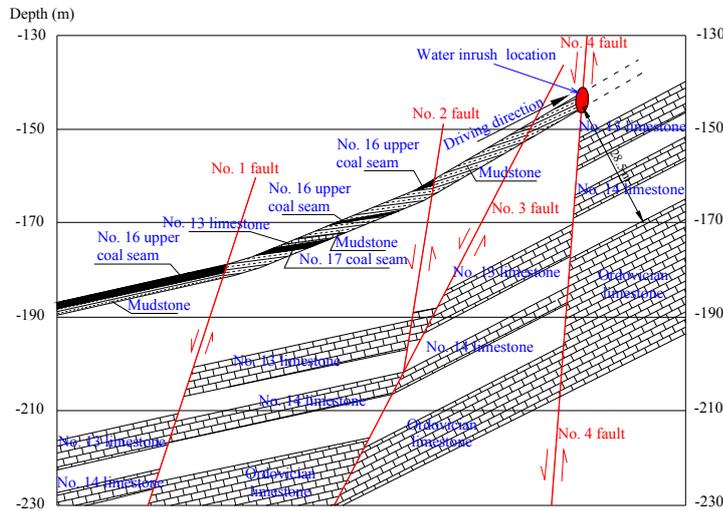
Fig. 2 Top view of geological section map and the location of water inrush point.

The No. 8602 working face is situated in the middle of the No. 8 mining district. The No. 8602 working face's middle gateway was driving along the No. 16 coal seam with an average rising dip angle of 11°. On August 17, 2010, at 23:23, a water inrush with a flow rate of 3 m³/h occurred at the time of disclosing the No. 4 fault (Fig. 2). The flow rate rose

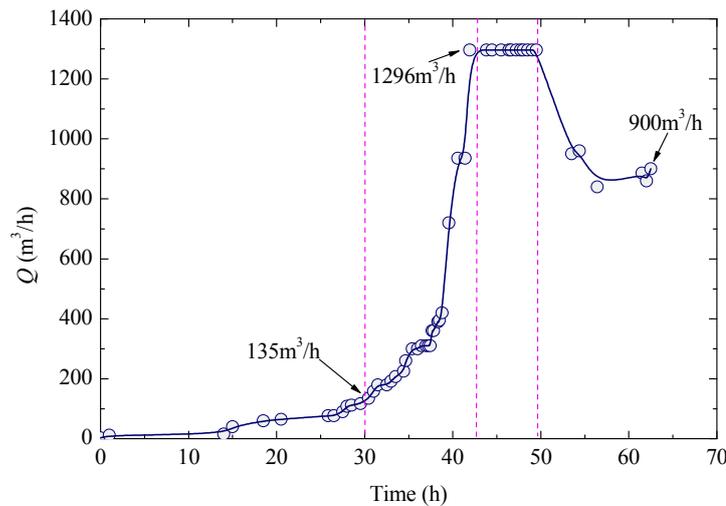
Fig. 3 Flow rate (Q) distribution at the middle gateway.

up rapidly after that time, and the flow rate had accordingly increased nearly 110 times which increased from 12 m³/h at 00:30, August 18, 2010 to 1296 m³/h at 17:26, August 19, 2010. Then, the flow rate dropped back to be about 900 m³/h at 05:00, August 20, 2010 (Fig. 3). Moreover, water quality test result shows that it came from Ordovician aquifer. There is no doubt that the water inrush accident must be associated with the fault. As shown in Figure 2, three aquifers which include No. 13 limestone aquifer, No. 14 limestone aquifer and Ordovician limestone aquifer exit under the floor of the working face. Furthermore, defining the water source of the inrush accident is necessary and important. According to the hydrologic observation wells in Tianzhuang coal mine, the water level in an Ordovician hydrologic observation well which was about 1 kilometer apart from the water inrush point dropped 8 m during the water inrush accident, while the water levels in No. 13 and No. 14 limestone observation wells had not

More information can be obtained from the changing inflow during the water inrush accident (Fig. 3). For the next 30 hours after the beginning, the flow rate increased slowly, especially in the initial 14 hours. Then, from 30 to 42 hours, the flow rate rose up rapidly which increased to the maximum value in this stage. After 42 hours, the flow rate remained stable for some hours and then decline. As a consequence, we can get the information that the growing of water inrush channels would take some hours. Some water inrush accidents cases through faults in China (Feng et al., 2004; Li et al., 2006; Li et al., 2010; Zheng et al., 2010) were collected and

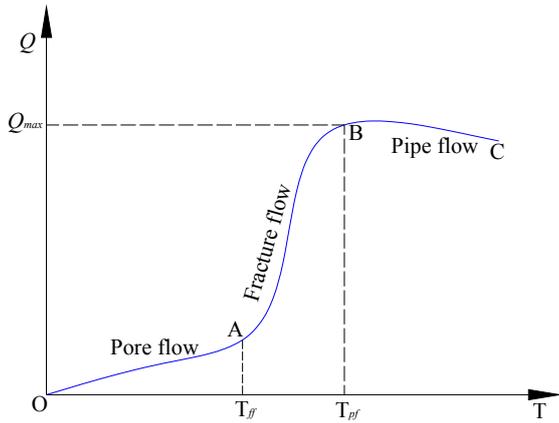
Fig. 4 Three stages of water inrush through faults.

inrush, water flows through pore structure of fracture zone or the small original cracks, and the flow rate is low. Then the flow rate rises up rapidly as a result of the washout of fine particulates and existing in-fill in the fracture zone, the porosity of the fault changes and connective cracks appear in the second stage (Barbara et al., 2011; Bai et al., 2013). With the expanding and connecting of cracks, water seepage will turn into a kind of analogous pipe flow and will result in a large scale water inrush (Fig. 4).

Although the fault is much more permeable than complete rock stratum, its impermeability cannot be ignored. According to the results of water injection tests and analyses above, the turning point A is the start of fracture flow, as shown in Figure 4 and Figure 7, and the observation pressure changes observably after the point, the injection pressure corresponding to A point can be defined as the initial water seepage pressure (P_{w0}) (Fig. 7). Furthermore, the impermeability of faults can be calculated briefly from the equation as Eq. 1:

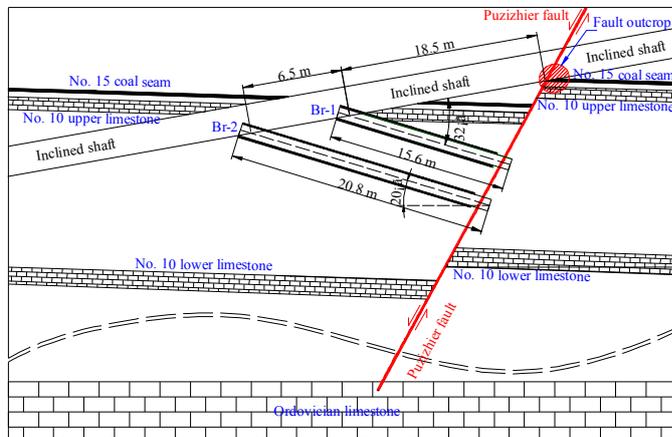
Fig. 5 Schematic section diagram of the test position and the design of two boreholes.

Puzizhier fault has a nearly north-south strike and a dip angles of 60°-80°W. Test site is beside the Puzizhier fault outcrop area of inclined shaft. According to the drilling data, the distance between the fault outcrop position and the No. 10 lower limestone aquifer is approximately 25 m (Fig. 5).

Water seepage propagation behavior in the fault and the impermeability of faults are measured in boreholes by drilling two boreholes, of which one borehole was used to inject water and the other borehole was used to monitor water pressure (Fig. 5). The water injection test method in this work is illustrated in Figure 6. Nowadays, the packer test is used to be the usual tool for hydro-geological testing in boreholes (Guo et al., 2003; Hamm et al., 2007; Cheng et al., 2009; Quinn et al., 2011). But it is difficult to install in coal mines sometimes due to the complex conditions, e.g., site conditions in the underground tunnel, construction conditions and geological conditions (Huang et al., 2014). In order to solve the problem and carry out the water injection test easily, the method as follow was used in this study. As shown in Figure 6, as soon as the boreholes are drilled, casing pipes are installed in the boreholes from top to the vicinage of the fault zone in order to seal off the test section from other parts. The pressure measuring sensor is installed in the fault zone, and the sensor is connected with the pressure measuring instrument by cables through sealing coil. On the other hand, the injection borehole is connected with a pump. In addition, the flow meter and pressure gauge are fixed. Flanges are used to seal off the boreholes at last. Under these conditions, water can be injected into the test section and the test can be carried out.

As shown in Figure 5, two boreholes (Br-1 and Br-2) were both drilled into the fault zone, with a depth of 15.6 m and 20.8 m, respectively. Two boreholes were made with an inclination of 32° with the inclined shaft. Br-2 was injection borehole, while Br-1 was observation borehole. Br-1 and Br-2 was 6.5 m apart. Br-1 and fault outcrop in the inclined shaft was 18.5 m apart.

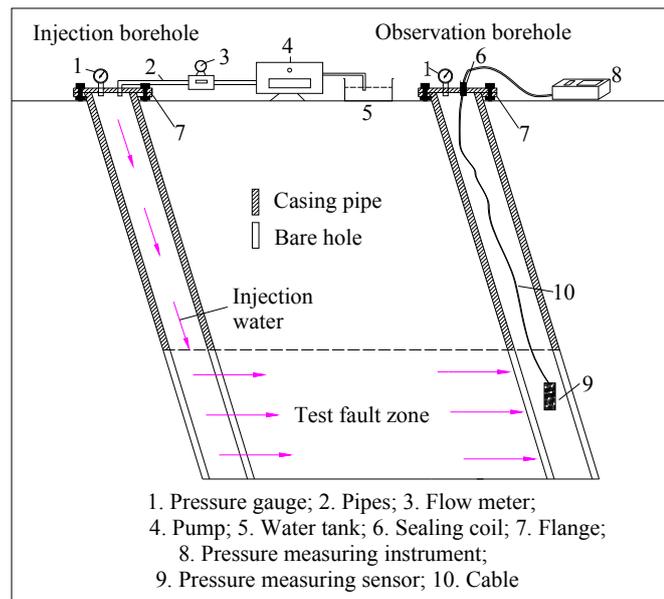
Fig. 6 Schematic diagram of the water injection test method.

The equipments used in this study mainly involved a pressure measuring sensor, a pressure measuring instrument and water injection equipments (Fig. 6). The pressure measuring sensor can observe

the changing water pressure with a range from 0 to 6 MPa. The pressure measuring instrument is easy to take and suitable for underground working, and it can monitor the water pressure of the sensor in time. The water injection equipments involve a high pressure pump with a rated pressure of 22 MPa and high pressure pipes and a water tank.

(3) Data collecting instruments in the observation borehole and water injection equipments in the injection borehole were installed as shown in Figure 6.

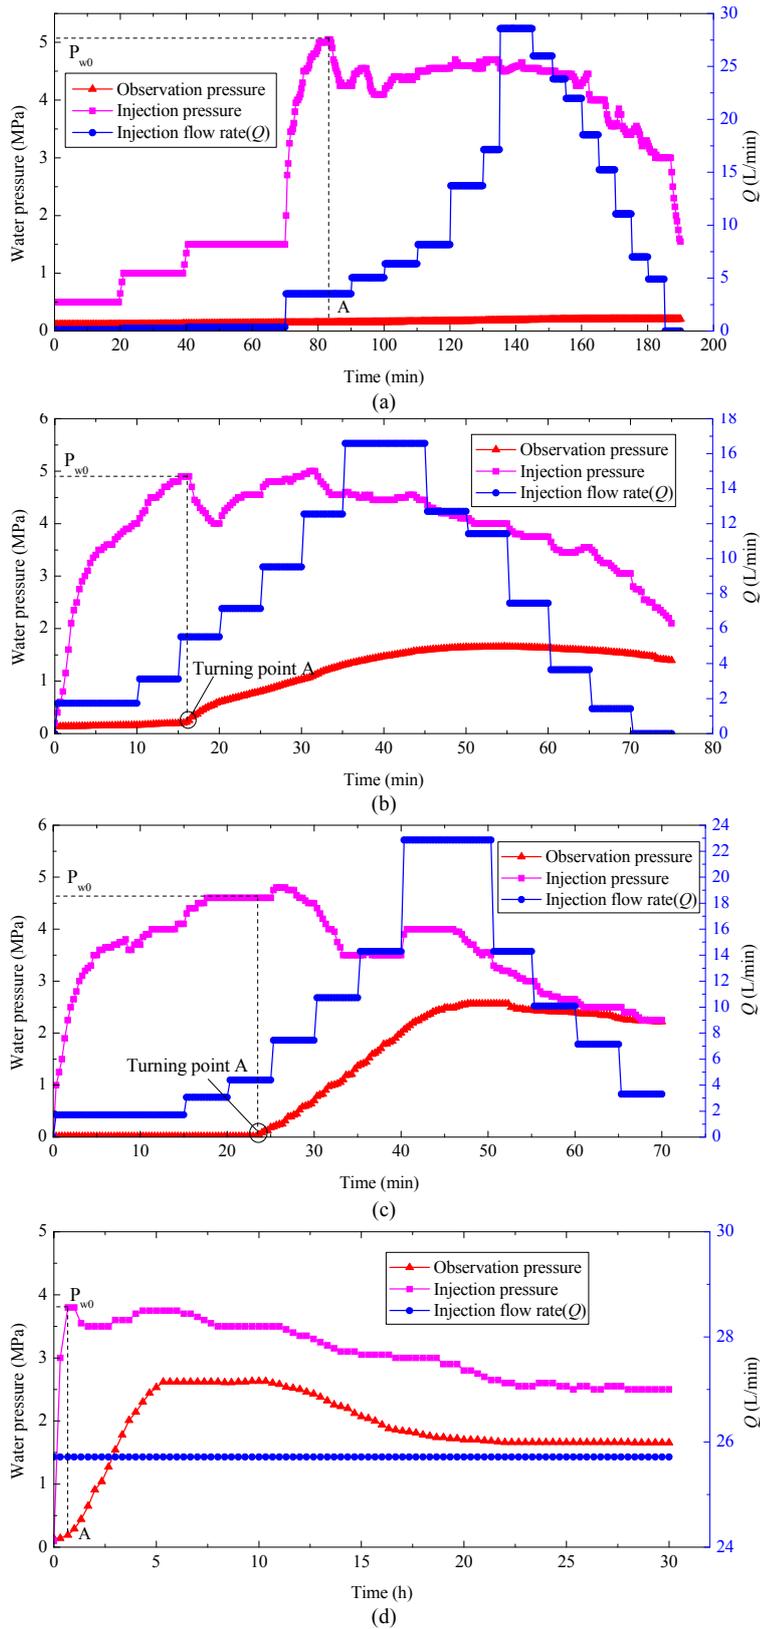
Fig. 7 Result curves of the water injection tests. a The first test. b The second test. c The third test. d The fourth test.

The injection water pressure and flow rate in Br-2 and observation water pressure in Br-1 during the tests are shown in Figure 7. The injection water pressures were translated into the pressure that imposed in the fault zone due to the fact that the monitored injection pressure is the pressure at the orifice. A total of four water injection tests were conducted. For the first three, the flow rates were changed manually. And for the last one, the flow rate was held steady at a high rate.

The injection pressure in Br-2 increases with the increasing flow rate at the outset of the first test (Fig. 7a), and the injection pressure reaches 5.05 MPa when the flow rate is only 3.52 L/min. Then, the injection pressure falls to a stable value of about 4.5 MPa, whilst the flow rate reaches to 28.6 L/min from 3.52 L/min. While, the observation pressure in Br-1 does not change obviously during the first test, it just increases from 0.12 MPa to 0.21 MPa. This result indicates that the permeability of the fault is low during the first test, and water may only flow through pore structure of fracture zone or the fine original cracks between Br-2 and Br-1, besides fine particulates and existing in-fill do not be washed out during the first test. In addition, the breakdown pressure is 5.05 MPa from the curve.

Contrary to the first test, the observation pressure in Br-1 of the second (Fig. 7b) and third test (Fig. 7c) begins to increase in about 20 min under diminutive flow rates, while it increases from the start of the

fourth test (Fig. 7d). When the observation pressure begins to increase, the injection pressure will drop. Moreover, similar curves are acquired from the second and third test. The observation pressure will maintain stable values for a period of time in the

second (Fig. 7b) and third test (Fig. 7c), which indicates that water seepage in the fault is stable. During the fourth test, the observation pressure changes with the injection pressure, the difference between them consists in value (Fig. 7d). From the

In the first test, P_{w0} is the peak pressure due to the stable observation pressure (Fig. 7a). As opposed to the first test, the observation pressure changes from the start of the fourth test (Fig. 7d). The calculated

In addition, in spite of the effect of former water injection test that has caused a kind of fracture flow or pipe flow in the fault, three stages of water seepage in the fault still exist in the next test (Figs. 7a, b and c), and it can be speculated that water seepage in the fault will turn into pipe flow after repeated water injection tests (Fig. 7d). In other words, the impermeability of the fault still exists and will decrease after repeated tests (Table 2). The reason for this is the fault healing effect under the ground pressure, and the fault cannot heal completely after repeated water injection tests. Moreover, the cognition can be obtained as well that the risk of water inrush through faults owes a great deal to the water source. When a water source with high pressure and giant flow rate gushes through the fault, the impermeability of the fault will decrease gradually and it is more dangerous.

As shown in Figure 7, pore flow can be found in the first three tests. Consequently, the hydraulic conductivity of Puzizhier fault is calculated based on the data of water injection tests (Fig. 10). In general, the hydraulic conductivity results of Puzizhier fault are low, nearly all below $6.5 \times 10^{-7} \text{ m/s}$. As shown above, pore flow still exist in the prophase of the second and third tests, and the impermeability of the first, second and third tests could almost keep stable (Fig. 8). The hydraulic conductivity results are similar in the early stage of the second and third test and the first test (Fig. 10). Therefore, it can be considered as the initial hydraulic conductivity of Puzizhier fault. So, the initial hydraulic conductivity of Puzizhier fault is chiefly from $0.8 \times 10^{-7} \text{ m/s}$ to $6.5 \times 10^{-7} \text{ m/s}$.

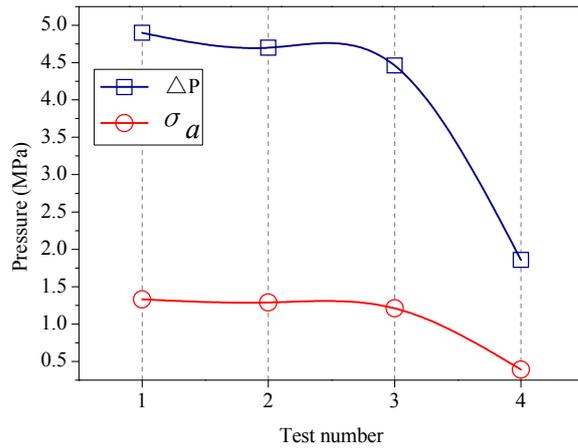
Fig. 8 The change processes of ΔP and σ_a .

According to the results (Table 2), the initial water seepage pressure (P_{w0}) has been decreasing from the first test to the last test (P_{w0} varies from 5.05 MPa to 1.5 MPa), which indicates the impermeability will drop under the repeated water injection (Fig. 8). Puzizhierz fault has a relatively high impermeability. The results can indicate that the structure of original Puzizhierz fault is dense and has a relatively high impermeability.

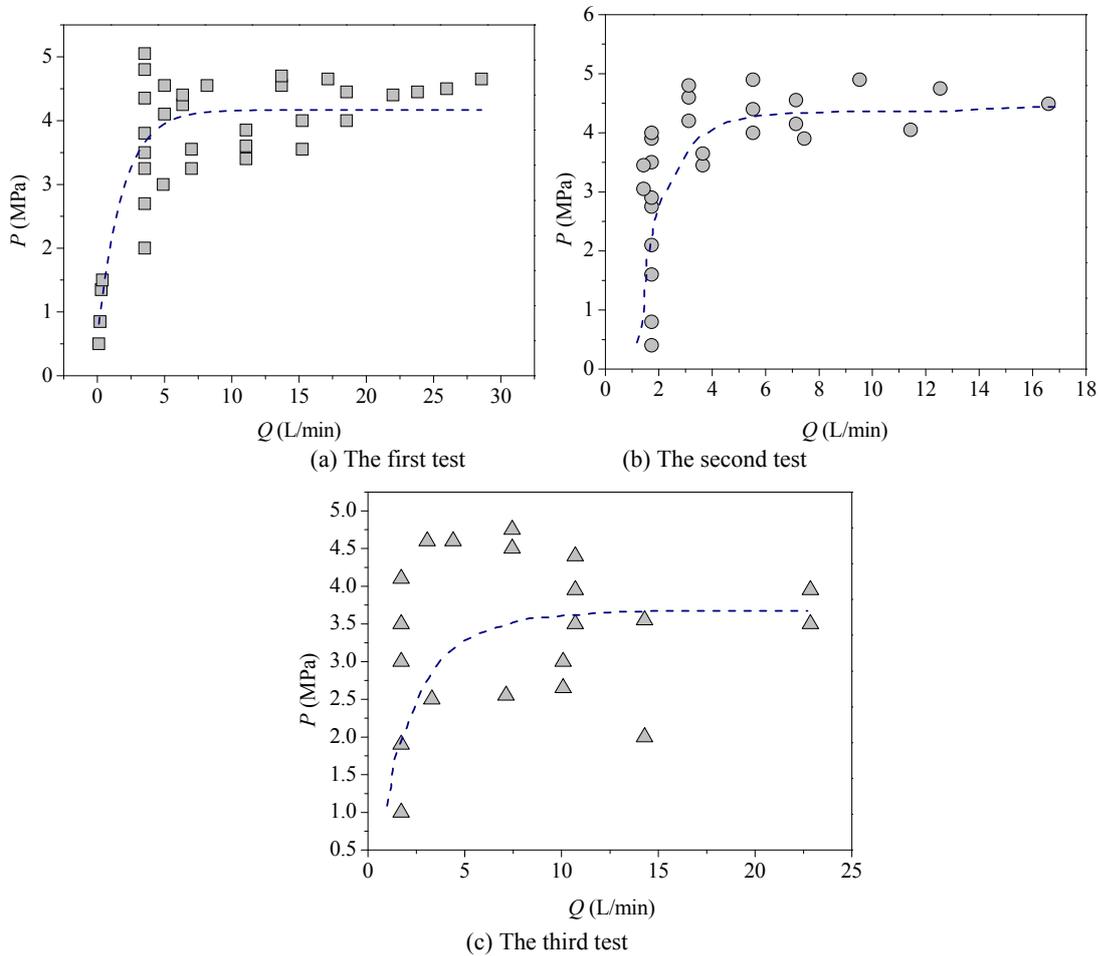
Fig. 9 The relationship between the flow rate (Q) and the injection pressure (P).

The relationship between the flow rate and the injection pressure is a useful parameter to analyze the result of the injection tests (Jiang et al., 2007; Wu et al., 2003). The relationship between the flow rate and the injection pressure is shown in Figure 9. Ying (Ying et al., 2008) put forward three types of Q - P relationship under high water pressure, e.g., Hydraulic fracturing, Expansion and Pervious laminar. For the Hydraulic fracturing, the flow rate increases rapidly when the pressure reaches initial water seepage pressure and shows low permeability. However, the initial water seepage pressure is not apparent for the type of Expansion. Hence, the tests of Puzizhierz fault are classified into the type of Hydraulic fracturing (Fig. 9), indicating that the permeability of the fault is low.

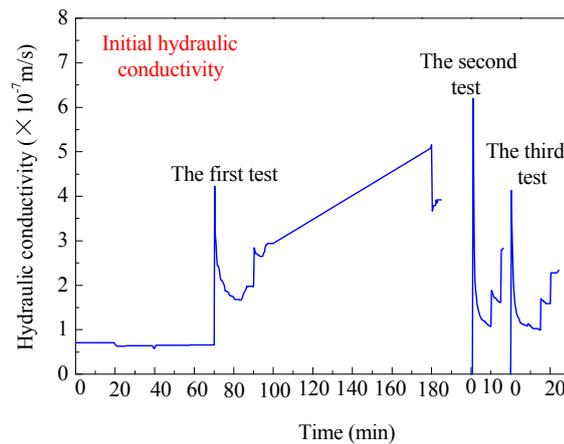
Fig. 10 Result of initial hydraulic conductivity (K) of Puzizhier fault.
