DEPARTMENT OF ENGINEERING GEOLOGY

THEMATIC RESEARCH FOCUS

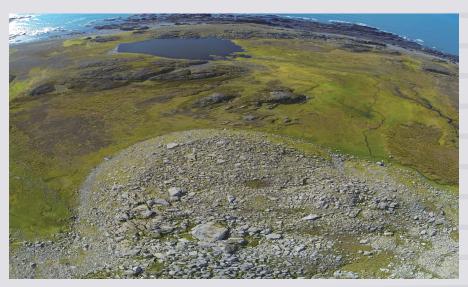
Wide-angle photo of rock glacier and coastal plain at Hornsund, Svalbard (NO)

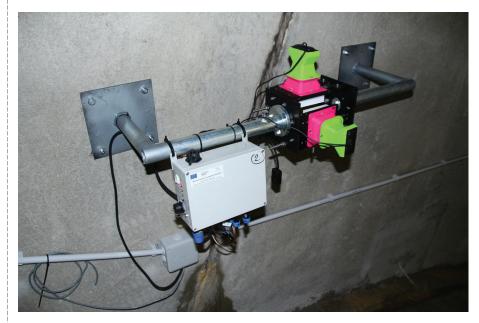
Newly installed current version of the TM-71 automatized 3D dilatometer inside the Horka lake dam (CZ)
